ECO INSPECTION CERTIFICATE

121 Points Vehicle Inspection Certificate

Ordered By : Shailesh Nayak	Inspection Date : 2019-03-11	Valid Till : 2019-06-11	Inspected By

Harley-Davidson Street 750 750CC, 2014

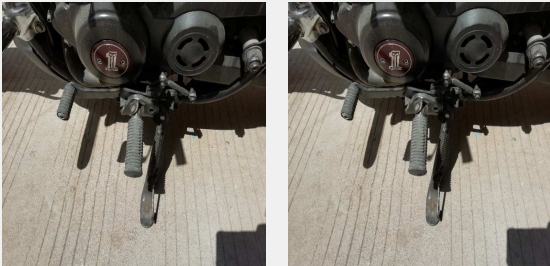
INSPECTION CHECKPOINTS	SCORE(X/10)	REMARKS/COMMENTS	OPTIONAL SPEND EST. (RS)
CENTRE STAND CONDITION	9	NOT AVAILABLE	0
CENTRE STAND RETENTION	9	NOT AVAILABLE	0
SIDE STAND CONDITION	9	GOOD CONDITION	0
SIDE STAND RETENTION	9	GOOD CONDITION	0
