ECO INSPECTION CERTIFICATE

Order ID : 50497

121 Points Vehicle Inspection Certificate

Mini Cooper D 5 DOOR, 2013

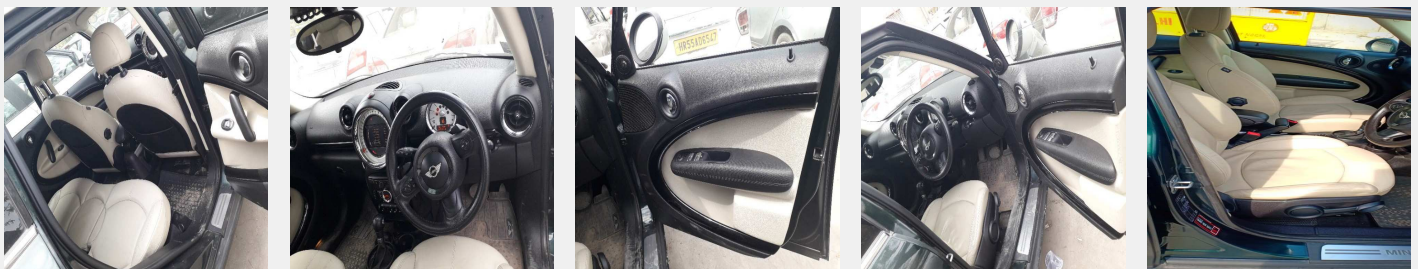
IMAGES

INSPECTION CHECKPOINTS	SCORE(X/10)	REMARKS/COMMENTS	OPTIONAL SPEND EST. (RS)
DOOR PANEL	7	GOOD	0
DOOR HINGES	7	GOOD	0
CARPET & FLOOR MAT	7	GOOD	0
DASHBOARD & INSTRUMENT PANEL	7	GOOD	0
HORN	7	GOOD	0
SPEAKERS & MUSIC SYSTEM	7	GOOD	0
HANDBRAKE	7	GOOD	0
STEERING-MOUNTED CONTROLS	7	GOOD	0
PEDALS	7	GOOD	0
CENTRAL LOCK	7	GOOD	0
A/C VENTS & HEATER	6	FAIR	0
CUP HOLDERS	7	GOOD	0
NAVIGATION (NO)	10		0
ODOMETER	7	GOOD	0
POWER WINDOWS (YES)	7	GOOD	0
HAZARD LIGHT	7	GOOD	0
SEAT & SEAT BELT	5	NEED DRYCLINIG	2500

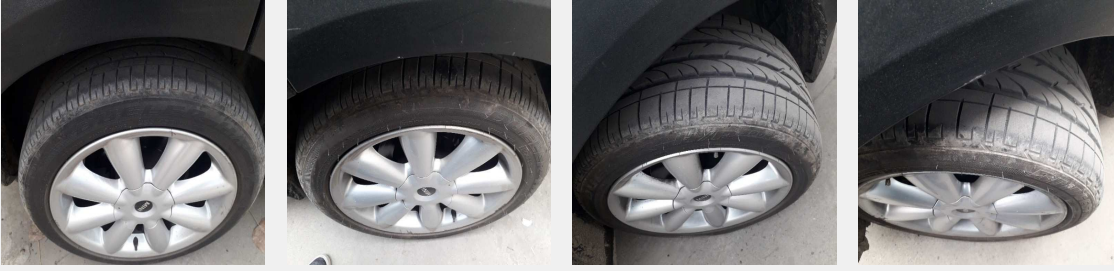
IMAGES

INSPECTION CHECKPOINTS	SCORE(X/10)	REMARKS/COMMENTS	OPTIONAL SPEND EST. (RS)
TYRES	7	GOOD	0
SPARE TYRE (NO)	10		0
WHEEL ASSEMBLY (ALLOY RIM)	7	GOOD	0

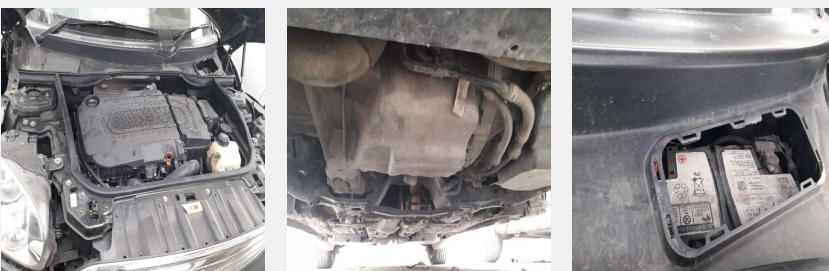
IMAGES

INSPECTION CHECKPOINTS	SCORE(X/10)	REMARKS/COMMENTS	OPTIONAL SPEND EST. (RS)
LH APRON	7	GOOD	0
RH APRON	7	GOOD	0
RADIATOR	7	GOOD	0
WIRING	7	GOOD	0
BATTERY	6	BATTERY CAVAR IS NOT AVAILABLE	1000
BRAKE FLUID LEVEL	7	GOOD	0
BRAKE & COOLANT HOSE PIPES	6	FAIR	0
UNDERCARRIAGE	6	FAIR	0
EXHAUST SYSTEM	6	FAIR	0
ENGINE OIL	4	POOR	4500
COOLANT LEVEL	4	POOR	1000
