# ECO INSPECTION CERTIFICATE

121 Points Vehicle Inspection Certificate

Ordered By : Somu Sil	Inspection Date : 2019-03-08	Valid Till : 2019-06-13
--------------------------	---------------------------------	----------------------------

## Toyota Prius 1.8, 2012

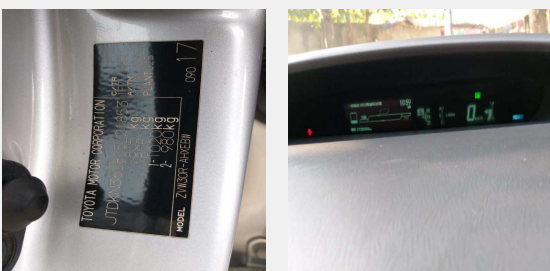
## IMAGES

INSPECTION CHECKPOINTS	SCORE(X/10)	REMARKS/COMMENTS	OPTIONAL SPEND EST. (RS)
STEERING PERFORMANCE	7	GOOD	0
BRAKE PERFORMANCE	7	GOOD	0
CLUTCH PERFORMANCE	7	GOOD	0
ENGINE NOISE	6	MINOR	0
IGNITION SYSTEM	6	FAIR	0
SUSPENSION PERFORMANCE	7	GOOD	0
SUSPENSION FRONT SHOCKS	7	GOOD	0
SUSPENSION REAR SHOCKS	7	GOOD	0
TRANSMISSION ENGAGE	6	FAIR	0
CRUISE CONTROL (YES)	6	FAIR	0
REAR PARKING SENSORS (NO)	10		0
REAR VIEW CAMERA (NO)	10		0

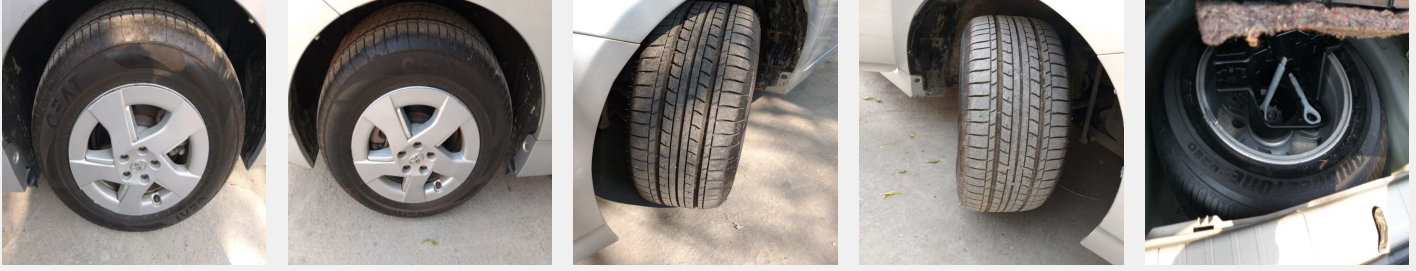
IMAGES

INSPECTION CHECKPOINTS	SCORE(X/10)	REMARKS/COMMENTS	OPTIONAL SPEND EST. (RS)
TYRES	7	GOOD	0
SPARE TYRE (YES)	7	GOOD	0
WHEEL ASSEMBLY (ALLOY RIM)	6	FAIR	0

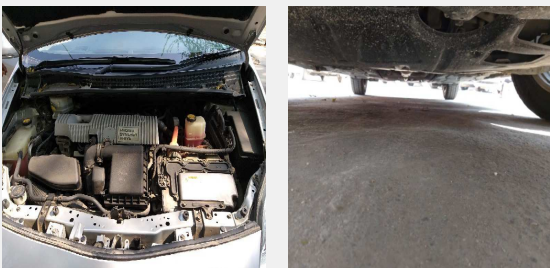
IMAGES

INSPECTION CHECKPOINTS	SCORE(X/10)	REMARKS/COMMENTS	OPTIONAL SPEND EST. (RS)
LH APRON	6	FAIR	0
RH APRON	6	FAIR	0
RADIATOR	6	FAIR	0
WIRING	6	FAIR	0
BATTERY	6	FAIR	0
BRAKE FLUID LEVEL	6	FAIR	0
ENGINE OIL	6	FAIR	0
COOLANT LEVEL	6	FAIR	0
BRAKE & COOLANT HOSE PIPES	6	FAIR	0
UNDERCARRIAGE	6	FAIR	0
EXHAUST SYSTEM	6	FAIR	0

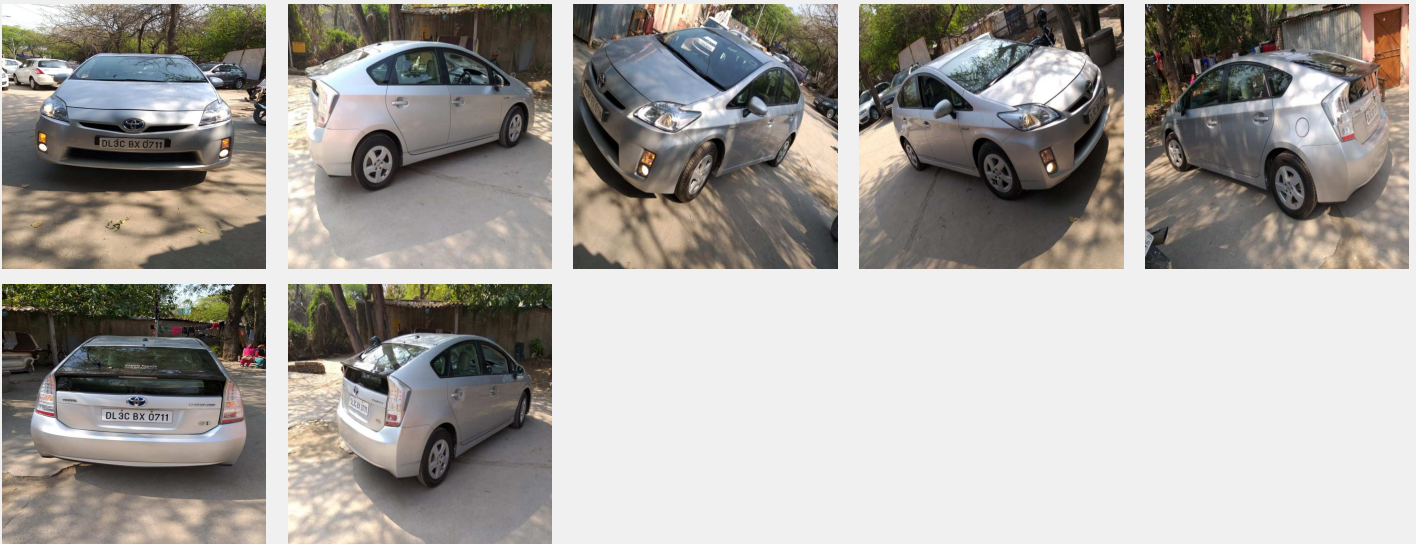
## IMAGES

INSPECTION CHECKPOINTS	SCORE(X/10)	REMARKS/COMMENTS	OPTIONAL SPEND EST. (RS)
LICENSE PLATE	6	FAIR	0
FRONT BUMPER	6	PAINTED	0
HEAD LIGHTS	7	GOOD	0
GRILLE	6	FAIR	0
TURN SIGNAL	6	FAIR	0
FOG LAMPS	7	GOOD	0
HOOD	6	PAINTED	0
PILLAR	6	PAINTED	0
FRONT WINDSHIELD	6	FAIR	0
SIDE VIEW MIRRORS	7	GOOD	0
LH FENDER	6	PAINTED	0
LH FRONT DOOR	6	PAINTED	0
LH REAR DOOR	6	PAINTED	0
LH RUNNING BOARD	6	PAINTED	0
LH QUARTER PANEL	6	PAINTED	0
FUEL LID	6	FAIR	0
REAR WINDSHIELD	6	FAIR	0
REAR BUMPER	6	PAINTED	0
TAIL LIGHT	6	FAIR	0
TRUNK LID/TAIL GATE	6	FAIR	0
LUGGAGE COMPARTMENT LIGHT	6	FAIR	0
RH QUARTER PANEL	6	PAINTED	0
RH RUNNING BOARD	6	PAINTED.	0
RH REAR DOOR	6	PAINTED	0

INSPECTION CHECKPOINTS	SCORE(X/10)	REMARKS/COMMENTS	OPTIONAL SPEND EST. (RS)
RH FRONT DOOR	6	PAINTED	0
RH FENDER	6	PAINTED	0
BODY RUST	6	MINOR	0
ROOF (REGULAR)	6	FAIR	0
PAINT CONDITION	6	FAIR	0
