ECO INSPECTION CERTIFICATE

121 Points Vehicle Inspection Certificate

Triumph Thunderbird Storm 1700CC, 2015

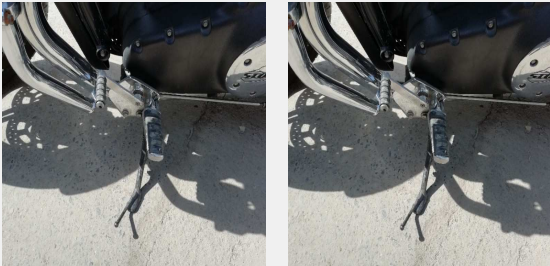
INSPECTION CHECKPOINTS	SCORE(X/10)	REMARKS/COMMENTS	OPTIONAL SPEND EST. (RS)
CENTRE STAND CONDITION	9	NOT AVAILABLE	0
CENTRE STAND RETENTION	9	NOT AVAILABLE	0
SIDE STAND CONDITION	9	GOOD CONDITION	0
SIDE STAND RETENTION	9	GOOD CONDITION	0
