# ECO INSPECTION CERTIFICATE

Order ID : 82573

121 Points Vehicle Inspection Certificate

## Honda Mobilio S I-DTEC, 2015

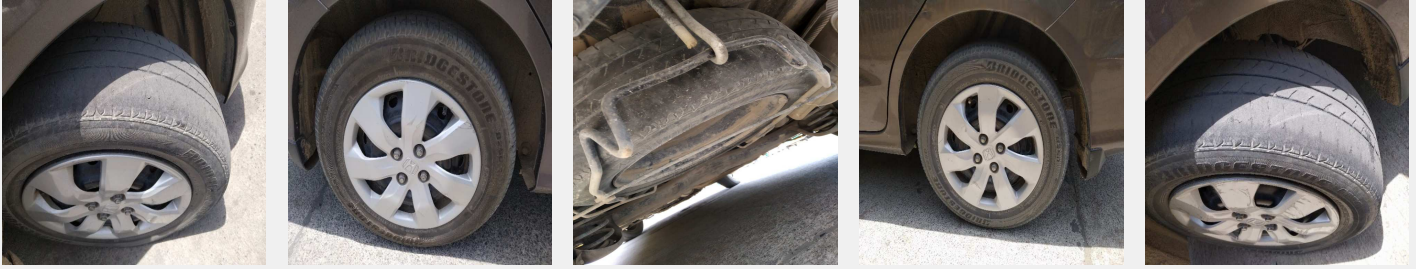
INSPECTION CHECKPOINTS	SCORE(X/10)	REMARKS/COMMENTS	OPTIONAL SPEND EST. (RS)
SPARE TYRE (YES)	8		0
WHEEL ASSEMBLY (STEEL RIM)	8		0
TYRES	2	FRONT BOTH SIDE TYRE CRACKING	10000

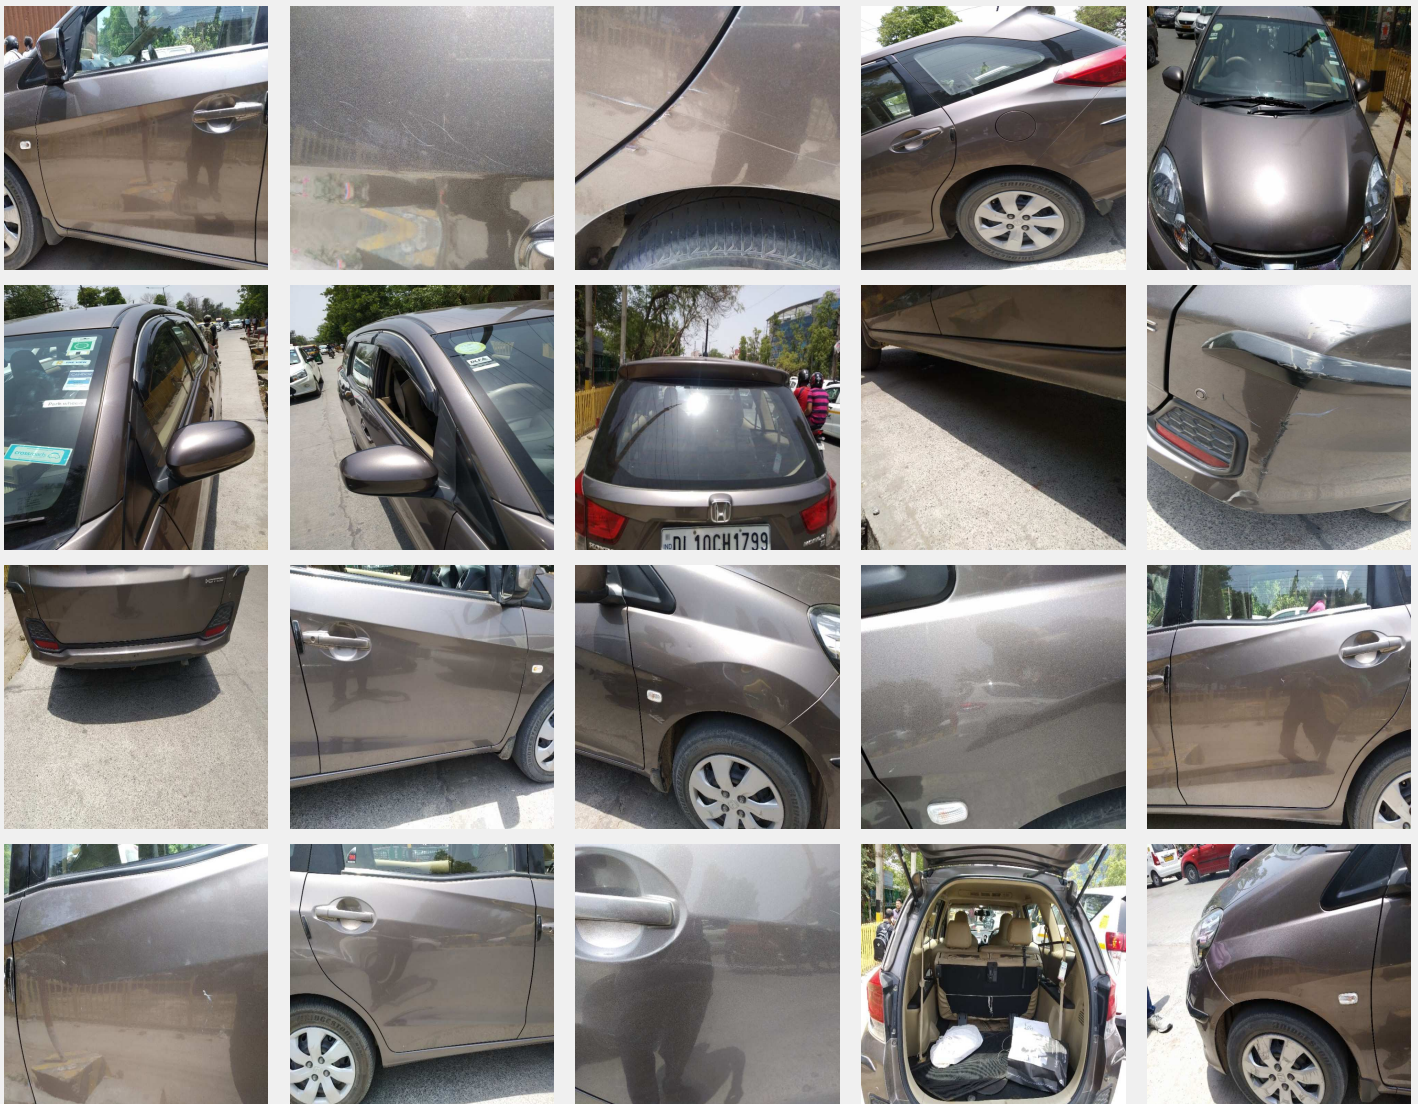
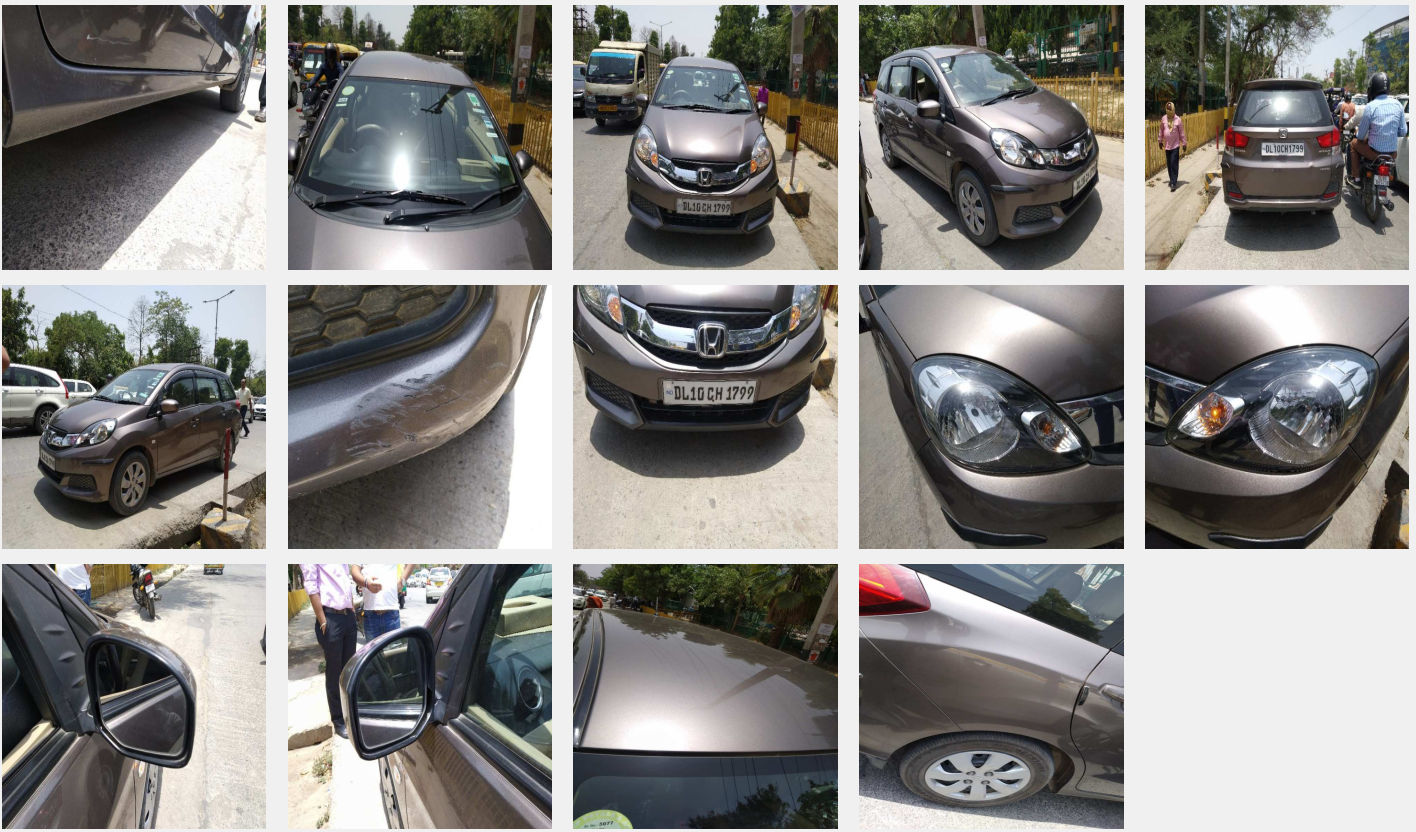
INSPECTION CHECKPOINTS	SCORE(X/10)	REMARKS/COMMENTS	OPTIONAL SPEND EST. (RS)
LICENSE PLATE	7		0
FRONT BUMPER	6	MINOR SCRATCHES	300
HEAD LIGHTS	7		0
GRILLE	7		0
TURN SIGNAL	7		0
HOOD	8		0
PILLAR	7		0
FRONT WINDSHIELD	7		0
SIDE VIEW MIRRORS	7		0
LH FENDER	8		0
LH FRONT DOOR	6	MINOR SCRATCHES	300
LH REAR DOOR	6	MINOR SCRATCHES	300
LH RUNNING BOARD	7		0
LH QUARTER PANEL	6	MINOR SCRATCHES AND DENT	500
FUEL LID	7		0
REAR WINDSHIELD	8		0
REAR BUMPER	6	MINOR SCRATCHES	300
LUGGAGE COMPARTMENT LIGHT	7		0
RH QUARTER PANEL	7		0
RH RUNNING BOARD	7		0
RH REAR DOOR	6	MINOR SCRATCHES	300
RH FRONT DOOR	7		0
RH FENDER	6	MINOR DENT AND SCRATCHES	300
BODY RUST	7		0

INSPECTION CHECKPOINTS	SCORE(X/10)	REMARKS/COMMENTS	OPTIONAL SPEND EST. (RS)
ROOF (REGULAR)	7		0
PAINT CONDITION	7		0
FOG LAMPS	0	NA	0
TAIL LIGHT	2	LH SIDE TAIL LIGHT DAMAGE	5000
TRUNK LID/TAIL GATE	3	NEED TO REPAIR	2500

minor scratches and minor dent front bumper and rear bumper already painted
