# ECO INSPECTION CERTIFICATE

121 Points Vehicle Inspection Certificate

Ordered By : Radhey	Inspection Date : 2019-06-12	Location : NOIDA

## Maruti Suzuki Celerio VXI, 2016

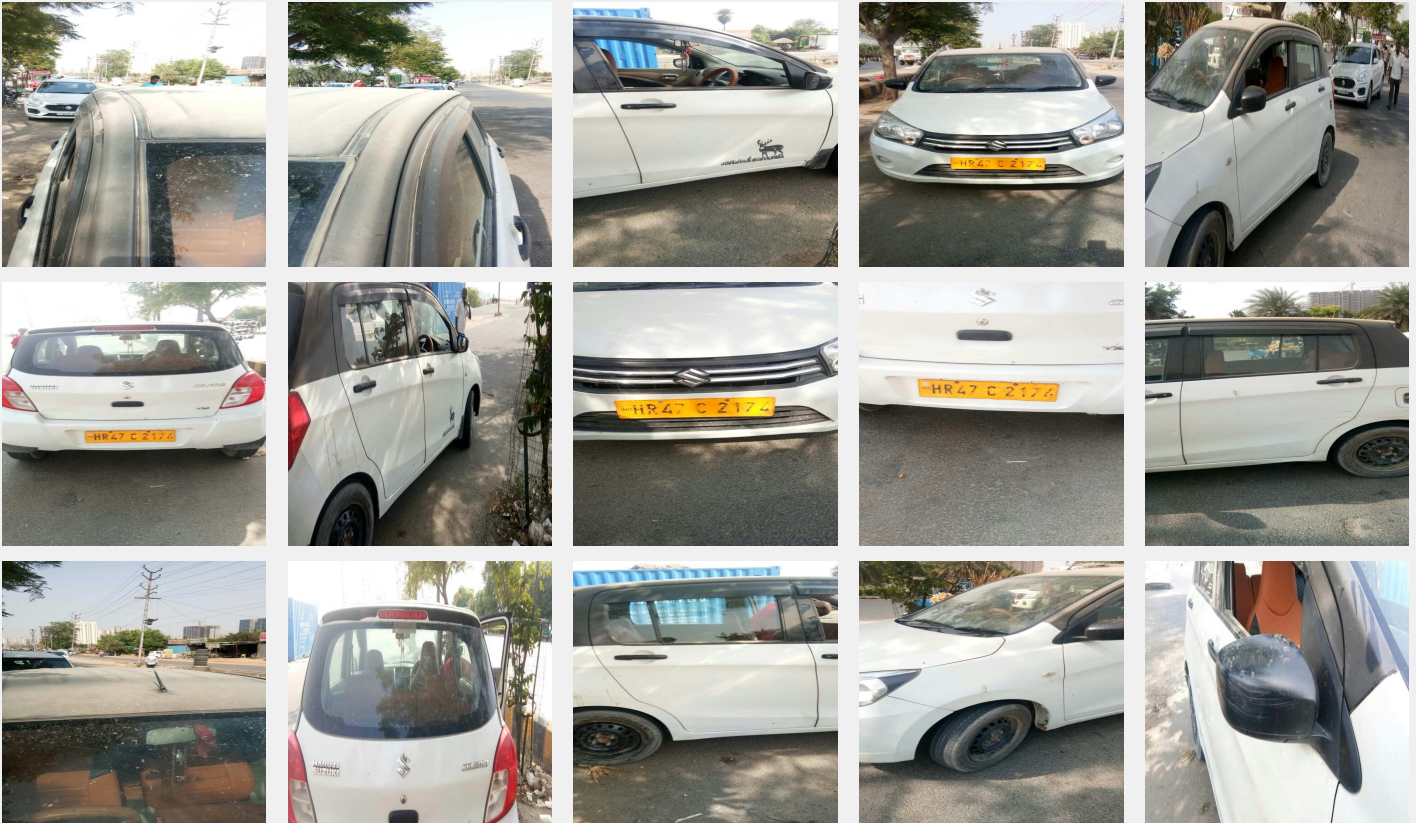
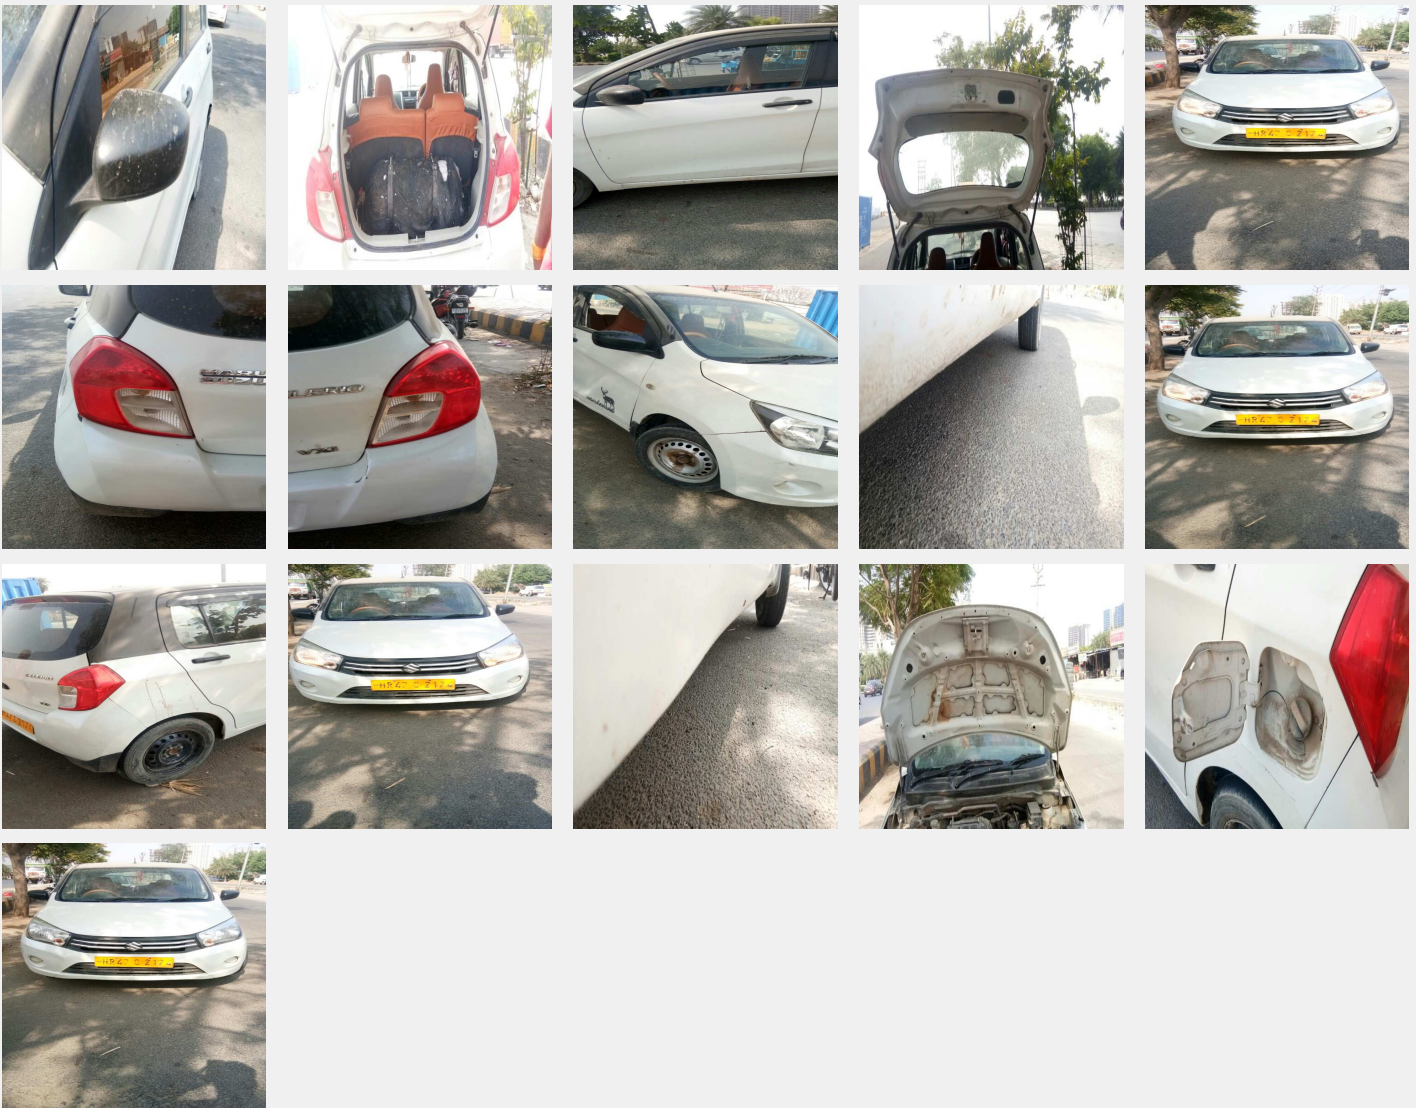
INSPECTION CHECKPOINTS	SCORE(X/10)	REMARKS/COMMENTS	OPTIONAL SPEND EST. (RS)
PAINT CONDITION	7		0
FOG LAMPS	0	NA	0
FRONT WINDSHIELD	5	MIRROR BROKEN NEED TO BE BEW INSTALL	4000
LH QUARTER PANEL	5	MINIOUR SCRATCHES NEED TO BE REPAIR	1000
REAR BUMPER	0	REAR BUMPER BROKEN NEED TO BE CHANGE	4500

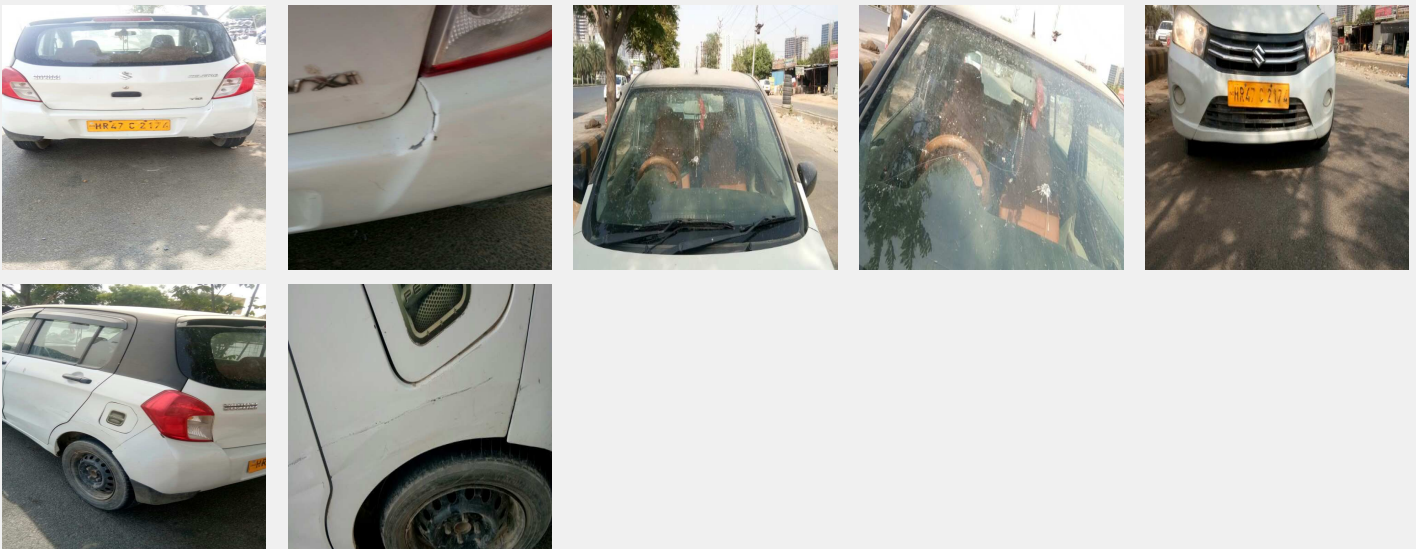
**NEED ATTENTION**

rear bumper is broken need to be change front right and left side suspension leeaage need to be ch
