ECO INSPECTION CERTIFICATE

121 Points Vehicle Inspection Certificate

Ordered By : Purab Nihalani	Inspection Date : 2019-06-14	Location : MATUNGA	Inspected By

Maruti Suzuki Baleno ZETA 1.2, 2016

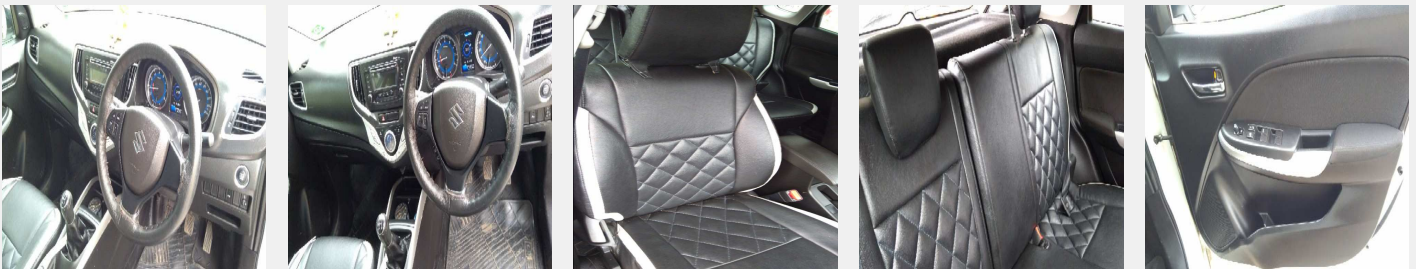
INTERIOR

INSPECTION CHECKPOINTS	SCORE(X/10)	REMARKS/COMMENTS	OPTIONAL SPEND EST. (RS)
DOOR PANEL	7	GOOD CONDITION	0
DOOR HINGES	7	GOOD CONDITION	0
CARPET & FLOOR MAT	7	GOOD CONDITION	0
SEAT & SEAT BELT	7	GOOD CONDITION	0
DASHBOARD & INSTRUMENT PANEL	8	GOOD CONDITION	0
HORN	8	GOOD SOUND	0
SPEAKERS & MUSIC SYSTEM	7	GOOD CONDITION	0
HANDBRAKE	7	GOOD CONDITION	0
STEERING-MOUNTED CONTROLS	7	GOOD CONDITION	0
PEDALS	7	GOOD CONDITION	0
CENTRAL LOCK	7	GOOD CONDITION	0
A/C VENTS & HEATER	7	GOOD COOLING	0
CUP HOLDERS	7	GOOD CONDITION	0
NAVIGATION (NO)	10		0
ODOMETER	8	GOOD CONDITION	0
POWER WINDOWS (YES)	8	GOOD CONDITION	0
HAZARD LIGHT	7	GOOD CONDITION	0

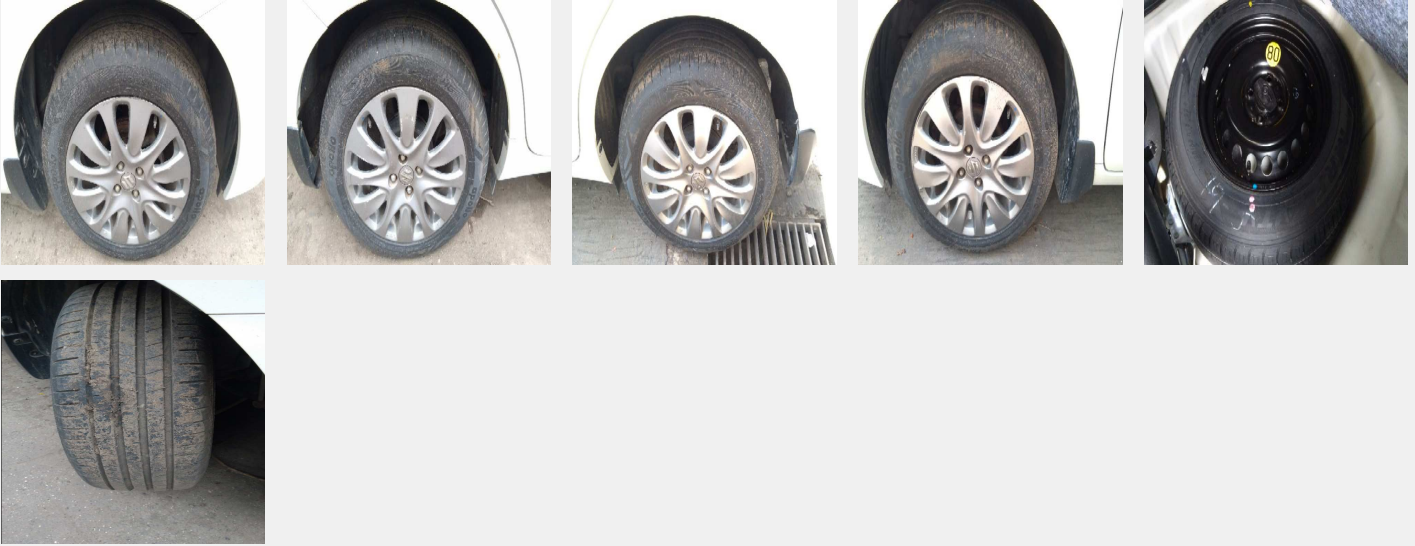
INSPECTION CHECKPOINTS	SCORE(X/10)	REMARKS/COMMENTS	OPTIONAL SPEND EST. (RS)
TYRES	7	GOOD CONDITION	0
SPARE TYRE (YES)	8	GOOD CONDITION	0
WHEEL ASSEMBLY (ALLOY RIM)	7	GOOD CONDITION	0

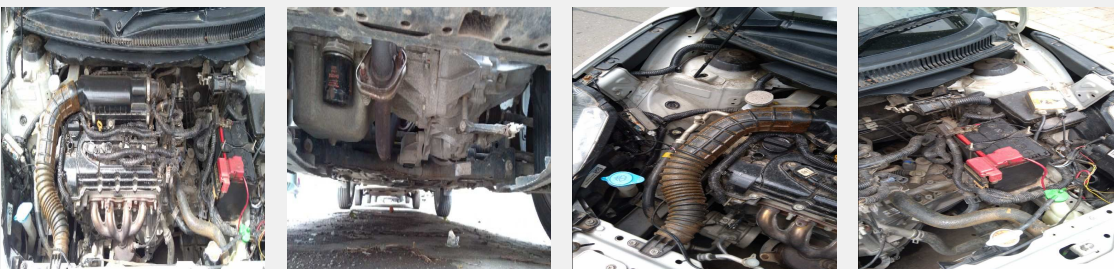
HOOD

INSPECTION CHECKPOINTS	SCORE(X/10)	REMARKS/COMMENTS	OPTIONAL SPEND EST. (RS)
LH APRON	7	GOOD CONDITION	0
RH APRON	7	GOOD CONDITION	0
RADIATOR	7	GOOD CONDITION	0
WIRING	6	NO DAMAGE	0
BATTERY	7	GOOD CONDITION	0
BRAKE FLUID LEVEL	7	MAXIMUM	0
ENGINE OIL	7	GOOD CONDITION	0
COOLANT LEVEL	7	MAXIMUM	0
BRAKE & COOLANT HOSE PIPES	6	ACCEPTABLE CONDITION	0
UNDERCARRIAGE	7	GOOD CONDITION	0
EXHAUST SYSTEM	7	GOOD CONDITION	0

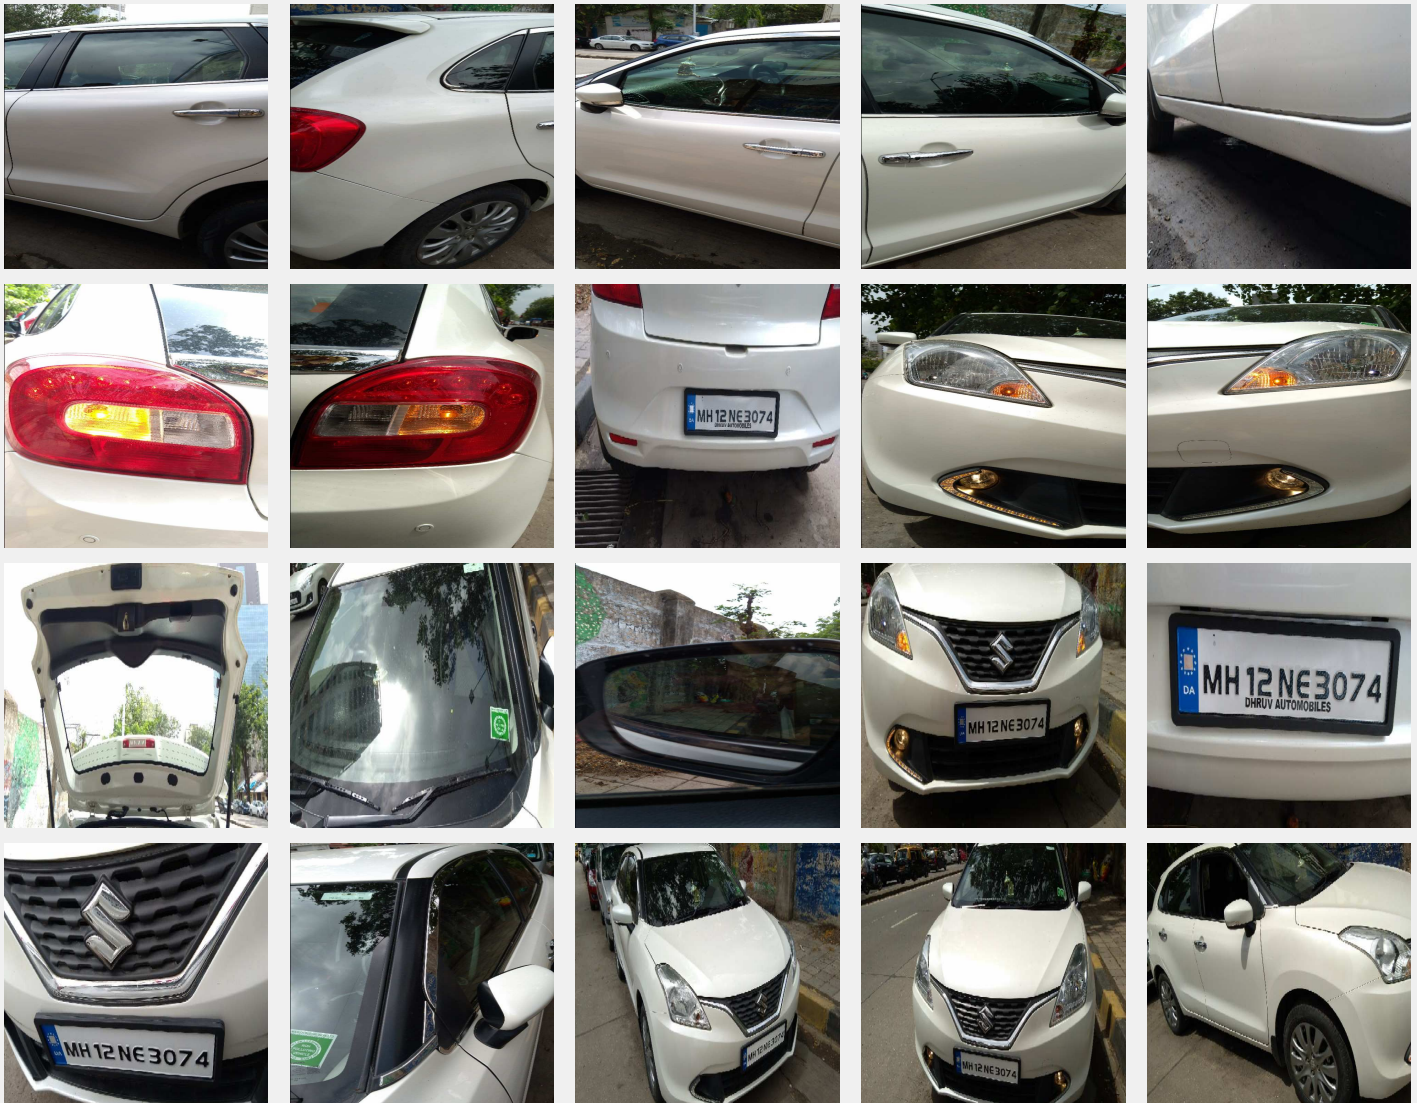
EXTERIOR (CONTINUED)

INSPECTION CHECKPOINTS	SCORE(X/10)	REMARKS/COMMENTS	OPTIONAL SPEND EST. (RS)
RH FRONT DOOR	7	GOOD CONDITION	0
RH FENDER	7	GOOD CONDITION	0
BODY RUST	7	NO RUST	0
ROOF (REGULAR)	7	GOOD CONDITION	0
PAINT CONDITION	7	GOOD	0
