# ECO INSPECTION CERTIFICATE

121 Points Vehicle Inspection Certificate

## Tata Nano TWIST XT, 2014

MAKE	TATA	ENGINE NUMBER	12614
MODEL	NANO	REGISTRATION NO.	KA03MU8625
MFG. DATE	09/2014	VIN/CHASSIS NUMBER	MAT612280EKJ13084
TRIM	TWIST XT	ODOMETER READING	9212
COLOR	D PURPLE	INSURANCE EXPIRY	2019-6-14
BODY TYPE	HATCHBACK	VEHICLE PASSING	PRIVATE
FUEL TYPE	PETROL	ENGINE SOUND LINK	<a href="#">LISTEN ENGINE SOUND</a>

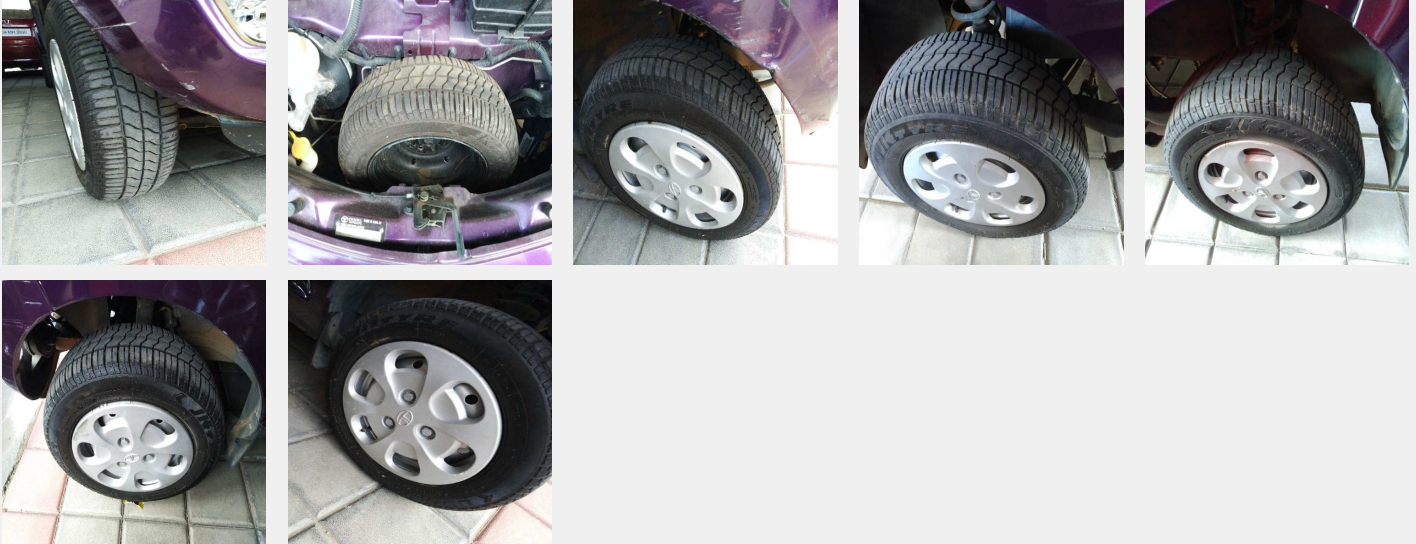
IMAGES

INSPECTION CHECKPOINTS	SCORE(X/10)	REMARKS/COMMENTS	OPTIONAL SPEND EST. (RS)
TYRES	8		0
SPARE TYRE (YES)	8		0
WHEEL ASSEMBLY (STEEL RIM)	8		0

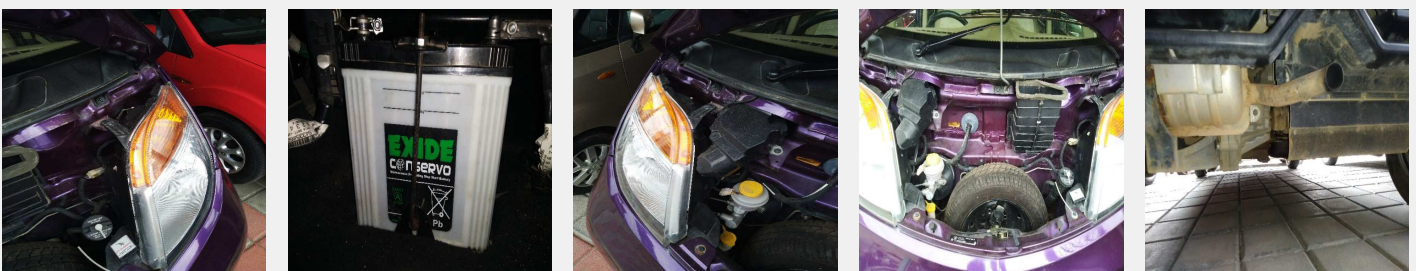
IMAGES

INSPECTION CHECKPOINTS	SCORE(X/10)	REMARKS/COMMENTS	OPTIONAL SPEND EST. (RS)
LH APRON	8		0
RH APRON	8		0
RADIATOR	7		0
WIRING	7		0
BATTERY	8		0
BRAKE FLUID LEVEL	7		0
ENGINE OIL	7		0
COOLANT LEVEL	7		0
BRAKE & COOLANT HOSE PIPES	7		0
UNDERCARRIAGE	8		0
EXHAUST SYSTEM	8		0

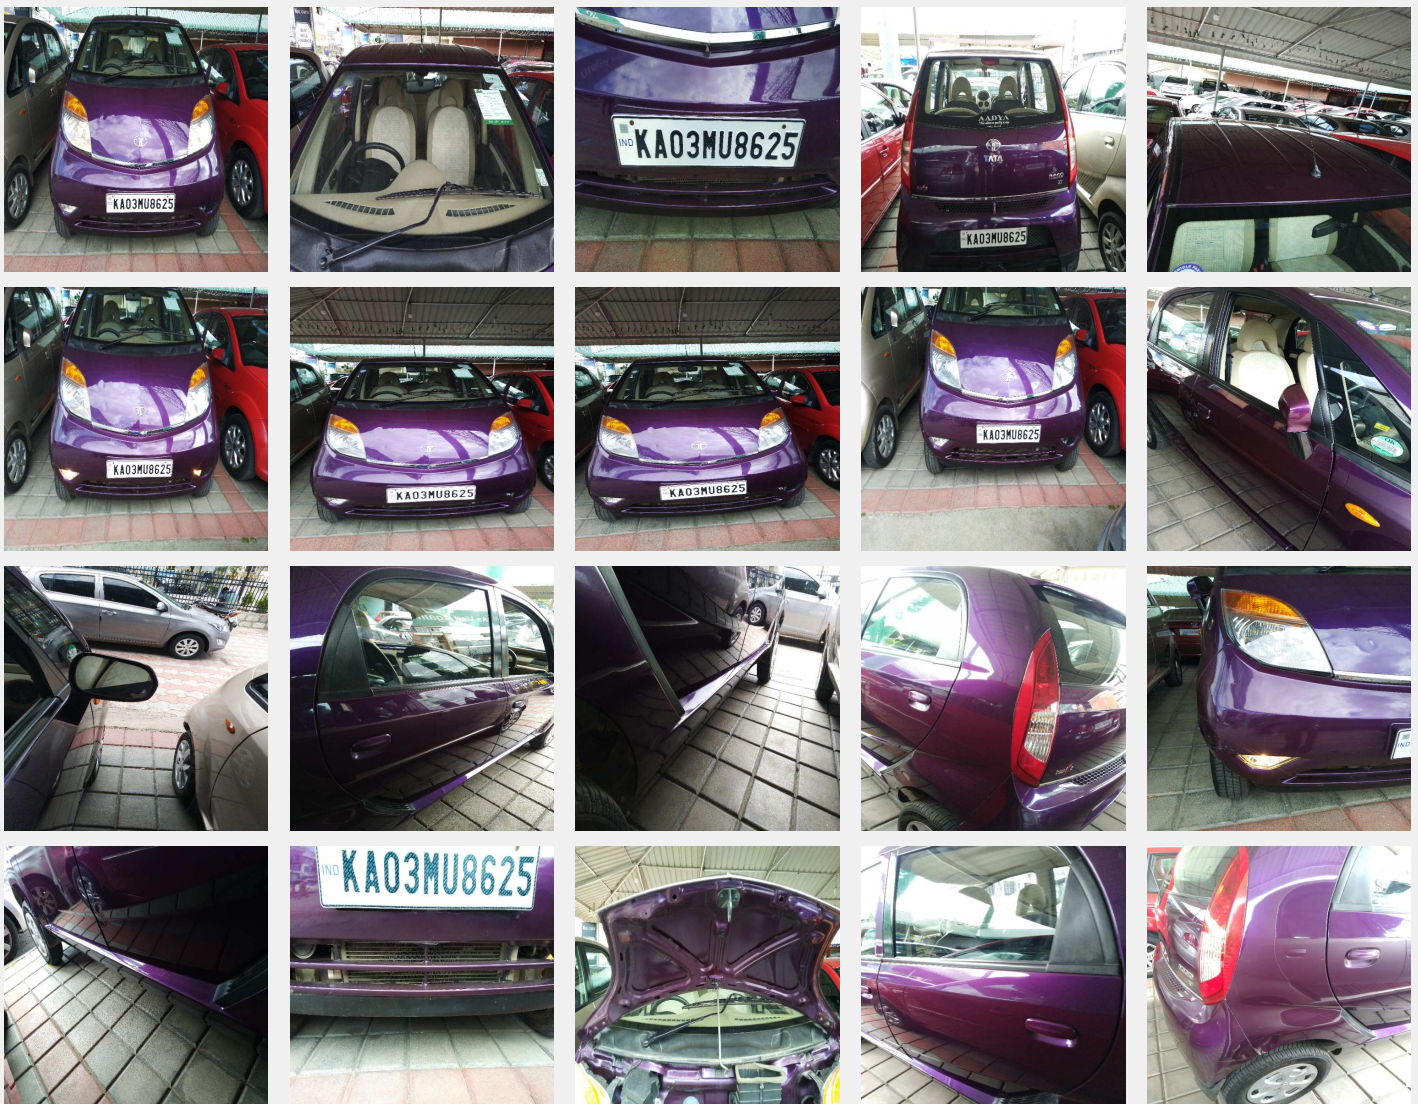
## IMAGES

INSPECTION CHECKPOINTS	SCORE(X/10)	REMARKS/COMMENTS	OPTIONAL SPEND EST. (RS)
LICENSE PLATE	8		0
FRONT BUMPER	6	POLISHING	1000
HEAD LIGHTS	8		0
GRILLE	7		0
TURN SIGNAL	8		0
FOG LAMPS	7		0
HOOD	8		0
PILLAR	8		0
FRONT WINDSHIELD	8		0
SIDE VIEW MIRRORS	8		0
LH FENDER	7		0
LH FRONT DOOR	6	TOUCHUP	1000
LH REAR DOOR	8		0
LH RUNNING BOARD	8		0
LH QUARTER PANEL	8		0
FUEL LID	10		0
REAR WINDSHIELD	8		0
REAR BUMPER	8		0
TAIL LIGHT	8		0
TRUNK LID/TAIL GATE	10		0
LUGGAGE COMPARTMENT LIGHT	10		0
RH QUARTER PANEL	6	DENTING AND PAINTING	1500
RH RUNNING BOARD	8		0
RH REAR DOOR	7		0

INSPECTION CHECKPOINTS	SCORE(X/10)	REMARKS/COMMENTS	OPTIONAL SPEND EST. (RS)
RH FRONT DOOR	8		0
RH FENDER	6	DENTING AND PAINTING	1500
BODY RUST	8		0
ROOF (REGULAR)	8		0
PAINT CONDITION	8		0
