ECO INSPECTION CERTIFICATE

121 Points Vehicle Inspection Certificate

Inspection Date :
2019-06-15

Honda Activa 110CC, 2010

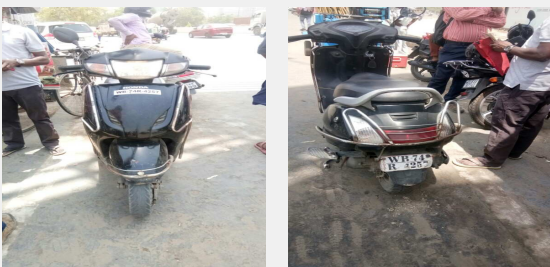
IMAGES

| INSPECTION CHECKPOINTS | SCORE(X/10) | REMARKS/COMMENTS | OPTIONAL SPEND EST. (RS) |
|---|---|---|---|
| MIRRORS CONDITION | 5 | MIRROR MISSING NEED TO BE NEW INSTALL | 300 |
| MIRRORS AIM | 5 | LEFT SIDE MIRROR MISSING NEED TO BE NEW INSTALL | 300 |
