# ECO INSPECTION CERTIFICATE

Order ID : 80475

121 Points Vehicle Inspection Certificate

## Volkswagen Polo 1.2 TDI HIGHLINE, 2011

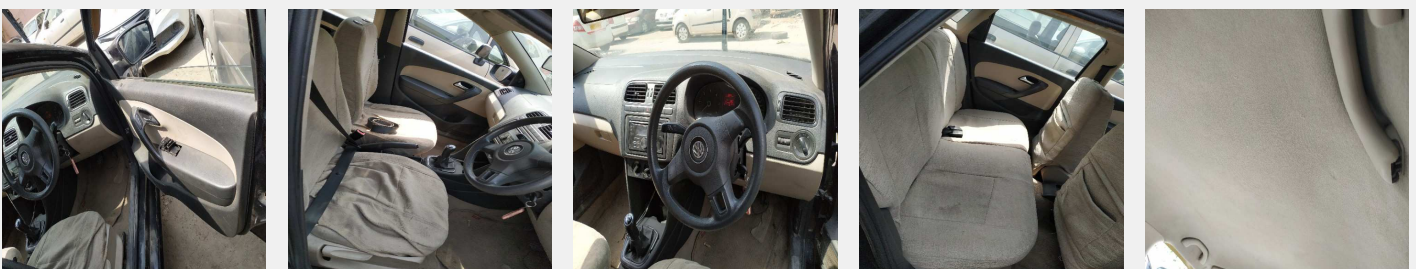
INSPECTION CHECKPOINTS	SCORE(X/10)	REMARKS/COMMENTS	OPTIONAL SPEND EST. (RS)
DOOR HINGES	7		0
CARPET & FLOOR MAT	7		0
SEAT & SEAT BELT	7		0
HORN	7		0
HANDBRAKE	7		0
PEDALS	7		0
A/C VENTS & HEATER	7		0
CUP HOLDERS	7		0
NAVIGATION (NO)	10		0
ODOMETER	7		0
POWER WINDOWS (YES)	7		0
HAZARD LIGHT	7		0
DOOR PANEL	3	NEED REPAIR WINDOWS BUTTON	1000
DASHBOARD & INSTRUMENT PANEL	4	NEED DRY CLEAN	1500
SPEAKERS & MUSIC SYSTEM	4	NOT WORKING NEED REPAIR WIRING CONNECTION	1500
STEERING-MOUNTED CONTROLS	0	NA	0
CENTRAL LOCK	0	NA	0

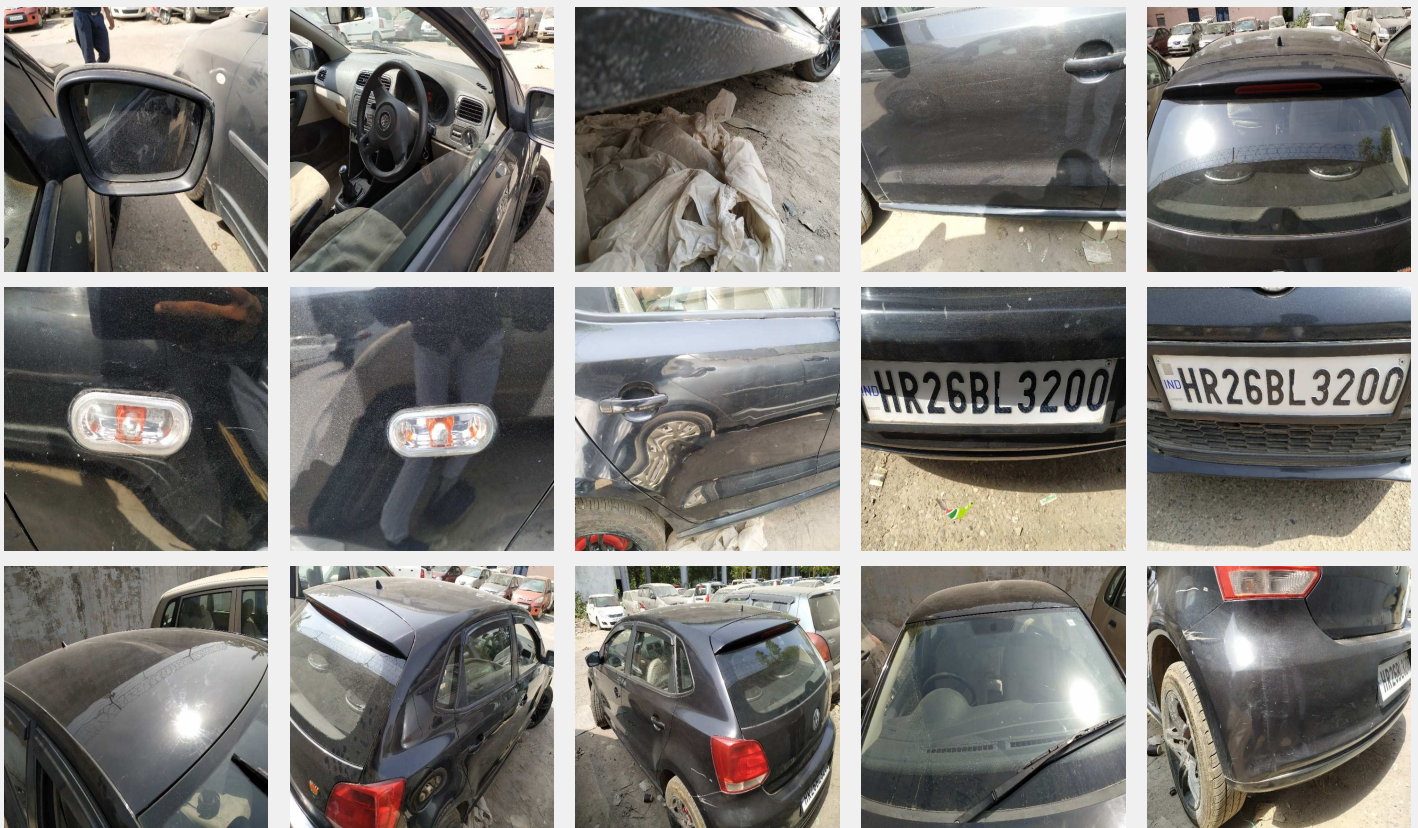
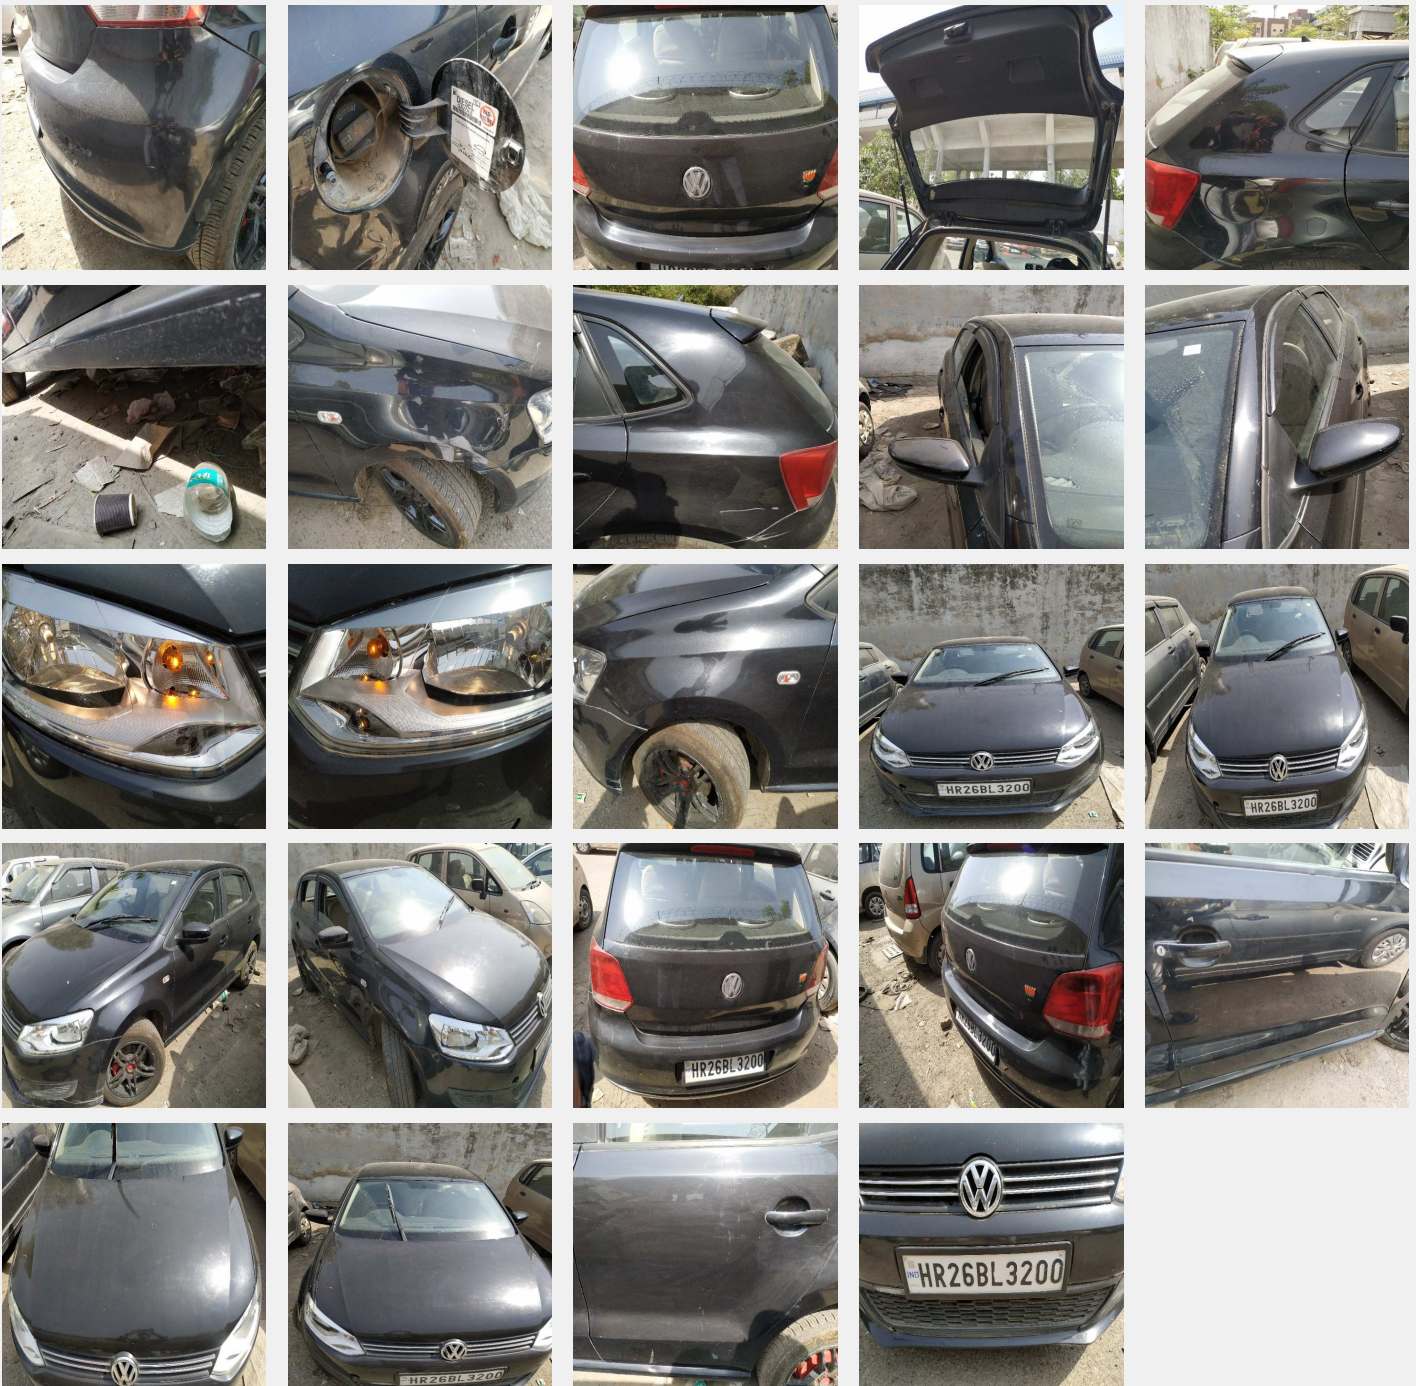
INSPECTION CHECKPOINTS	SCORE(X/10)	REMARKS/COMMENTS	OPTIONAL SPEND EST. (RS)
LICENSE PLATE	7		0
HEAD LIGHTS	7		0
GRILLE	7		0
TURN SIGNAL	7		0
HOOD	6	MINOR SCRATCHES	1500
PILLAR	7		0
FRONT WINDSHIELD	7		0
SIDE VIEW MIRRORS	7		0
LH FENDER	7		0
LH FRONT DOOR	7		0
LH REAR DOOR	7		0
LH RUNNING BOARD	7		0
LH QUARTER PANEL	6	MINOR SCRATCHES	1500
FUEL LID	7		0
REAR WINDSHIELD	7		0
REAR BUMPER	6	MINOR SCRATCHES	1500
TRUNK LID/TAIL GATE	7		0
RH QUARTER PANEL	7		0
RH RUNNING BOARD	7		0
RH REAR DOOR	6		0
RH FRONT DOOR	7		0
RH FENDER	7		0
BODY RUST	7		0
ROOF (REGULAR)	7		0

INSPECTION CHECKPOINTS	SCORE(X/10)	REMARKS/COMMENTS	OPTIONAL SPEND EST. (RS)
PAINT CONDITION	7		0
FRONT BUMPER	4	NEED REPAIR	4000
FOG LAMPS	0	NA	0
TAIL LIGHT	4	RHS BREAKLIGHT NOT WORKING AND BOTH SIDE REVERS LIGHT NOT WORKING NEED REPAIR	1000
LUGGAGE COMPARTMENT LIGHT	0	NA	0
