ECO INSPECTION CERTIFICATE

Order ID : 77334

121 Points Vehicle Inspection Certificate

Hyundai I20 MAGNA 1.2, 2010

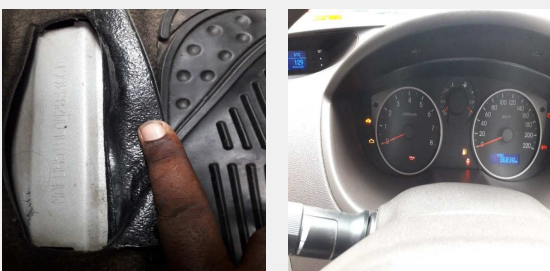
IMAGES

INSPECTION CHECKPOINTS	SCORE(X/10)	REMARKS/COMMENTS	OPTIONAL SPEND EST. (RS)
STEERING PERFORMANCE	6	GOOD	0
BRAKE PERFORMANCE	6	GOOD	0
CLUTCH PERFORMANCE	6	GOOD	0
ENGINE NOISE	6	GOOD	0
IGNITION SYSTEM	6	GOOD	0
SUSPENSION PERFORMANCE	6	GOOD	0
SUSPENSION FRONT SHOCKS	6	GOOD	0
SUSPENSION REAR SHOCKS	6	GOOD	0
TRANSMISSION ENGAGE	6	GOOD	0
CRUISE CONTROL (YES)	6	GOOD	0
REAR PARKING SENSORS (YES)	6	GOOD	0
REAR VIEW CAMERA (YES)	6	GOOD	0

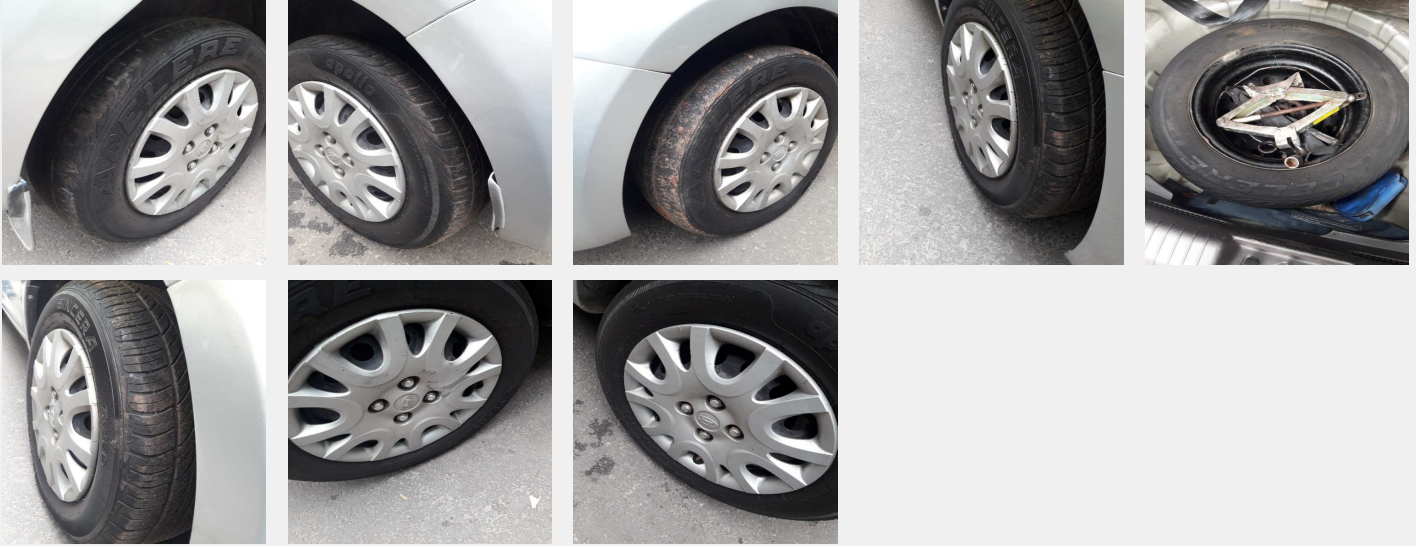
IMAGES

INSPECTION CHECKPOINTS	SCORE(X/10)	REMARKS/COMMENTS	OPTIONAL SPEND EST. (RS)
TYRES	6	GOOD	0
SPARE TYRE (YES)	6	GOOD	0
WHEEL ASSEMBLY (STEEL RIM)	6	GOOD	0

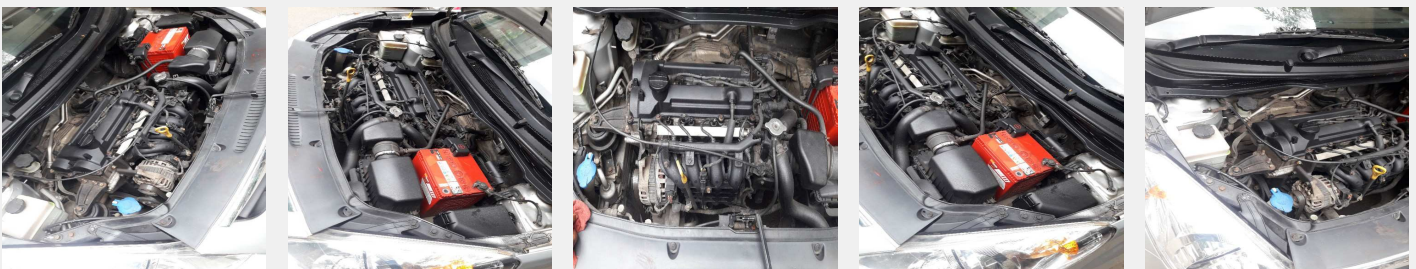
IMAGES

INSPECTION CHECKPOINTS	SCORE(X/10)	REMARKS/COMMENTS	OPTIONAL SPEND EST. (RS)
LH APRON	6	GOOD	0
RH APRON	6	GOOD	0
RADIATOR	6	GOOD	0
WIRING	6	GOOD	0
BATTERY	6	GOOD	0
BRAKE FLUID LEVEL	6	GOOD	0
ENGINE OIL	6	GOOD	0
COOLANT LEVEL	6	GOOD	0
BRAKE & COOLANT HOSE PIPES	6	GOOD	0
UNDERCARRIAGE	6	GOOD	0
EXHAUST SYSTEM	6	GOOD	0

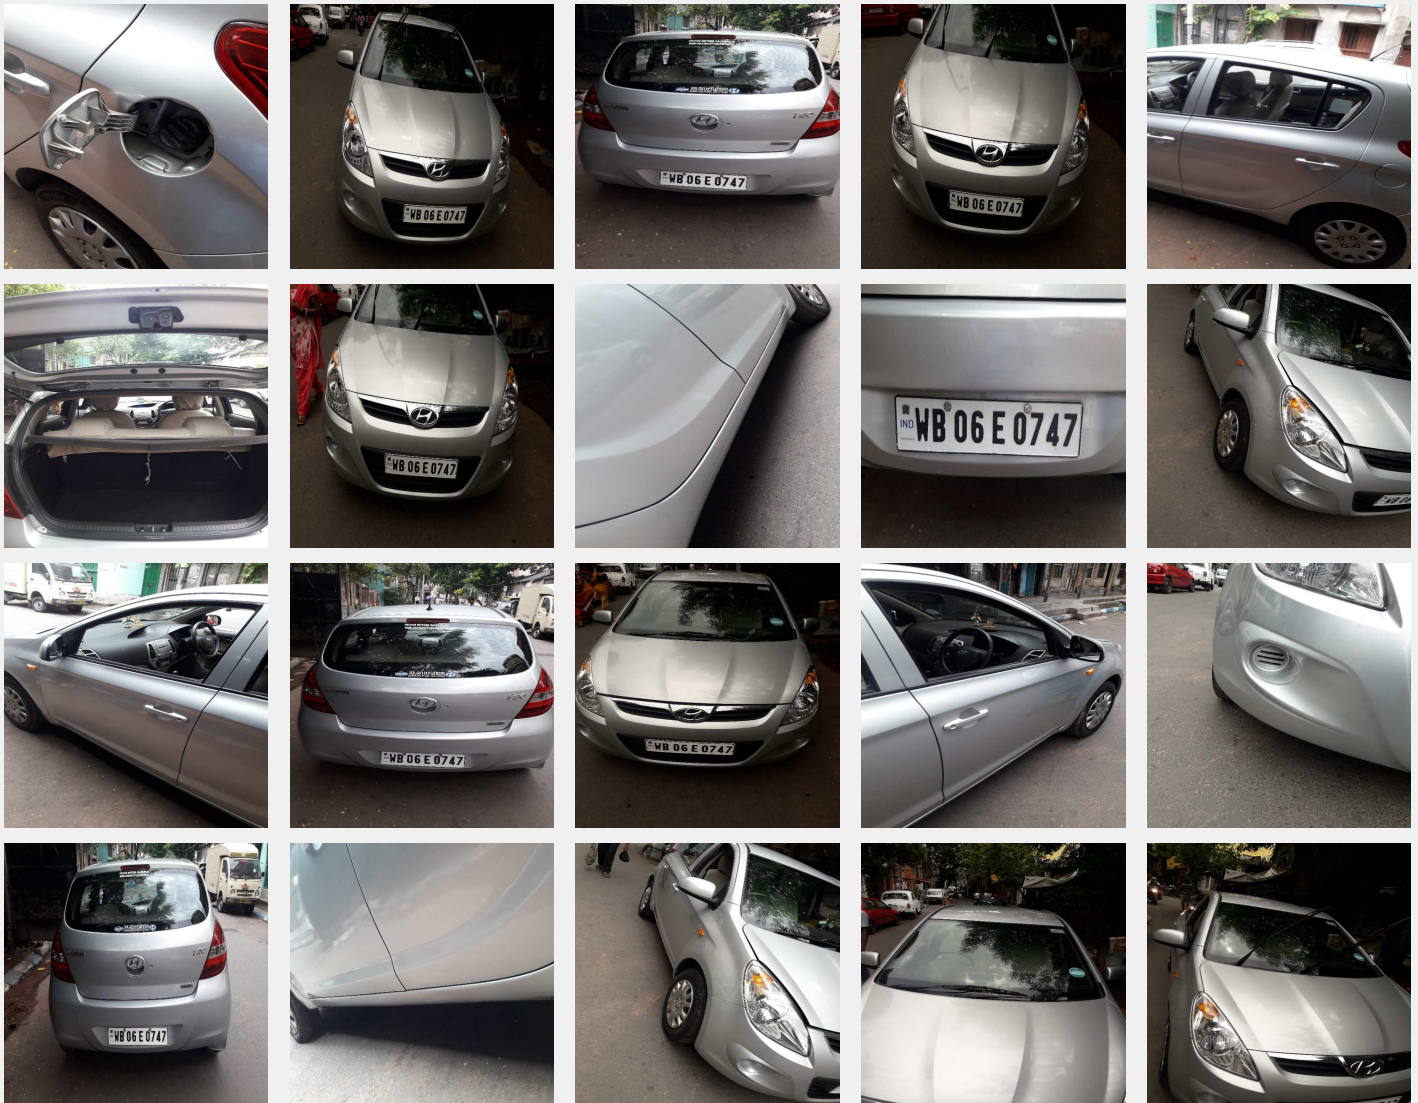
IMAGES

INSPECTION CHECKPOINTS	SCORE(X/10)	REMARKS/COMMENTS	OPTIONAL SPEND EST. (RS)
RH FRONT DOOR	6	GOOD	0
RH FENDER	6	GOOD	0
BODY RUST	6	GOOD	0
ROOF (REGULAR)	6	GOOD	0
PAINT CONDITION	6	GOOD	0
