ECO INSPECTION CERTIFICATE

121 Points Vehicle Inspection Certificate

Ordered By : Deep	Inspection Date : 2019-06-17	Location : PUNE

Maruti Suzuki Eeco 7 STR, 2010

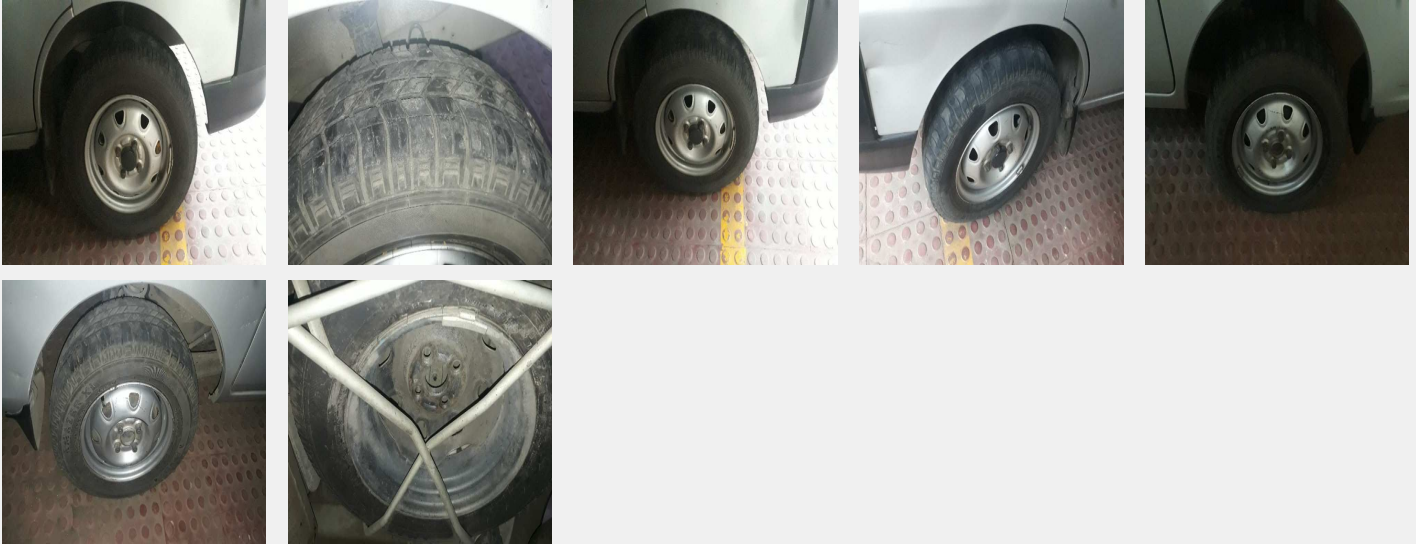
INSPECTION CHECKPOINTS	SCORE(X/10)	REMARKS/COMMENTS	OPTIONAL SPEND EST. (RS)
TYRES	7	GOOD	0
SPARE TYRE (YES)	7	GOOD	0
WHEEL ASSEMBLY (STEEL RIM)	7	GOOD	0

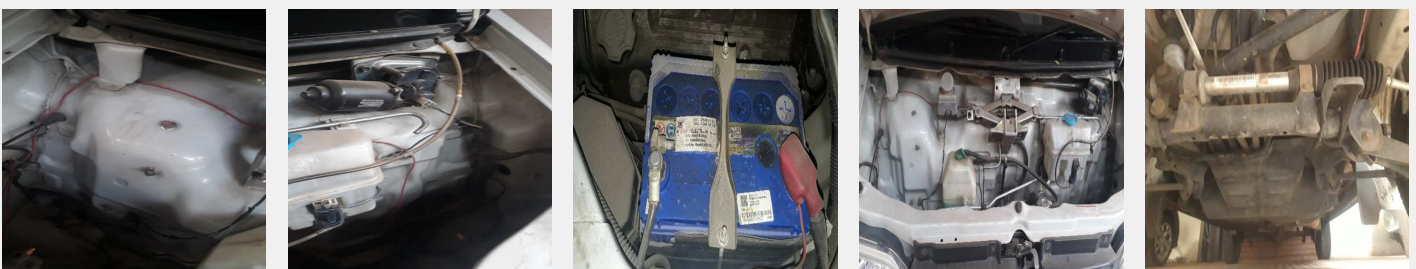
HOOD

INSPECTION CHECKPOINTS	SCORE(X/10)	REMARKS/COMMENTS	OPTIONAL SPEND EST. (RS)
LH APRON	7	GOOD	0
RH APRON	7	GOOD	0
RADIATOR	7	GOOD	0
WIRING	7	GOOD	0
BATTERY	7	GOOD	0
BRAKE FLUID LEVEL	7	GOOD	0
ENGINE OIL	7	GOOD	0
COOLANT LEVEL	7	GOOD	0
BRAKE & COOLANT HOSE PIPES	7	GOOD	0
UNDERCARRIAGE	7	GOOD	0
EXHAUST SYSTEM	7	GOOD	0

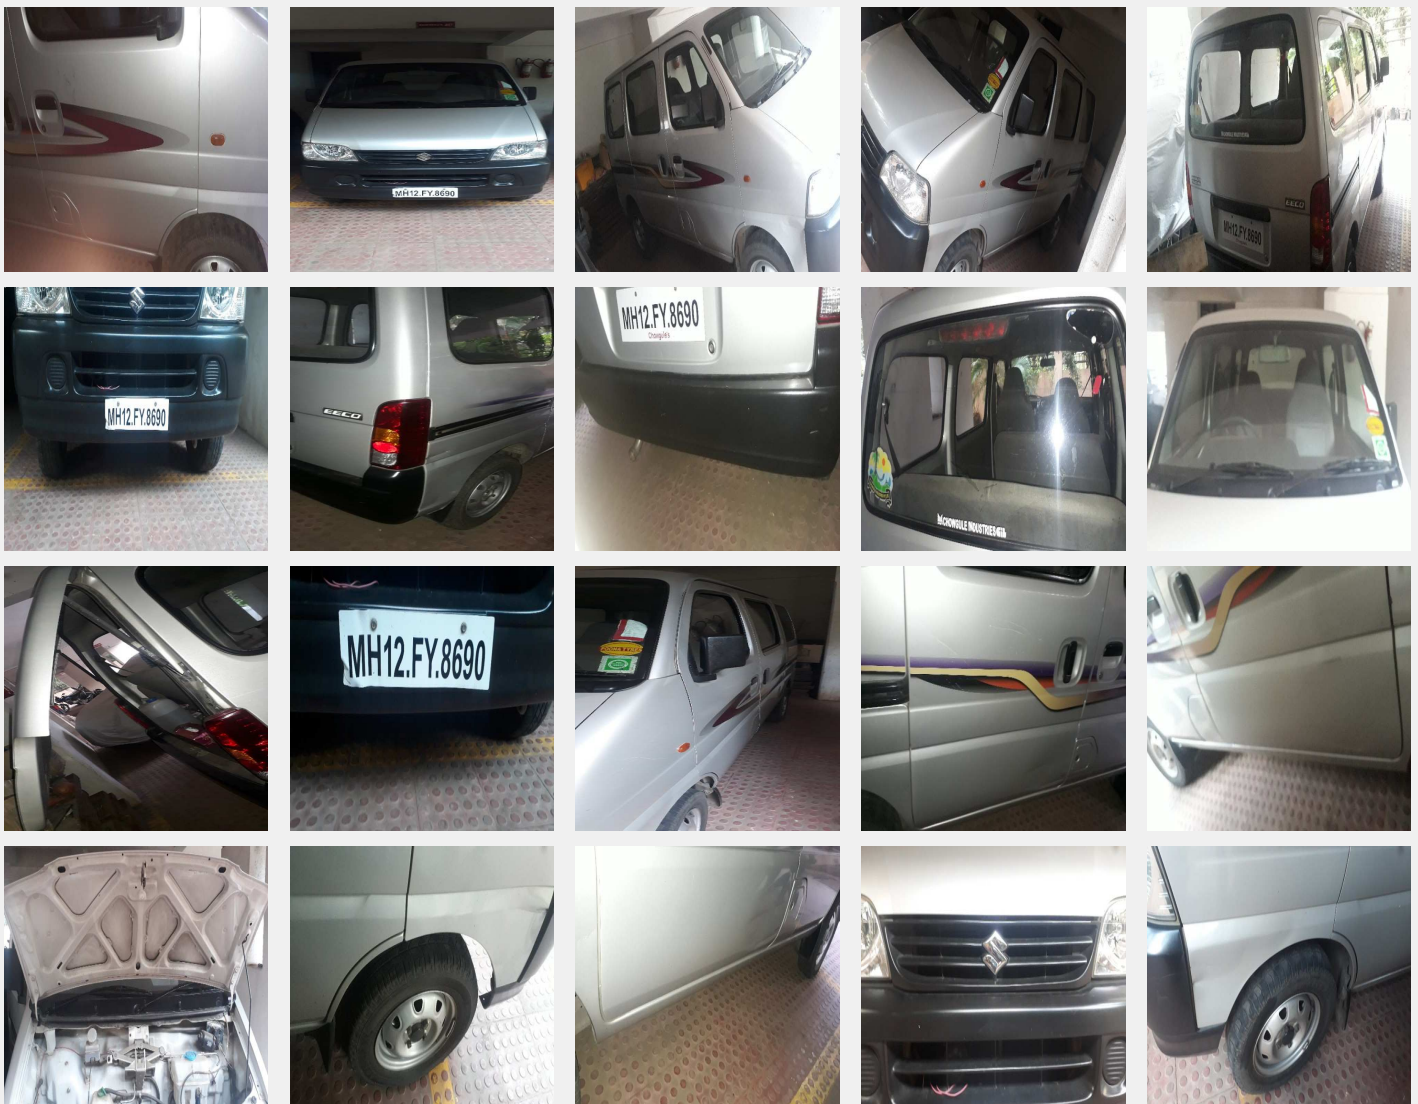
EXTERIOR (CONTINUED)

INSPECTION CHECKPOINTS	SCORE(X/10)	REMARKS/COMMENTS	OPTIONAL SPEND EST. (RS)
RH FRONT DOOR	7	GOOD	0
RH FENDER	7	GOOD	0
BODY RUST	7	GOOD	0
ROOF (REGULAR)	7	GOOD	0
PAINT CONDITION	7	GOOD	0
