ECO INSPECTION CERTIFICATE

Order ID : 83793

121 Points Vehicle Inspection Certificate

Ford Ecosport TITANIUM 1.5L TI-VCT AT, 2014

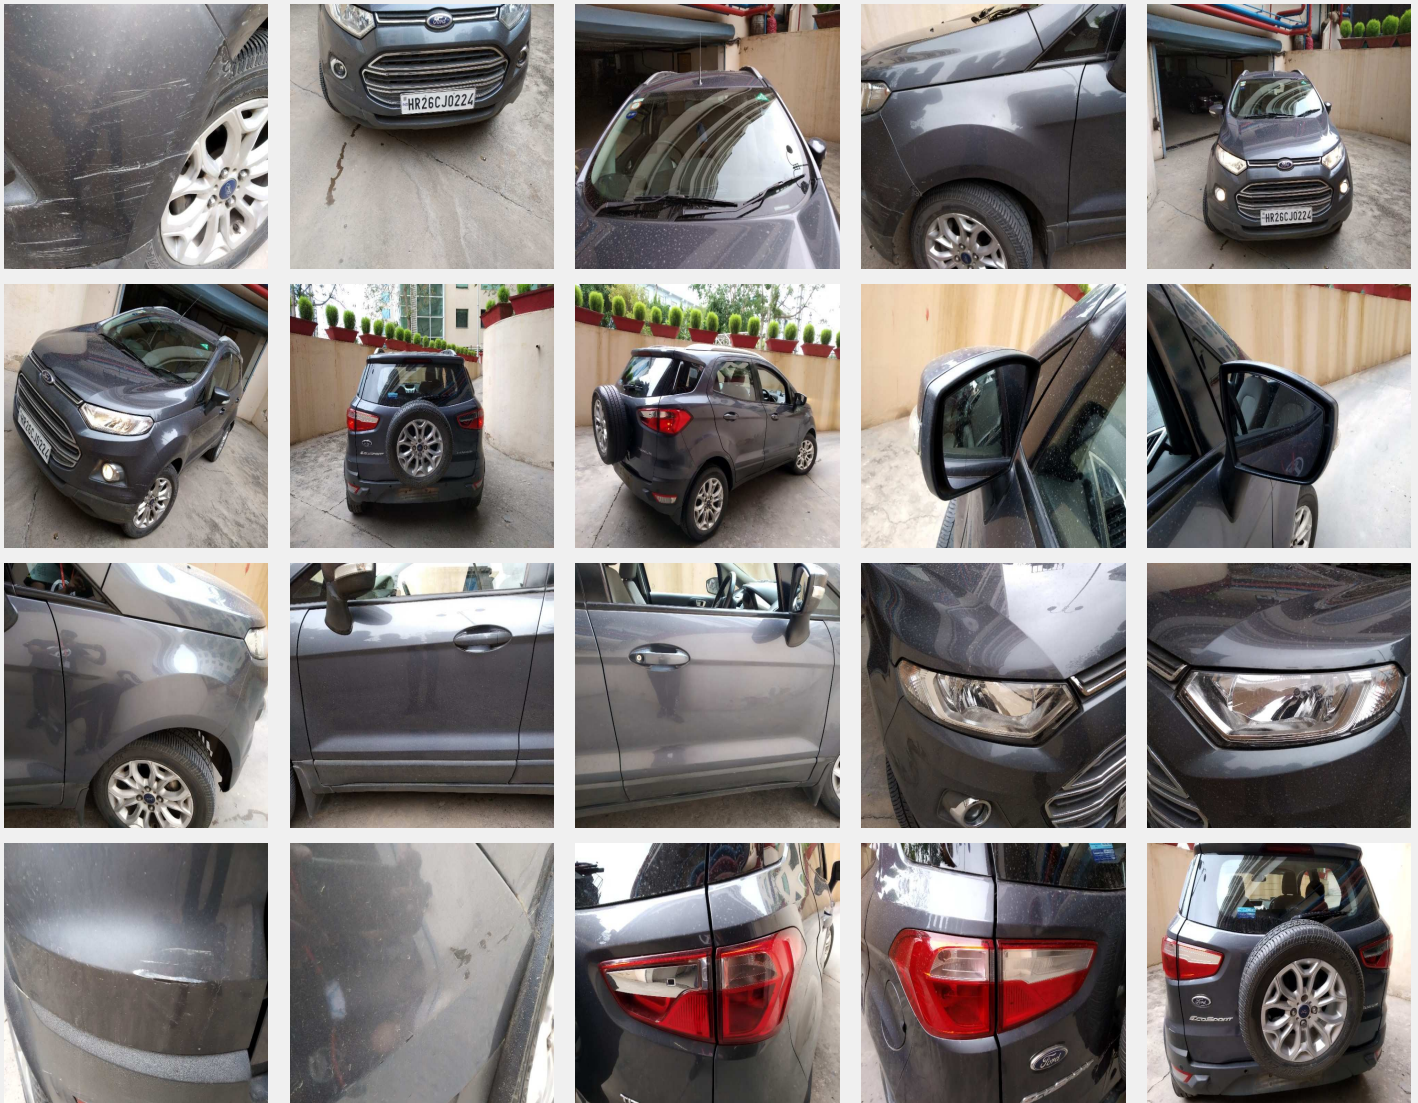
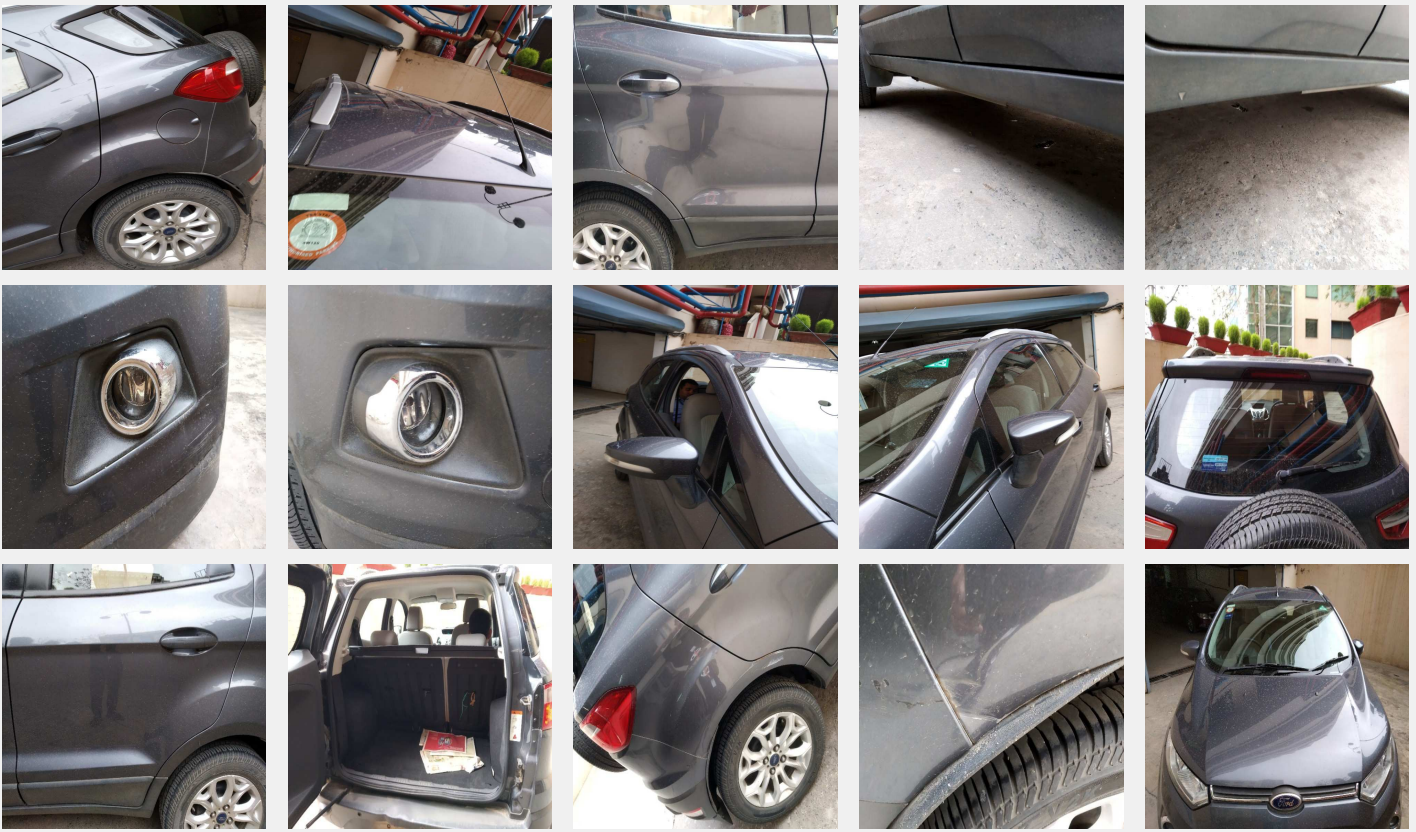
INSPECTION CHECKPOINTS	SCORE(X/10)	REMARKS/COMMENTS	OPTIONAL SPEND EST. (RS)
LICENSE PLATE	8		0
FRONT BUMPER	6	MINOR SCRATCHES	300
HEAD LIGHTS	8		0
GRILLE	8		0
TURN SIGNAL	8		0
FOG LAMPS	8		0
HOOD	8		0
PILLAR	8		0
FRONT WINDSHIELD	8		0
SIDE VIEW MIRRORS	8		0
LH FENDER	8		0
LH FRONT DOOR	8		0
LH REAR DOOR	8		0
LH RUNNING BOARD	8		0
LH QUARTER PANEL	8		0
FUEL LID	8		0
REAR WINDSHIELD	8		0
REAR BUMPER	6	MINOR SCRATCHES	300
TAIL LIGHT	8		0
TRUNK LID/TAIL GATE	8		0
LUGGAGE COMPARTMENT LIGHT	8		0
RH QUARTER PANEL	6	MINOR DENT AND SCRATCHES	400
RH RUNNING BOARD	8		0
RH REAR DOOR	8		0

minor scratches and minor dent
