# ECO INSPECTION CERTIFICATE

Order ID : 83122

121 Points Vehicle Inspection Certificate

## Royal Enfield Bullet Electra Twinspark 350CC, 2016

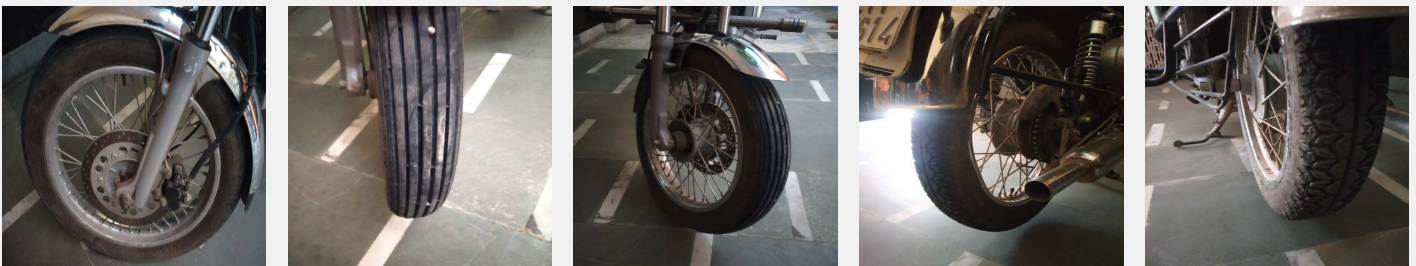
| INSPECTION CHECKPOINTS | SCORE(X/10) | REMARKS/COMMENTS | OPTIONAL SPEND EST. (RS) |
|---|---|---|---|
| FRONT TYRE CONDITION & AIR PRESSURE | 7 | | 0 |
| REAR TYRE CONDITION & AIR PRESSURE | 7 | | 0 |

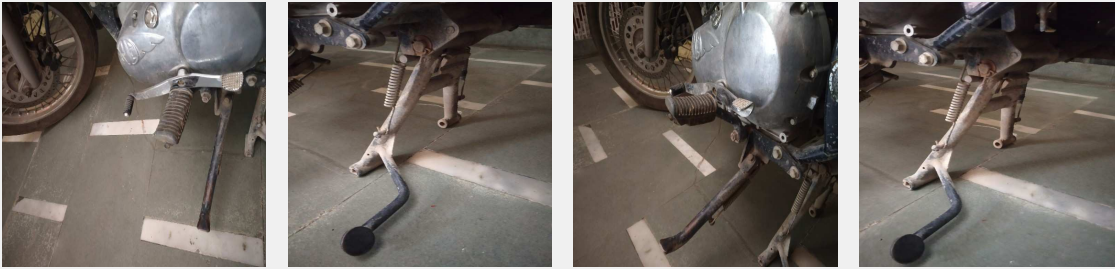
| INSPECTION CHECKPOINTS | SCORE(X/10) | REMARKS/COMMENTS | OPTIONAL SPEND EST. (RS) |
|---|---|---|---|
| CENTRE STAND CONDITION | 7 | | 0 |
| SIDE STAND CONDITION | 7 | | 0 |

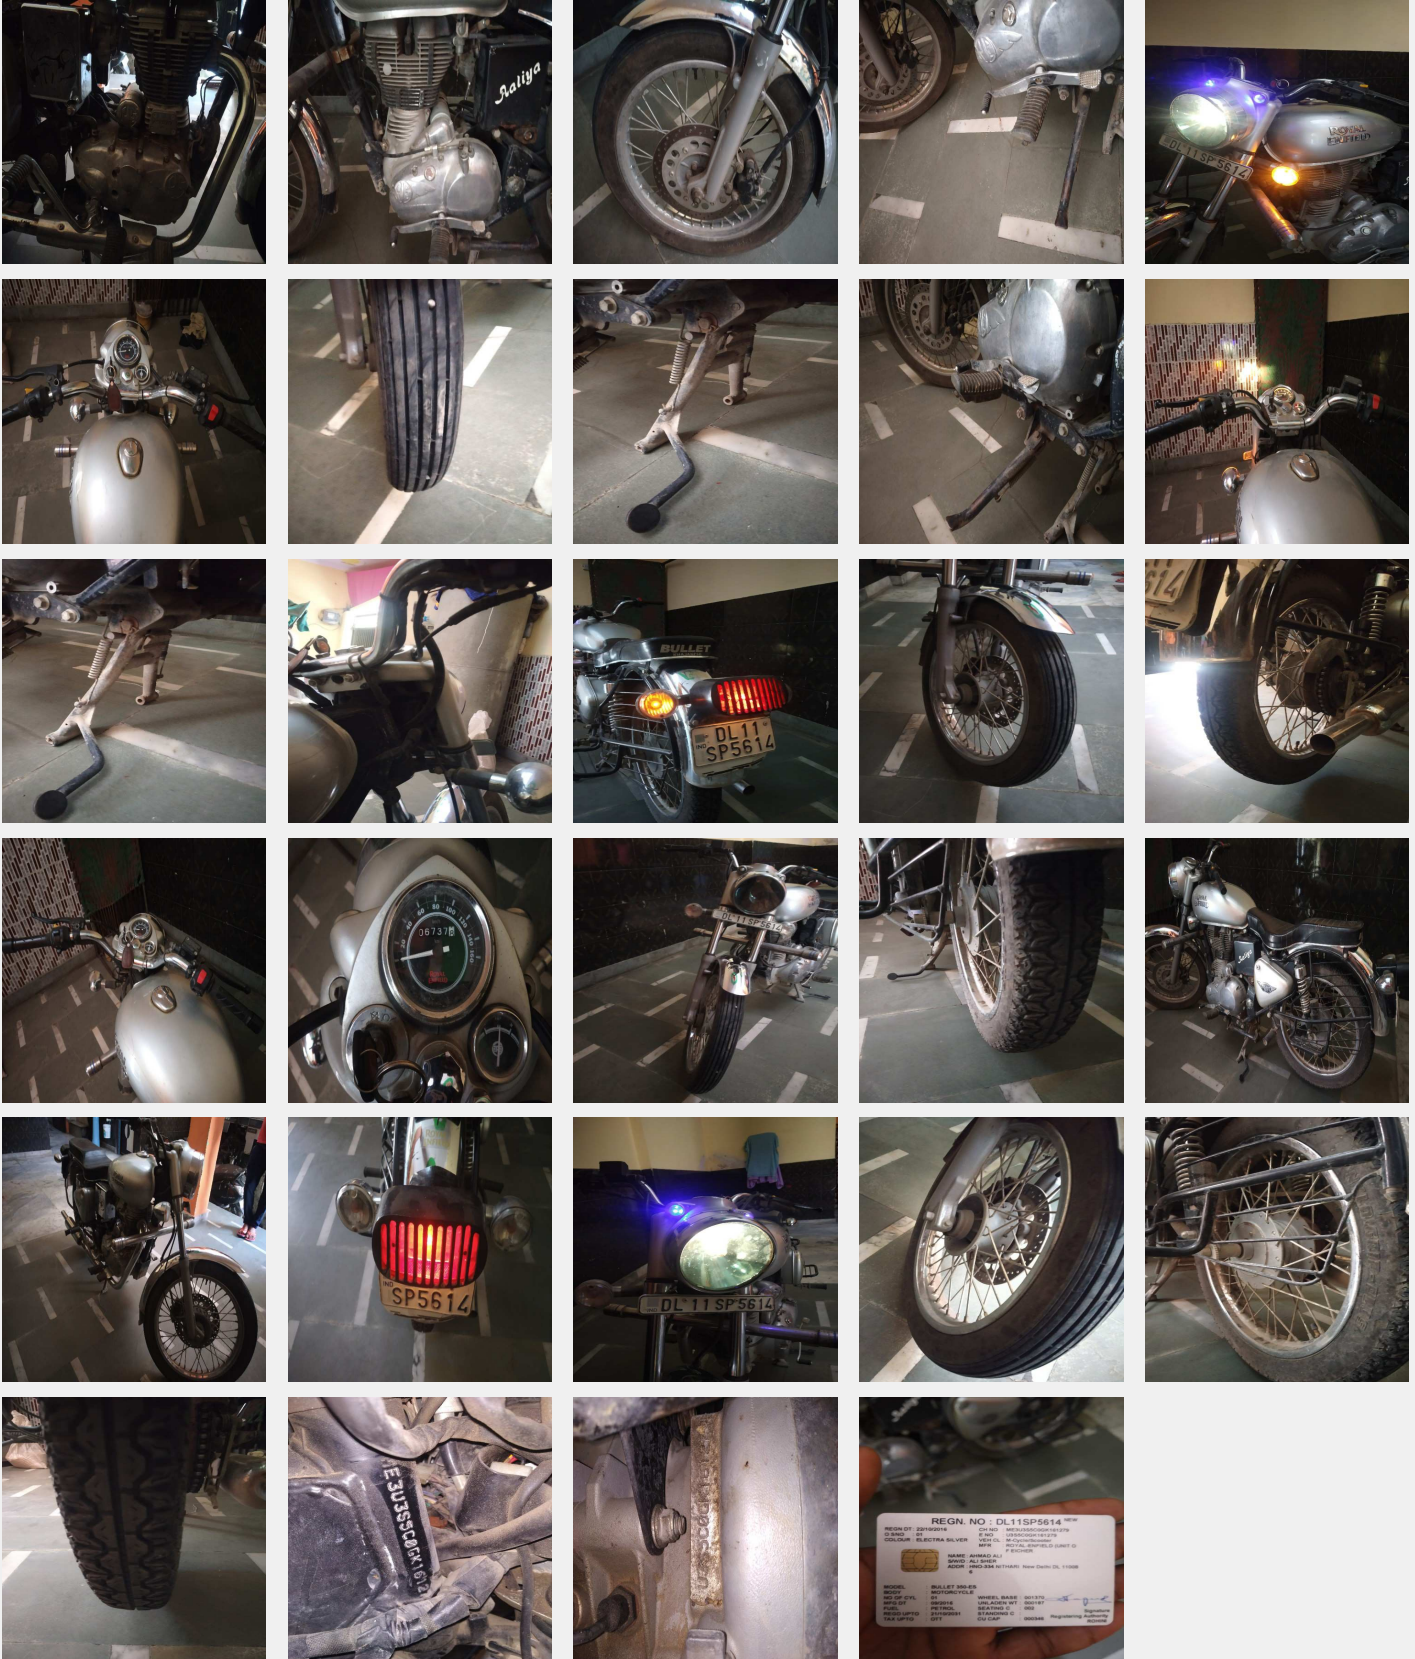
service due and insurance not available and body corner have rust and meter tamper
