# ECO INSPECTION CERTIFICATE

121 Points Vehicle Inspection Certificate

## Hyundai I10 ASTA 1.2 KAPPA2, 2015

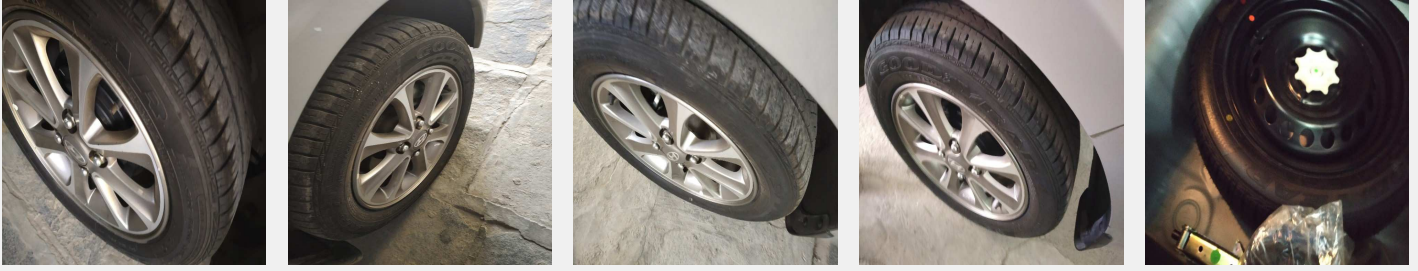
IMAGES

INSPECTION CHECKPOINTS	SCORE(X/10)	REMARKS/COMMENTS	OPTIONAL SPEND EST. (RS)
TYRES	7		0
SPARE TYRE (YES)	8		0
WHEEL ASSEMBLY (ALLOY RIM)	8		0

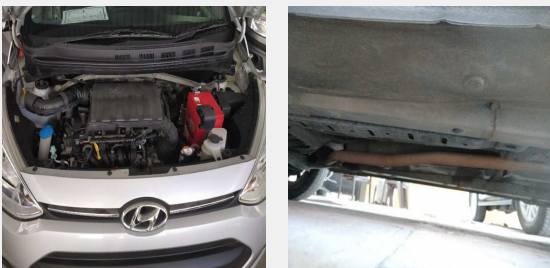
IMAGES

INSPECTION CHECKPOINTS	SCORE(X/10)	REMARKS/COMMENTS	OPTIONAL SPEND EST. (RS)
LH APRON	6		0
RH APRON	8		0
RADIATOR	7		0
WIRING	7		0
BATTERY	7		0
BRAKE FLUID LEVEL	7		0
ENGINE OIL	7		0
COOLANT LEVEL	7		0
BRAKE & COOLANT HOSE PIPES	7		0
UNDERCARRIAGE	7		0
EXHAUST SYSTEM	7		0

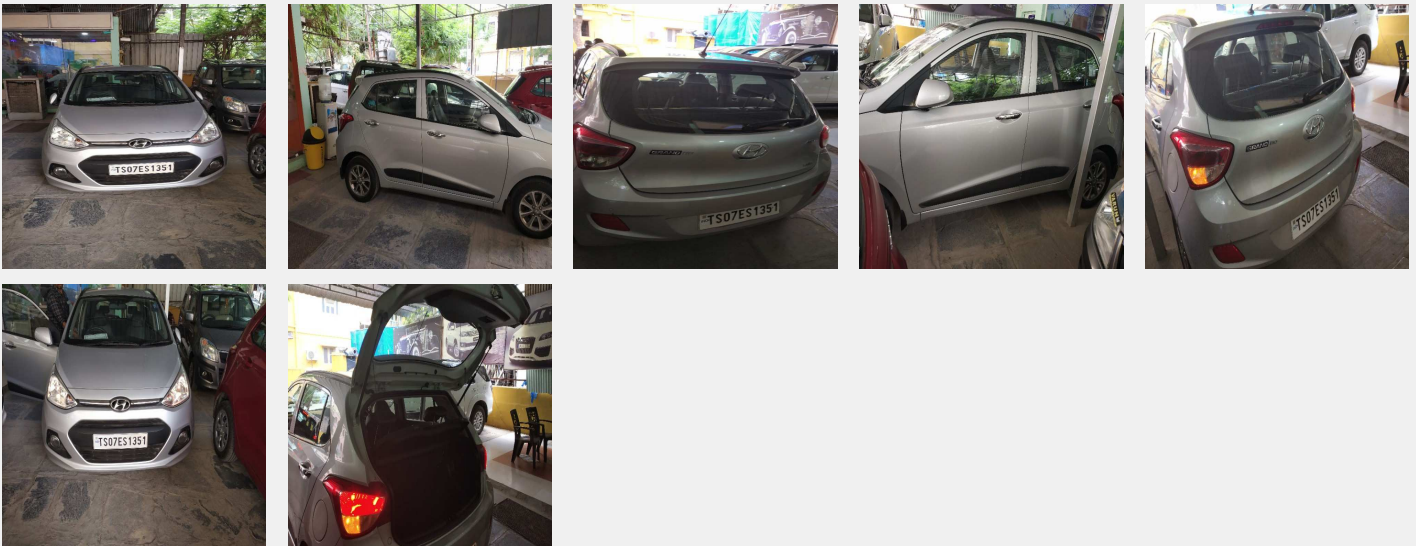
## IMAGES

INSPECTION CHECKPOINTS	SCORE(X/10)	REMARKS/COMMENTS	OPTIONAL SPEND EST. (RS)
RH FRONT DOOR	7		0
RH FENDER	7		0
BODY RUST	7		0
ROOF (REGULAR)	7		0
PAINT CONDITION	7		0
