ECO INSPECTION CERTIFICATE

121 Points Vehicle Inspection Certificate

Ordered By : TaranDeep Singh	Inspection Date : 2019-06-16	Location : DELHI	Inspected By Verified Technician 475+ vehicle inspected 1+ years experience Aabid Ali
---------------------------------	---------------------------------	---------------------	--

Hyundai Verna VGT CRDI SX, 2014

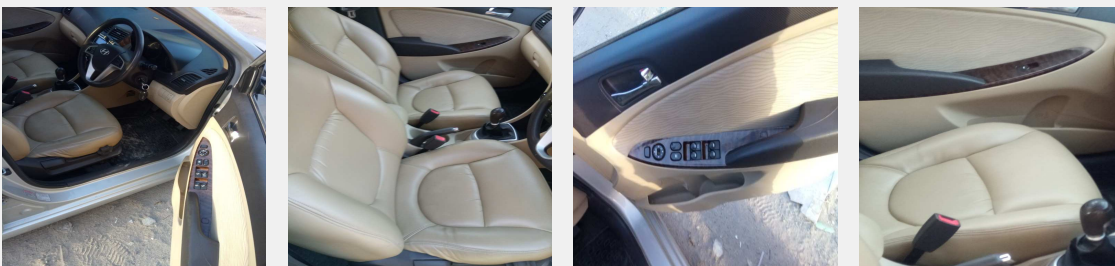
INTERIOR

INSPECTION CHECKPOINTS	SCORE(X/10)	REMARKS/COMMENTS	OPTIONAL SPEND EST. (RS)
DOOR PANEL	7	GOOD	0
DOOR HINGES	7	GOOD	0
CARPET & FLOOR MAT	7	GOOD	0
SEAT & SEAT BELT	7	GOOD	0
DASHBOARD & INSTRUMENT PANEL	7	GOOD	0
HORN	7	GOOD	0
SPEAKERS & MUSIC SYSTEM	7	GOOD	0
HANDBRAKE	7	GOOD	0
STEERING-MOUNTED CONTROLS	7	GOOD	0
PEDALS	7	GOOD	0
CENTRAL LOCK	7	GOOD	0
A/C VENTS & HEATER	7	GOOD	0
CUP HOLDERS	7	GOOD	0
NAVIGATION (NO)	10		0
ODOMETER	7	GOOD	0
POWER WINDOWS (YES)	7	GOOD	0
HAZARD LIGHT	7	GOOD	0

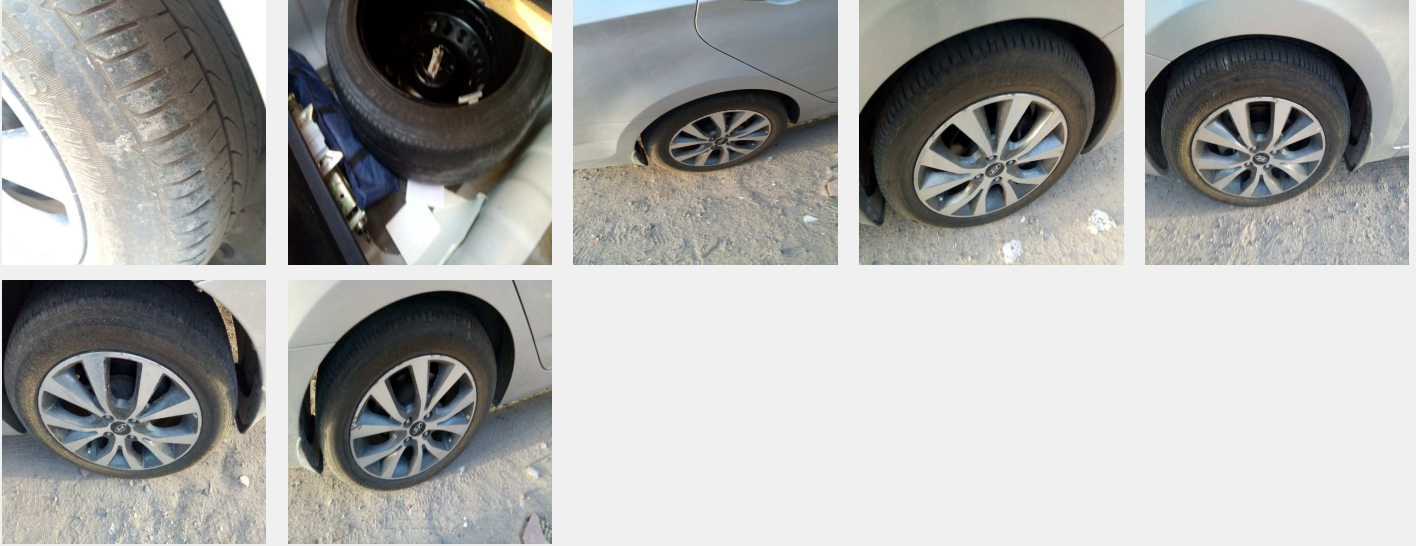
INSPECTION CHECKPOINTS	SCORE(X/10)	REMARKS/COMMENTS	OPTIONAL SPEND EST. (RS)
TYRES	7	GOOD	0
SPARE TYRE (YES)	7	GOOD	0
WHEEL ASSEMBLY (ALLOY RIM)	7	GOOD	0

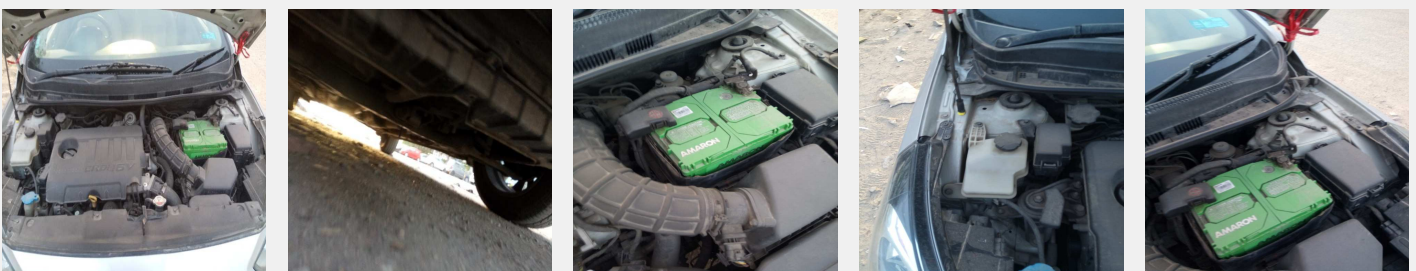
HOOD

INSPECTION CHECKPOINTS	SCORE(X/10)	REMARKS/COMMENTS	OPTIONAL SPEND EST. (RS)
LH APRON	7	GOOD	0
RH APRON	7	GOOD	0
RADIATOR	7	GOOD	0
WIRING	7	GOOD	0
BATTERY	7	GOOD	0
BRAKE FLUID LEVEL	7	GOOD	0
ENGINE OIL	7	GOOD	0
COOLANT LEVEL	7	GOOD	0
BRAKE & COOLANT HOSE PIPES	7	GOOD	0
UNDERCARRIAGE	7	GOOD	0
EXHAUST SYSTEM	7	GOOD	0

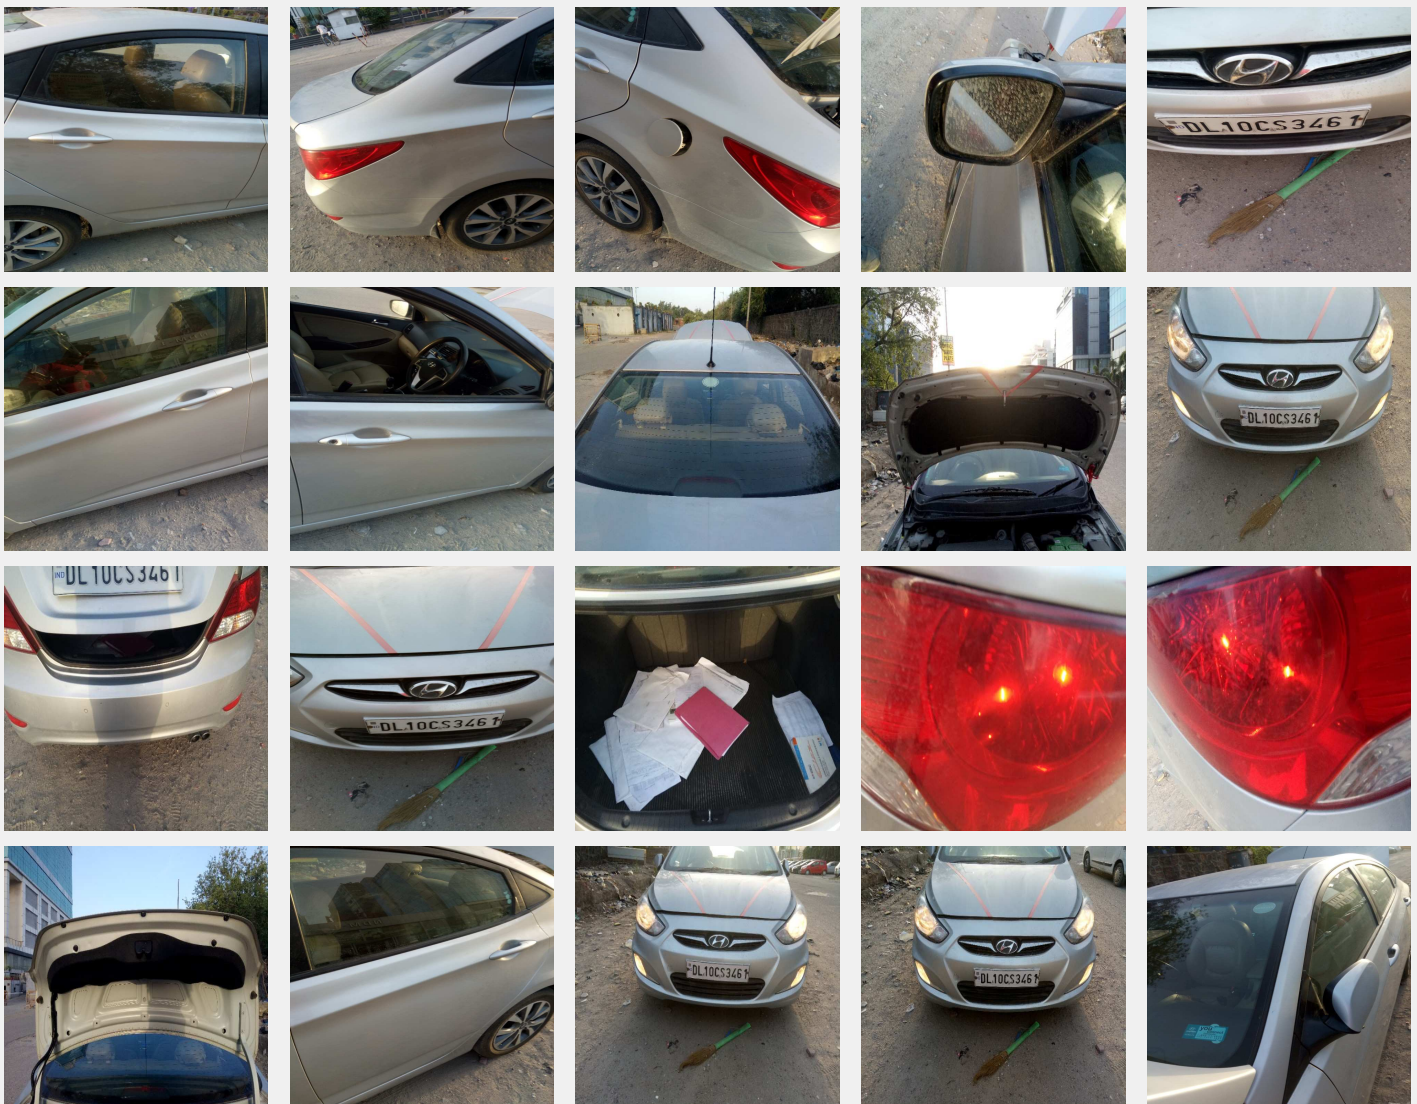
EXTERIOR (CONTINUED)

INSPECTION CHECKPOINTS	SCORE(X/10)	REMARKS/COMMENTS	OPTIONAL SPEND EST. (RS)
RH FRONT DOOR	7	GOOD	0
RH FENDER	7	GOOD	0
BODY RUST	7	GOOD	0
ROOF (REGULAR)	7	GOOD	0
PAINT CONDITION	7	GOOD	0
