ECO INSPECTION CERTIFICATE

121 Points Vehicle Inspection Certificate

Mahindra Scorpio S10, 2015

MAKE	MAHINDRA	ENGINE NUMBER	
MODEL	SCORPIO	REGISTRATION NO.	TS09EJ0300
MFG. DATE	06/2015	VIN/CHASSIS NUMBER	MA1TA2SJXF2F40599
TRIM	S10	ODOMETER READING	75943
COLOR	COB WHITE	INSURANCE EXPIRY	2016-7-26
BODY TYPE	SUV	VEHICLE PASSING	PRIVATE
FUEL TYPE	PETROL	ENGINE SOUND LINK	LISTEN ENGINE SOUND

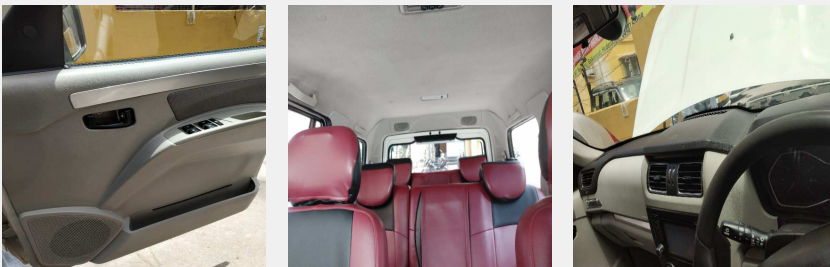
IMAGES

INTERIOR

INSPECTION CHECKPOINTS	SCORE(X/10)	REMARKS/COMMENTS	OPTIONAL SPEND EST. (RS)
DOOR PANEL	7		0
DOOR HINGES	7		0
CARPET & FLOOR MAT	7		0
SEAT & SEAT BELT	7		0
DASHBOARD & INSTRUMENT PANEL	7		0
HORN	7		0
SPEAKERS & MUSIC SYSTEM	7		0
HANDBRAKE	8		0
STEERING-MOUNTED CONTROLS	7		0
PEDALS	7		0
CENTRAL LOCK	7		0
A/C VENTS & HEATER	7		0
CUP HOLDERS	7		0
NAVIGATION (NO)	10		0
ODOMETER	7		0
POWER WINDOWS (YES)	7		0
HAZARD LIGHT	7		0

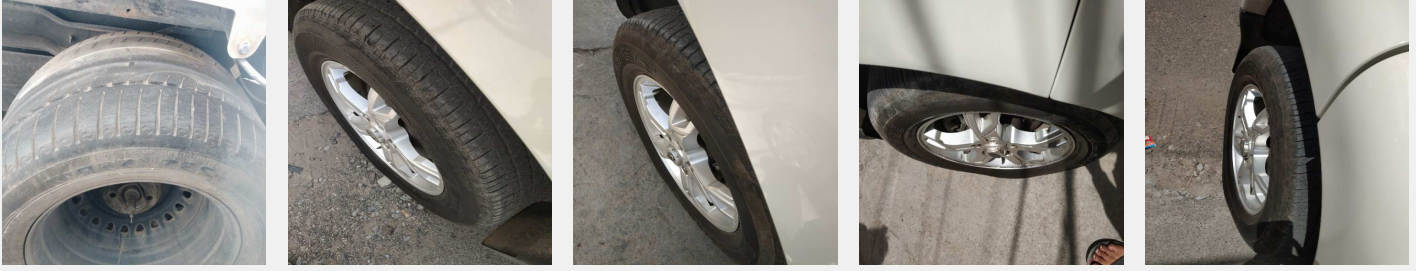
IMAGES

WHEEL

INSPECTION CHECKPOINTS	SCORE(X/10)	REMARKS/COMMENTS	OPTIONAL SPEND EST. (RS)
TYRES	8		0
SPARE TYRE (YES)	8		0
WHEEL ASSEMBLY (ALLOY RIM)	7		0

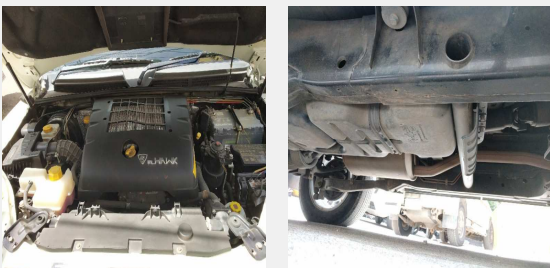
IMAGES

HOOD

INSPECTION CHECKPOINTS	SCORE(X/10)	REMARKS/COMMENTS	OPTIONAL SPEND EST. (RS)
LH APRON	7		0
RH APRON	7		0
RADIATOR	7		0
WIRING	8		0
BATTERY	7		0
BRAKE FLUID LEVEL	8		0
ENGINE OIL	7		0
COOLANT LEVEL	7		0
BRAKE & COOLANT HOSE PIPES	7		0
UNDERCARRIAGE	7		0
EXHAUST SYSTEM	7		0
