ECO INSPECTION CERTIFICATE

Order ID : 84542

121 Points Vehicle Inspection Certificate

Toyota Innova Crysta 2.8 GX AT 7 STR, 2017

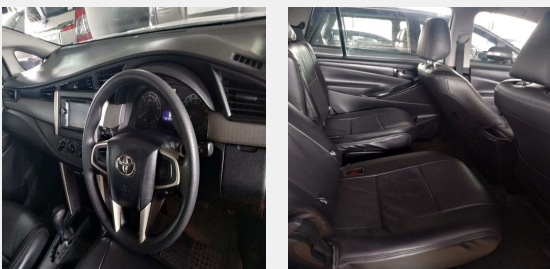
IMAGES

INTERIOR

INSPECTION CHECKPOINTS	SCORE(X/10)	REMARKS/COMMENTS	OPTIONAL SPEND EST. (RS)
DOOR PANEL	10		0
DOOR HINGES	10		0
CARPET & FLOOR MAT	10		0
SEAT & SEAT BELT	10		0
DASHBOARD & INSTRUMENT PANEL	10		0
HORN	10		0
SPEAKERS & MUSIC SYSTEM	10		0
HANDBRAKE	10		0
STEERING-MOUNTED CONTROLS	10		0
PEDALS	10		0
CENTRAL LOCK	10		0
A/C VENTS & HEATER	10		0
CUP HOLDERS	10		0
NAVIGATION (YES)	9		0
ODOMETER	10		0
POWER WINDOWS (YES)	10		0
HAZARD LIGHT	10		0

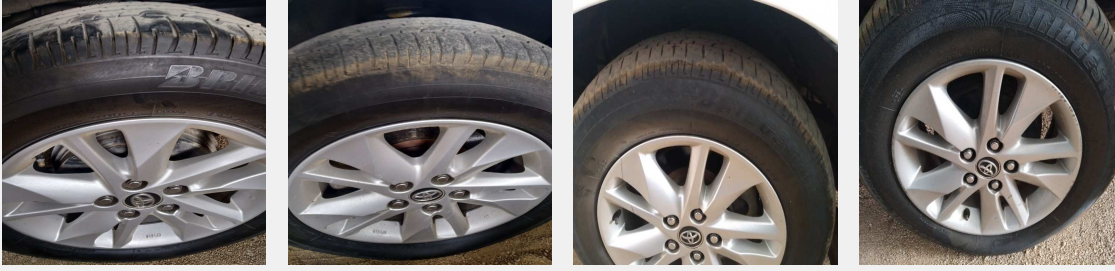
IMAGES

WHEEL

INSPECTION CHECKPOINTS	SCORE(X/10)	REMARKS/COMMENTS	OPTIONAL SPEND EST. (RS)
TYRES	10		0
SPARE TYRE (YES)	10		0
WHEEL ASSEMBLY (ALLOY RIM)	9		0

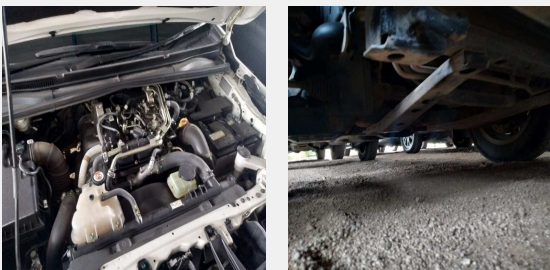
IMAGES

HOOD

INSPECTION CHECKPOINTS	SCORE(X/10)	REMARKS/COMMENTS	OPTIONAL SPEND EST. (RS)
LH APRON	10		0
RH APRON	10		0
RADIATOR	10		0
WIRING	10		0
BATTERY	10		0
BRAKE FLUID LEVEL	9		0
ENGINE OIL	10		0
COOLANT LEVEL	10		0
BRAKE & COOLANT HOSE PIPES	9		0
UNDERCARRIAGE	10		0
EXHAUST SYSTEM	10		0

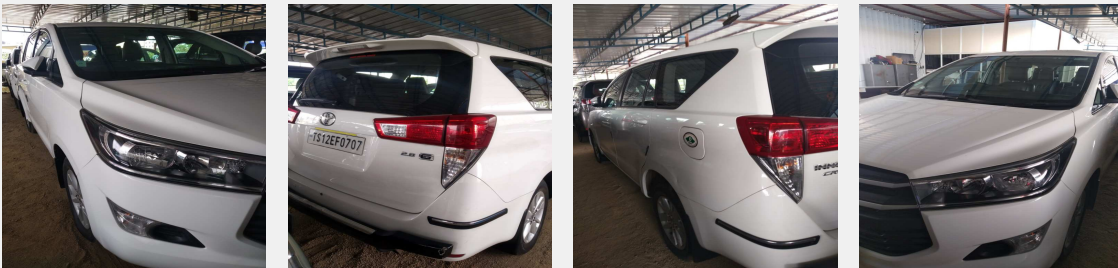
IMAGES

INSPECTION CHECKPOINTS	SCORE(X/10)	REMARKS/COMMENTS	OPTIONAL SPEND EST. (RS)
RH FRONT DOOR	10		0
RH FENDER	10		0
BODY RUST	10		0
ROOF (REGULAR)	10		0
PAINT CONDITION	10		0

good
