# ECO INSPECTION CERTIFICATE

Order ID : 84552

121 Points Vehicle Inspection Certificate

## Toyota Fortuner 3.0 4X2 AT, 2012

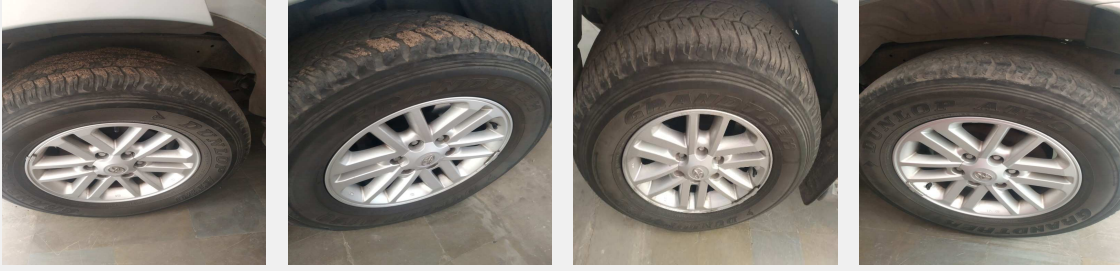
IMAGES

INSPECTION CHECKPOINTS	SCORE(X/10)	REMARKS/COMMENTS	OPTIONAL SPEND EST. (RS)
TYRES	10		0
SPARE TYRE (YES)	10		0
WHEEL ASSEMBLY (STEEL RIM)	10		0

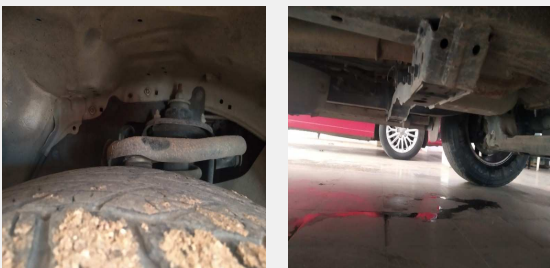
IMAGES

INSPECTION CHECKPOINTS	SCORE(X/10)	REMARKS/COMMENTS	OPTIONAL SPEND EST. (RS)
LH APRON	10		0
RH APRON	10		0
RADIATOR	10		0
WIRING	10		0
BATTERY	10		0
BRAKE FLUID LEVEL	10		0
ENGINE OIL	10		0
COOLANT LEVEL	10		0
BRAKE & COOLANT HOSE PIPES	10		0
UNDERCARRIAGE	10		0
EXHAUST SYSTEM	10		0

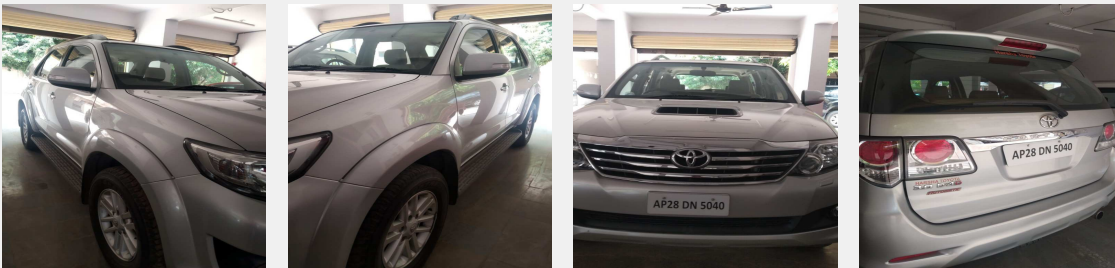
## IMAGES

INSPECTION CHECKPOINTS	SCORE(X/10)	REMARKS/COMMENTS	OPTIONAL SPEND EST. (RS)
RH FRONT DOOR	10		0
RH FENDER	10		0
BODY RUST	10		0
ROOF (REGULAR)	10		0
PAINT CONDITION	10		0

good
