# ECO INSPECTION CERTIFICATE

121 Points Vehicle Inspection Certificate

Inspection Date :  
2019-06-19

## Maruti Suzuki Ertiga Zdi+ Shvs, 2016

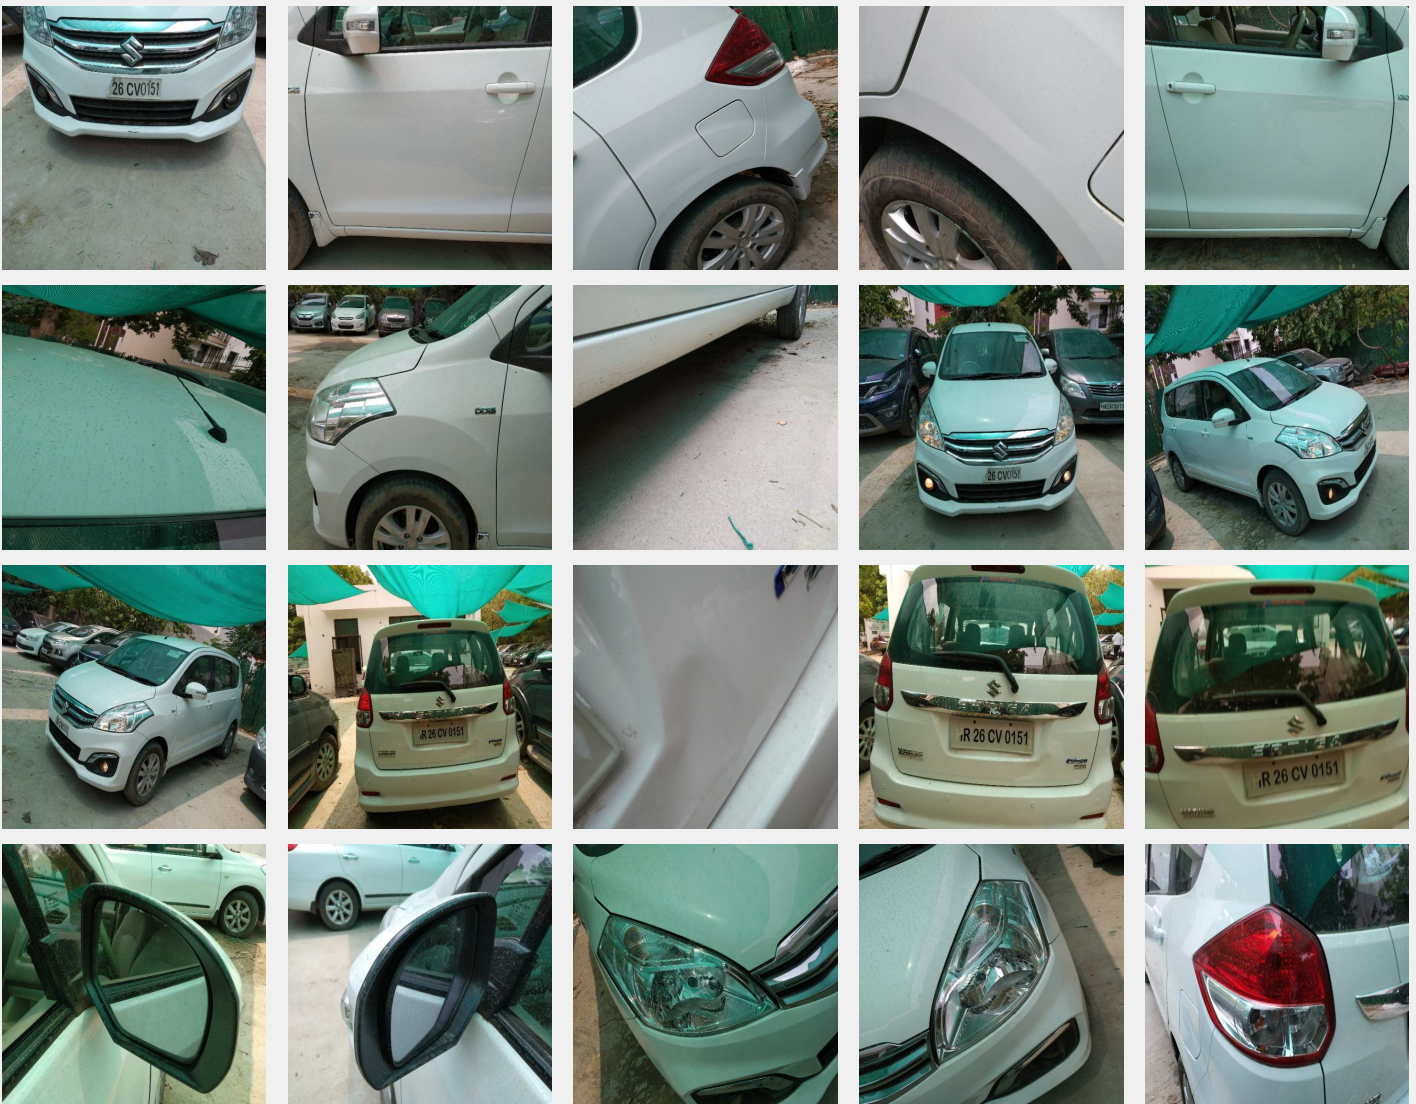
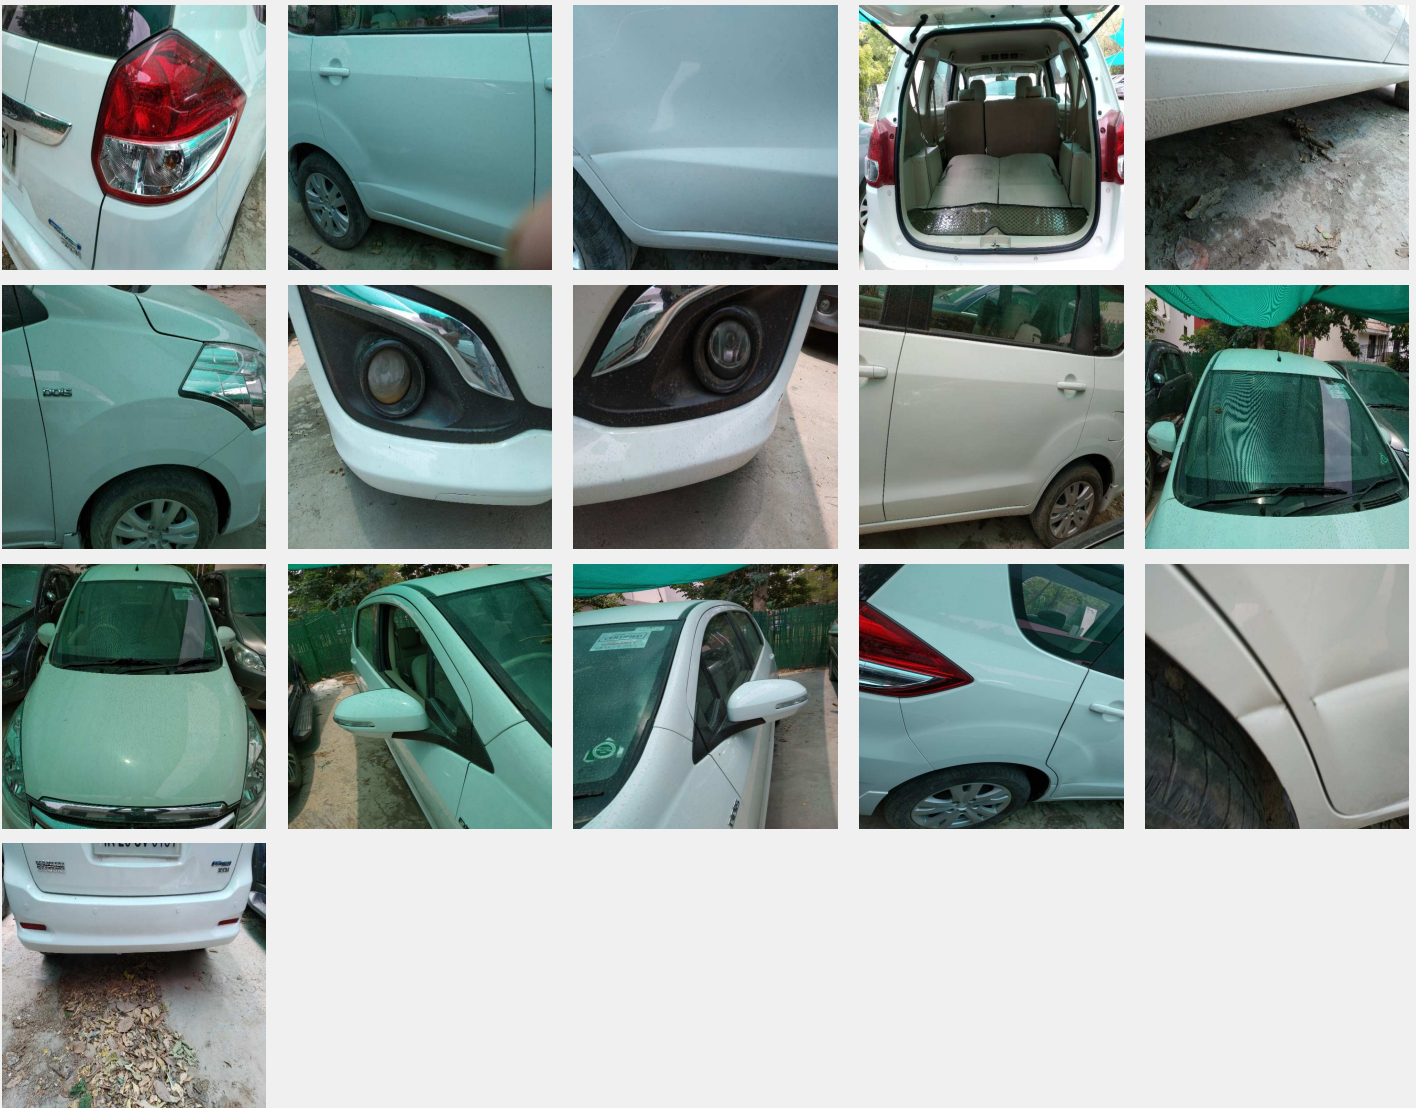
## IMAGES

INSPECTION CHECKPOINTS	SCORE(X/10)	REMARKS/COMMENTS	OPTIONAL SPEND EST. (RS)
FRONT BUMPER	7		0
HEAD LIGHTS	7		0
GRILLE	7		0
TURN SIGNAL	7		0
FOG LAMPS	7		0
HOOD	7		0
PILLAR	7		0
FRONT WINDSHIELD	7		0
SIDE VIEW MIRRORS	7		0
LH FENDER	7		0
LH FRONT DOOR	8		0
LH REAR DOOR	8		0
LH RUNNING BOARD	7		0
LH QUARTER PANEL	6	MINOR DENT	500
FUEL LID	8		0
REAR WINDSHIELD	8		0
REAR BUMPER	7		0
TAIL LIGHT	7		0
TRUNK LID/TAIL GATE	6	MINOR DENT	1500
LUGGAGE COMPARTMENT LIGHT	7		0
RH QUARTER PANEL	6	MINOR DENT	500
RH RUNNING BOARD	7		0
RH REAR DOOR	6	MINOR DENT	500
RH FRONT DOOR	7		0

INSPECTION CHECKPOINTS	SCORE(X/10)	REMARKS/COMMENTS	OPTIONAL SPEND EST. (RS)
RH FENDER	7		0
BODY RUST	7		0
ROOF (REGULAR)	8		0
PAINT CONDITION	8	CAR FULL PAINTED	0
LICENSE PLATE	2	NEED TO REPLACE	500

car fully painted minor dent all tyres already replaced
