ECO INSPECTION CERTIFICATE

Order ID : 84553

121 Points Vehicle Inspection Certificate

Toyota Fortuner 3.0 4X2 MT, 2015

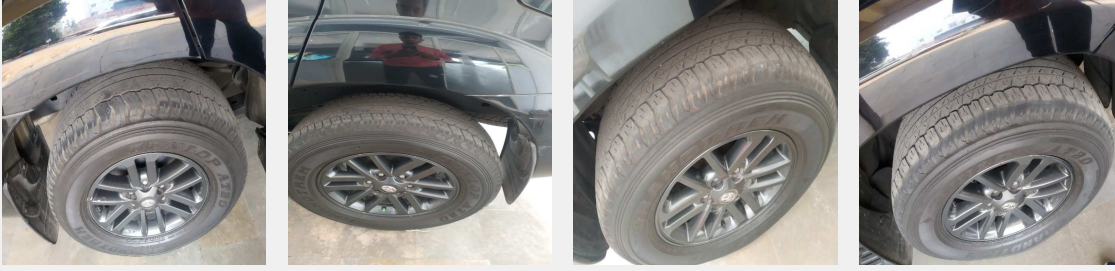
INSPECTION CHECKPOINTS	SCORE(X/10)	REMARKS/COMMENTS	OPTIONAL SPEND EST. (RS)
TYRES	10		0
SPARE TYRE (YES)	10		0
WHEEL ASSEMBLY (ALLOY RIM)	10		0

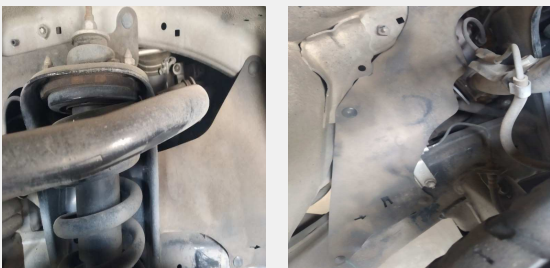
HOOD

INSPECTION CHECKPOINTS	SCORE(X/10)	REMARKS/COMMENTS	OPTIONAL SPEND EST. (RS)
LH APRON	10		0
RH APRON	10		0
RADIATOR	10		0
WIRING	10		0
BATTERY	10		0
BRAKE FLUID LEVEL	10		0
ENGINE OIL	10		0
COOLANT LEVEL	10		0
BRAKE & COOLANT HOSE PIPES	10		0
UNDERCARRIAGE	10		0
EXHAUST SYSTEM	10		0

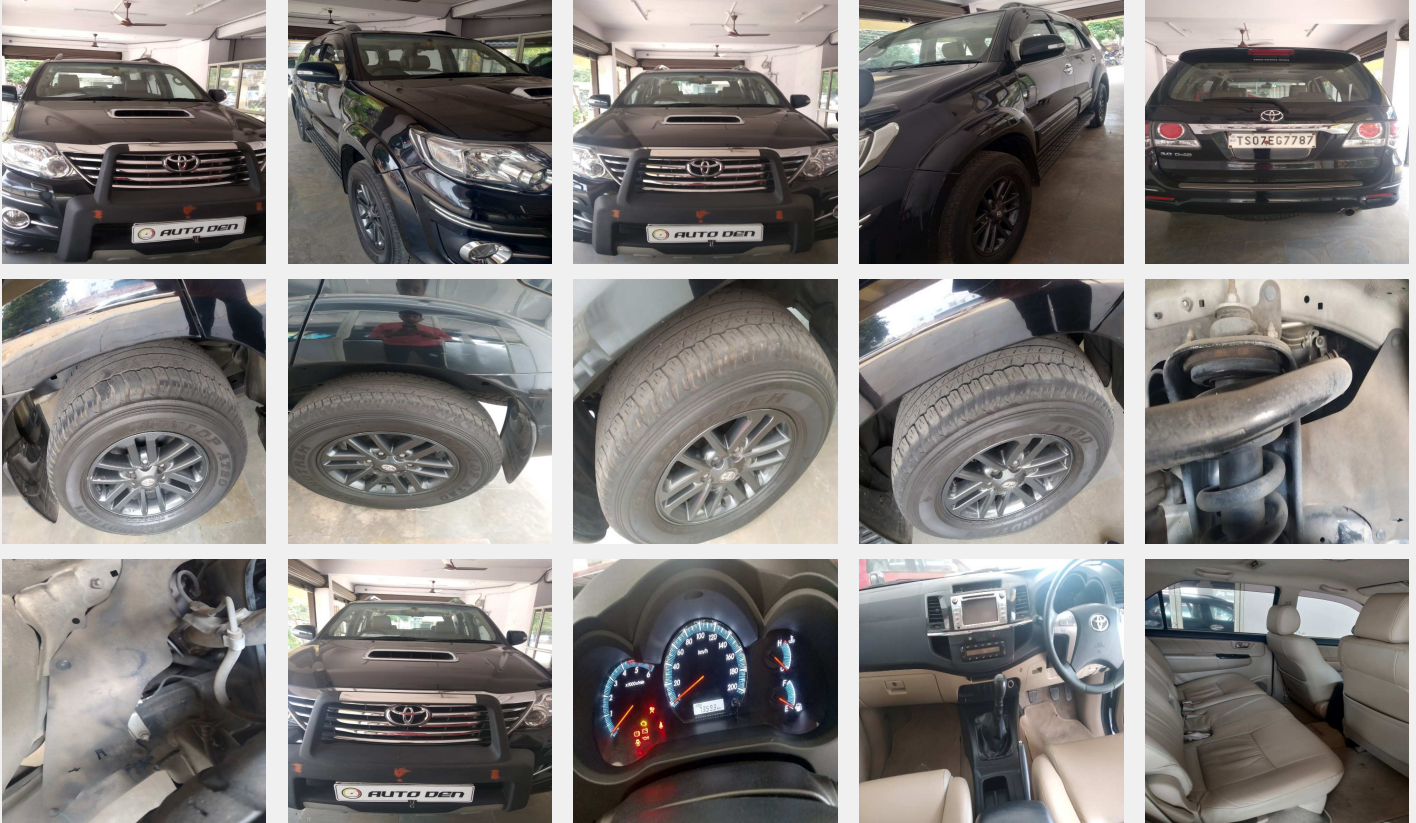
EXTERIOR (CONTINUED)

INSPECTION CHECKPOINTS	SCORE(X/10)	REMARKS/COMMENTS	OPTIONAL SPEND EST. (RS)
RH FRONT DOOR	10		0
RH FENDER	10		0
BODY RUST	10		0
ROOF (REGULAR)	10		0
PAINT CONDITION	10		0

good
