ECO INSPECTION CERTIFICATE

121 Points Vehicle Inspection Certificate

Ordered By : Vipin Malik	Inspection Date : 2019-06-26	Location : DELHI

Maruti Suzuki Wagon R 1.0 LXI CNG, 2014

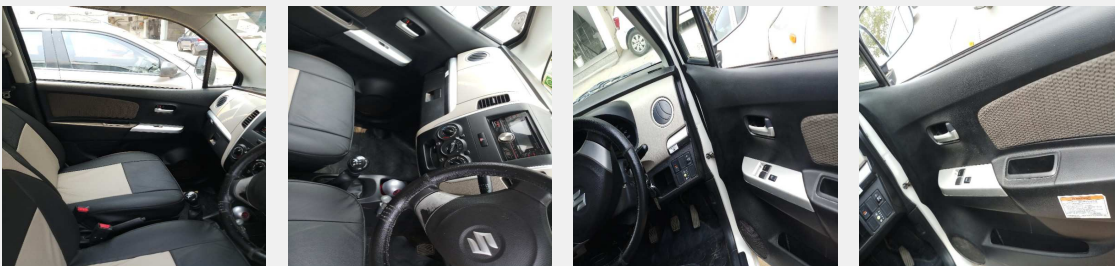
INTERIOR

INSPECTION CHECKPOINTS	SCORE(X/10)	REMARKS/COMMENTS	OPTIONAL SPEND EST. (RS)
DOOR PANEL	7		0
DOOR HINGES	7		0
CARPET & FLOOR MAT	7		0
SEAT & SEAT BELT	7		0
DASHBOARD & INSTRUMENT PANEL	7		0
HORN	7		0
SPEAKERS & MUSIC SYSTEM	7		0
HANDBRAKE	7		0
PEDALS	7		0
CENTRAL LOCK	7		0
A/C VENTS & HEATER	7		0
CUP HOLDERS	7		0
NAVIGATION (NO)	10		0
ODOMETER	7		0
POWER WINDOWS (YES - FRONT ONLY)	7		0
HAZARD LIGHT	7		0
STEERING-MOUNTED CONTROLS	0	NA	0

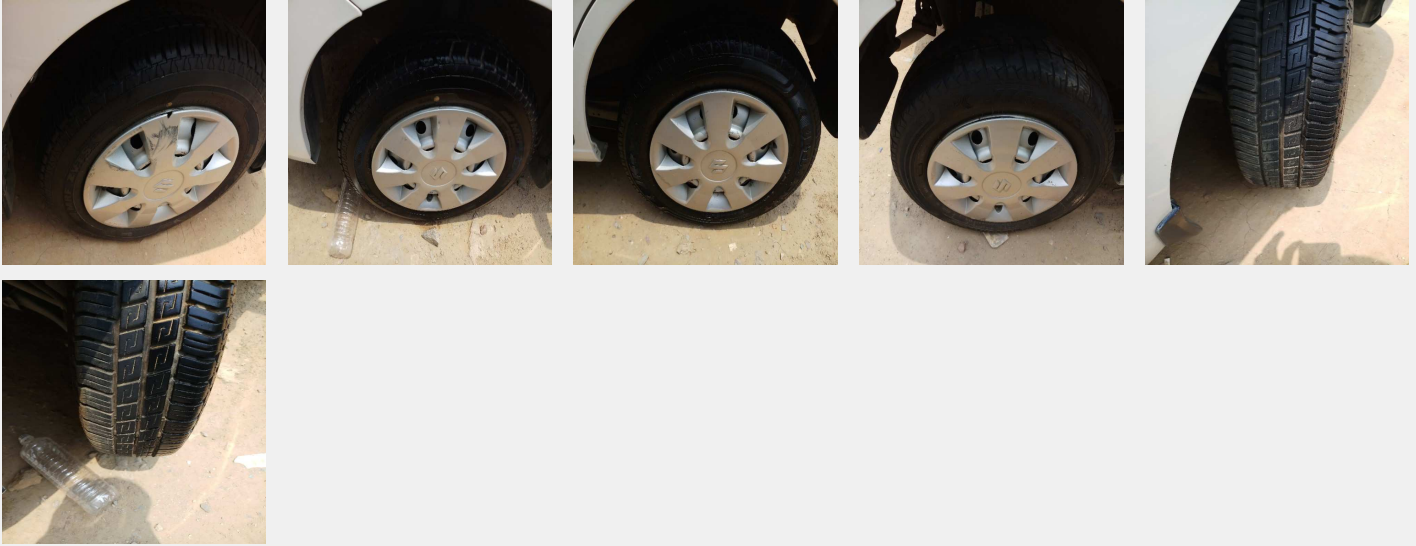
INSPECTION CHECKPOINTS	SCORE(X/10)	REMARKS/COMMENTS	OPTIONAL SPEND EST. (RS)
TYRES	7		0
SPARE TYRE (YES)	6		0
WHEEL ASSEMBLY (STEEL RIM)	6		0

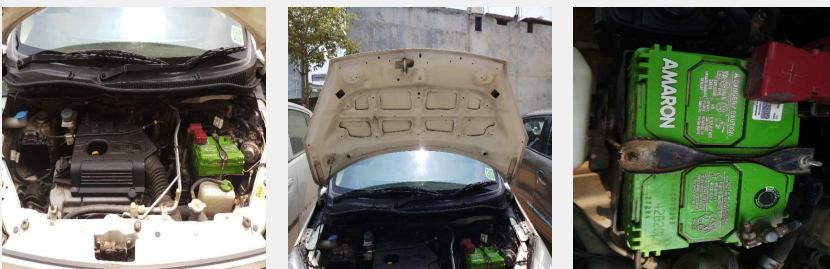
HOOD

INSPECTION CHECKPOINTS	SCORE(X/10)	REMARKS/COMMENTS	OPTIONAL SPEND EST. (RS)
LH APRON	7		0
RH APRON	7		0
RADIATOR	7		0
WIRING	7		0
BATTERY	7		0
BRAKE FLUID LEVEL	7		0
ENGINE OIL	7		0
COOLANT LEVEL	7		0
BRAKE & COOLANT HOSE PIPES	7		0
UNDERCARRIAGE	7		0
EXHAUST SYSTEM	7		0

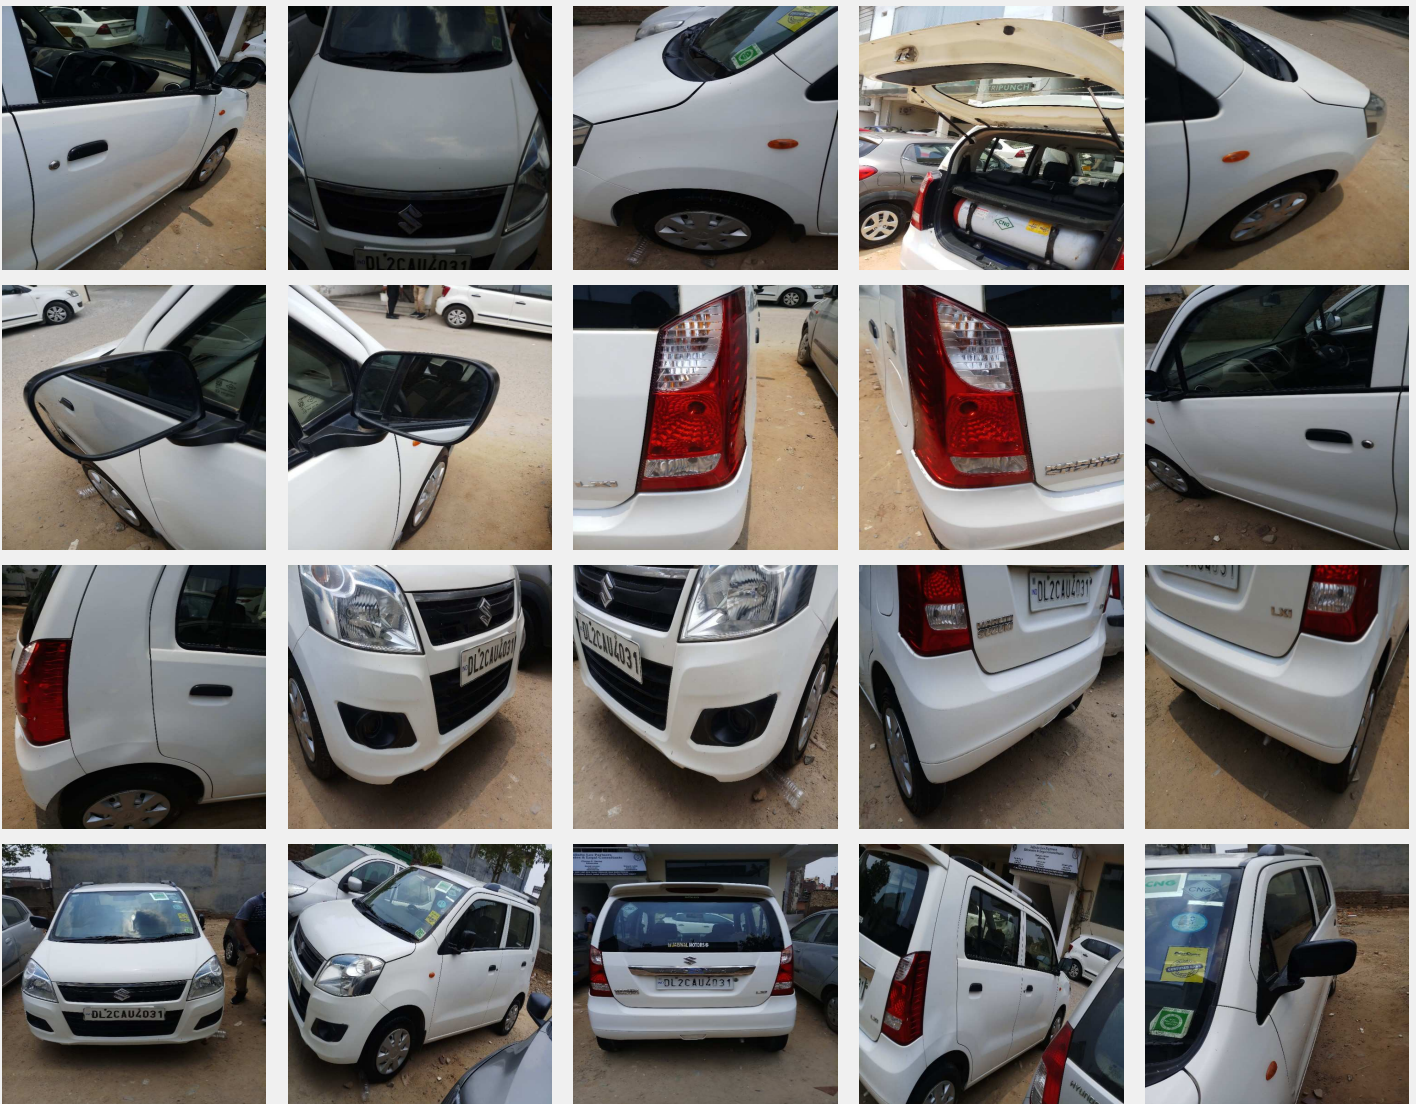
EXTERIOR (CONTINUED)

INSPECTION CHECKPOINTS	SCORE(X/10)	REMARKS/COMMENTS	OPTIONAL SPEND EST. (RS)
BODY RUST	7		0
ROOF (REGULAR)	7		0
PAINT CONDITION	7		0
FOG LAMPS	0	NA	0
LUGGAGE COMPARTMENT LIGHT	0	NA	0
