# ECO INSPECTION CERTIFICATE

Order ID : 85572

121 Points Vehicle Inspection Certificate

## Bajaj Dominar 400 ABS, 2017

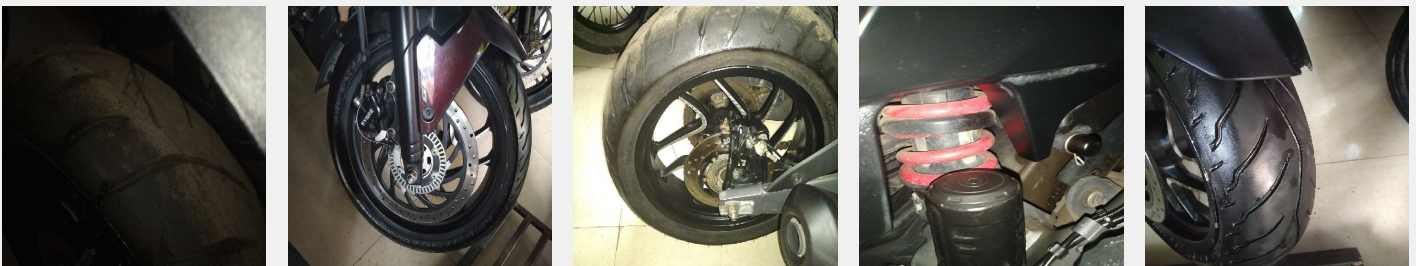
## TYRE

INSPECTION CHECKPOINTS	SCORE(X/10)	REMARKS/COMMENTS	OPTIONAL SPEND EST. (RS)
FRONT TYRE CONDITION & AIR PRESSURE	6	NORMAL WEAR & TEAR	0
REAR TYRE CONDITION & AIR PRESSURE	6	NORMAL WEAR & TEAR	0
WHEEL SPOKES FRONT	6	NO DAMAGE	0
WHEEL SPOKES REAR	6	NO DAMAGE	0
WHEEL RIM FRONT	6	NO DAMAGE	0
WHEEL RIM REAR	6	NO DAMAGE	0
WHEEL BEARINGS FRONT	6	WORKING CONDITION	0
WHEEL BEARINGS REAR	6	WORKING CONDITION	0
WHEEL SEALS FRONT	6	NO DAMAGE	0
WHEEL SEALS REAR	6	NO DAMAGE	0
BRAKE FUNCTION FRONT	6	WORKING CONDITION	0
BRAKE FUNCTION REAR	6	WORKING CONDITION	0
BRAKES CONDITION FRONT	6	WORKING CONDITION	0
BRAKES CONDITION REAR	6	WORKING CONDITION	0

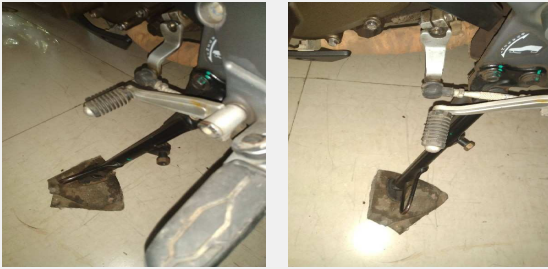
## STAND

INSPECTION CHECKPOINTS	SCORE(X/10)	REMARKS/COMMENTS	OPTIONAL SPEND EST. (RS)
CENTRE STAND CONDITION	6	NOT AVAILABLE	0
CENTRE STAND RETENTION	6	NOT AVAILABLE	0
SIDE STAND CONDITION	6	GOOD CONDITION	0
SIDE STAND RETENTION	6	WORKING CONDITION	0
