ECO INSPECTION CERTIFICATE

Order ID : 87515

121 Points Vehicle Inspection Certificate

Maruti Suzuki Baleno ALPHA 1.2, 2017

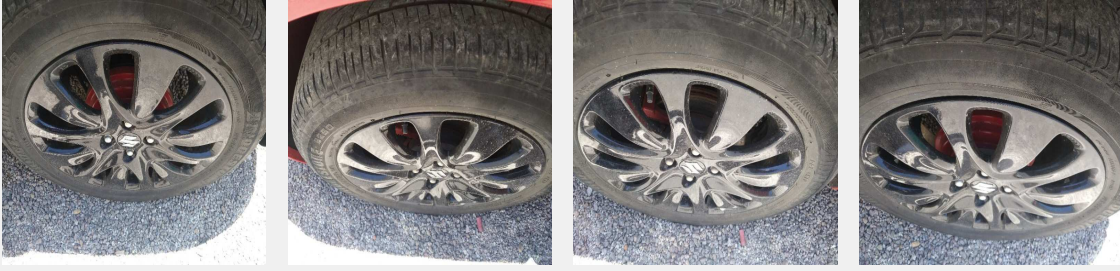
INSPECTION CHECKPOINTS	SCORE(X/10)	REMARKS/COMMENTS	OPTIONAL SPEND EST. (RS)
TYRES	10		0
SPARE TYRE (YES)	10		0
WHEEL ASSEMBLY (STEEL RIM)	10		0

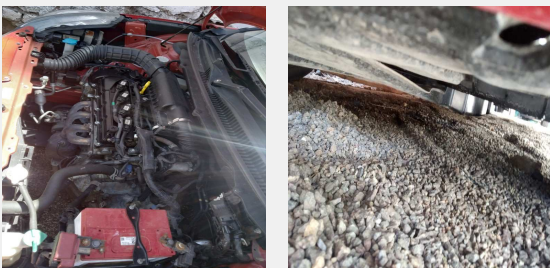
HOOD

INSPECTION CHECKPOINTS	SCORE(X/10)	REMARKS/COMMENTS	OPTIONAL SPEND EST. (RS)
LH APRON	9		0
RH APRON	10		0
RADIATOR	10		0
WIRING	10		0
BATTERY	10		0
BRAKE FLUID LEVEL	10		0
ENGINE OIL	10		0
COOLANT LEVEL	9		0
BRAKE & COOLANT HOSE PIPES	10		0
UNDERCARRIAGE	10		0
EXHAUST SYSTEM	9		0

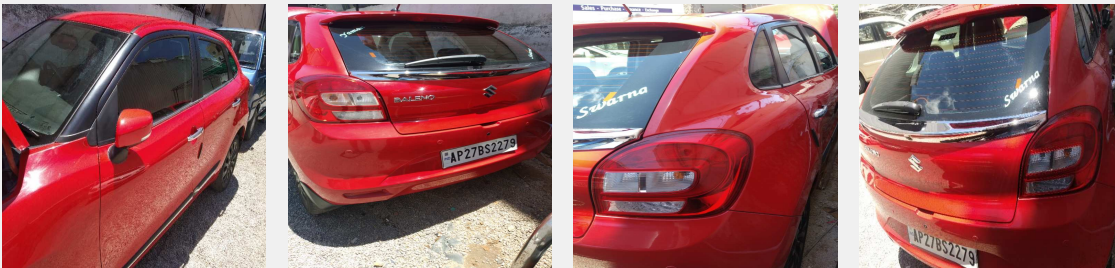
EXTERIOR (CONTINUED)

INSPECTION CHECKPOINTS	SCORE(X/10)	REMARKS/COMMENTS	OPTIONAL SPEND EST. (RS)
RH FRONT DOOR	10		0
RH FENDER	10		0
BODY RUST	10		0
ROOF (REGULAR)	10		0
PAINT CONDITION	10		0
