ECO INSPECTION CERTIFICATE

Order ID : 86238

121 Points Vehicle Inspection Certificate

Volkswagen Polo 1.2 MPI HIGHLINE, 2014

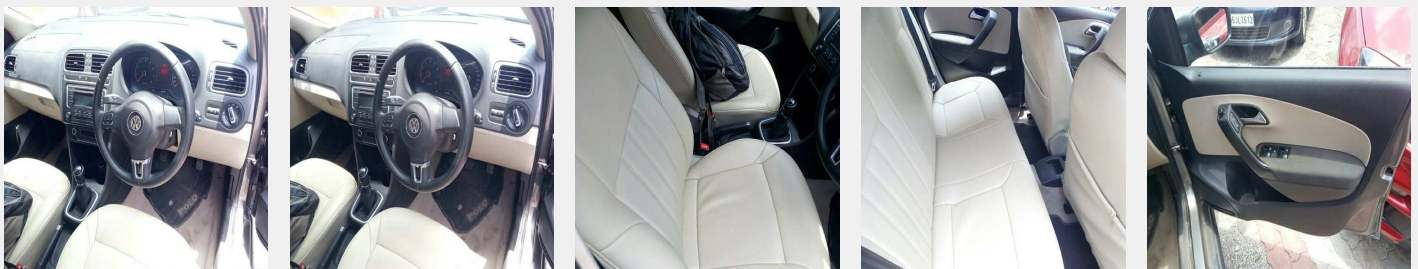
IMAGES

INTERIOR

8/10

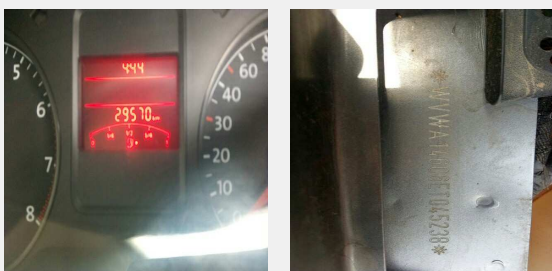
IMAGES

TEST DRIVE

9/10

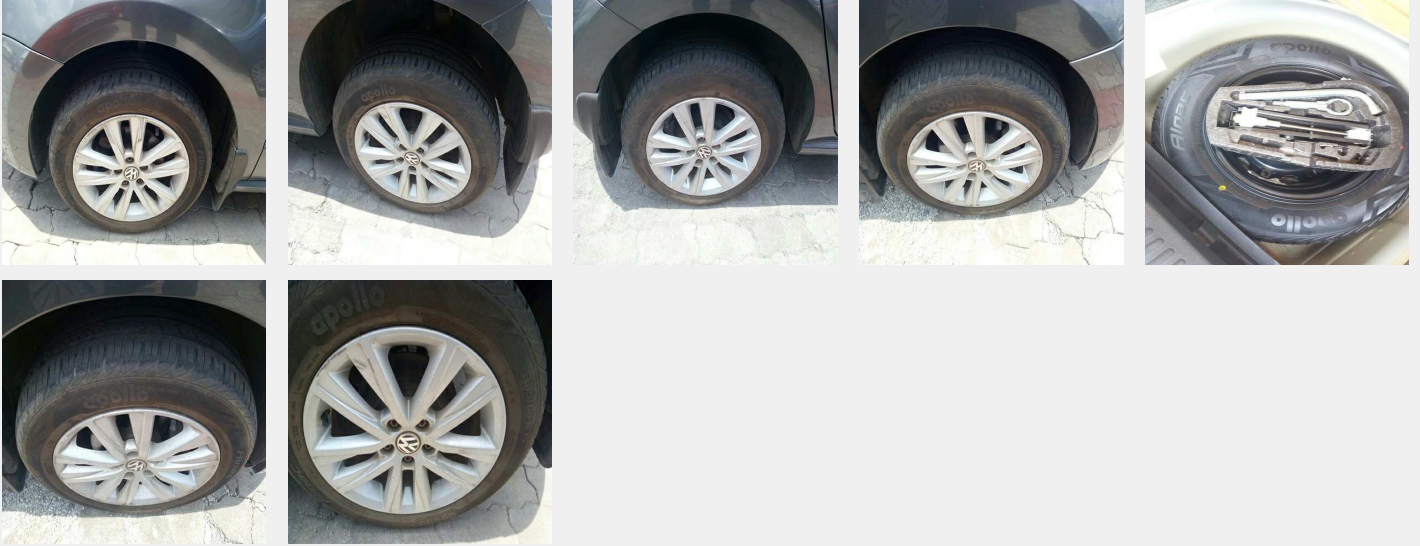
IMAGES

WHEEL

8/10

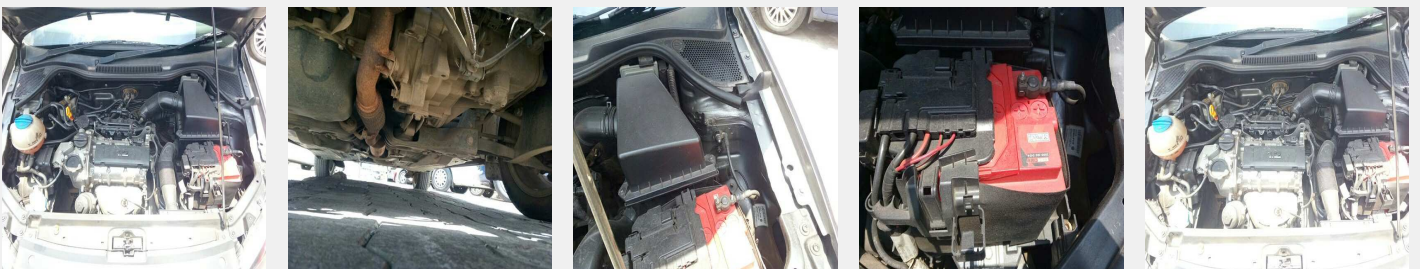
IMAGES

HOOD

8/10

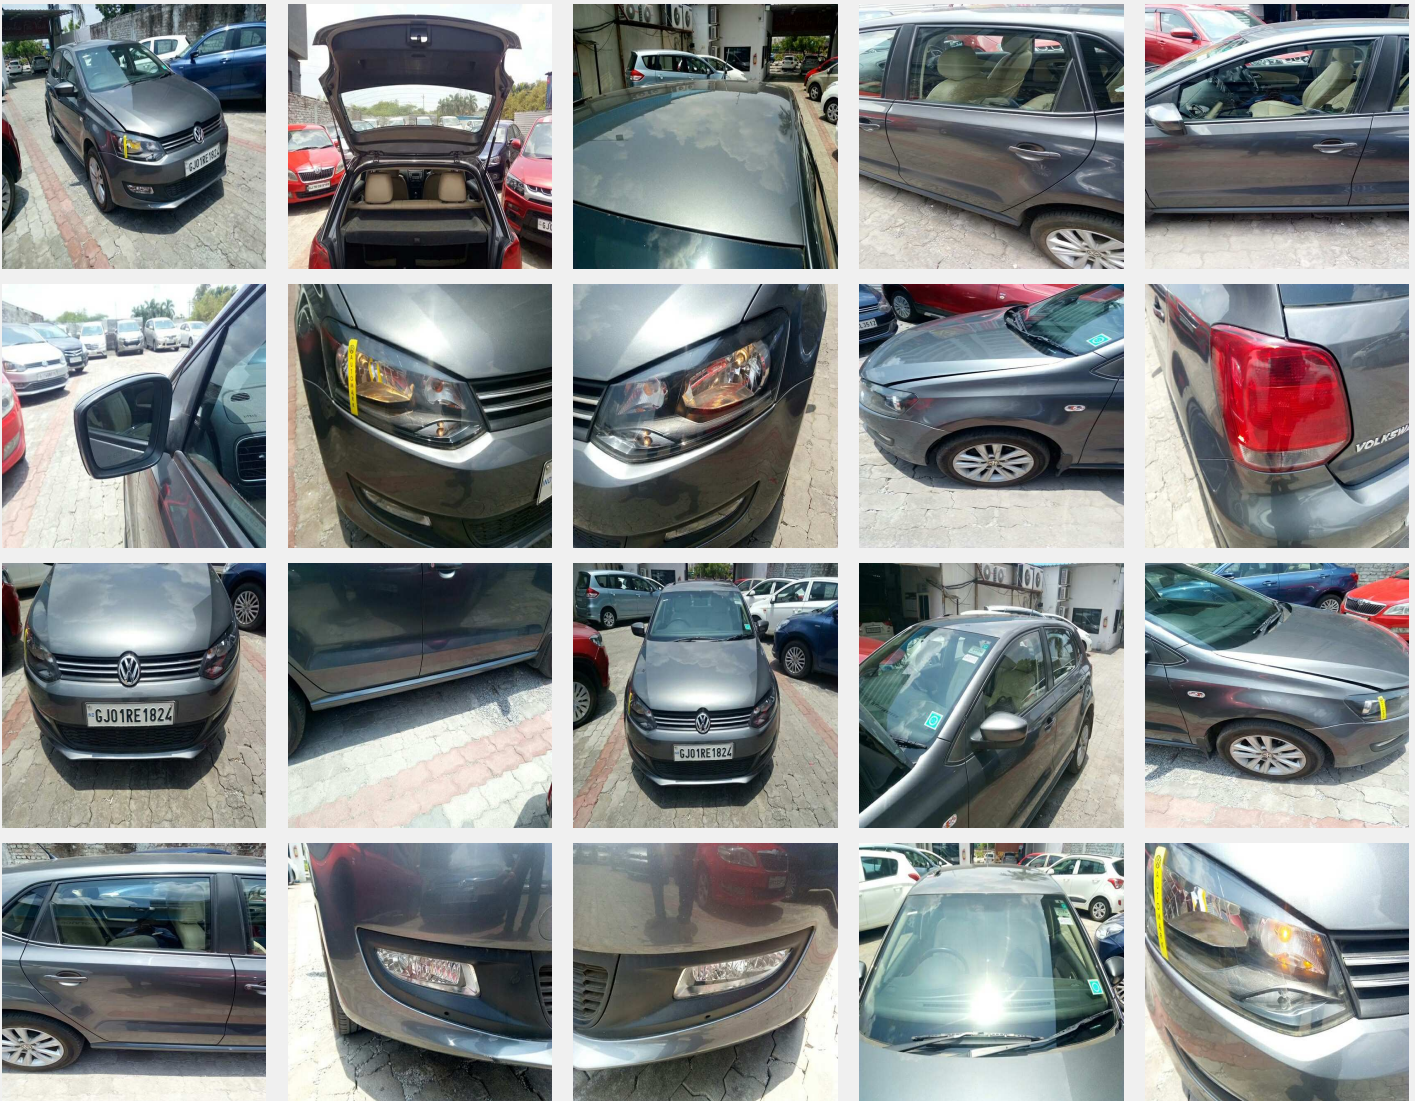
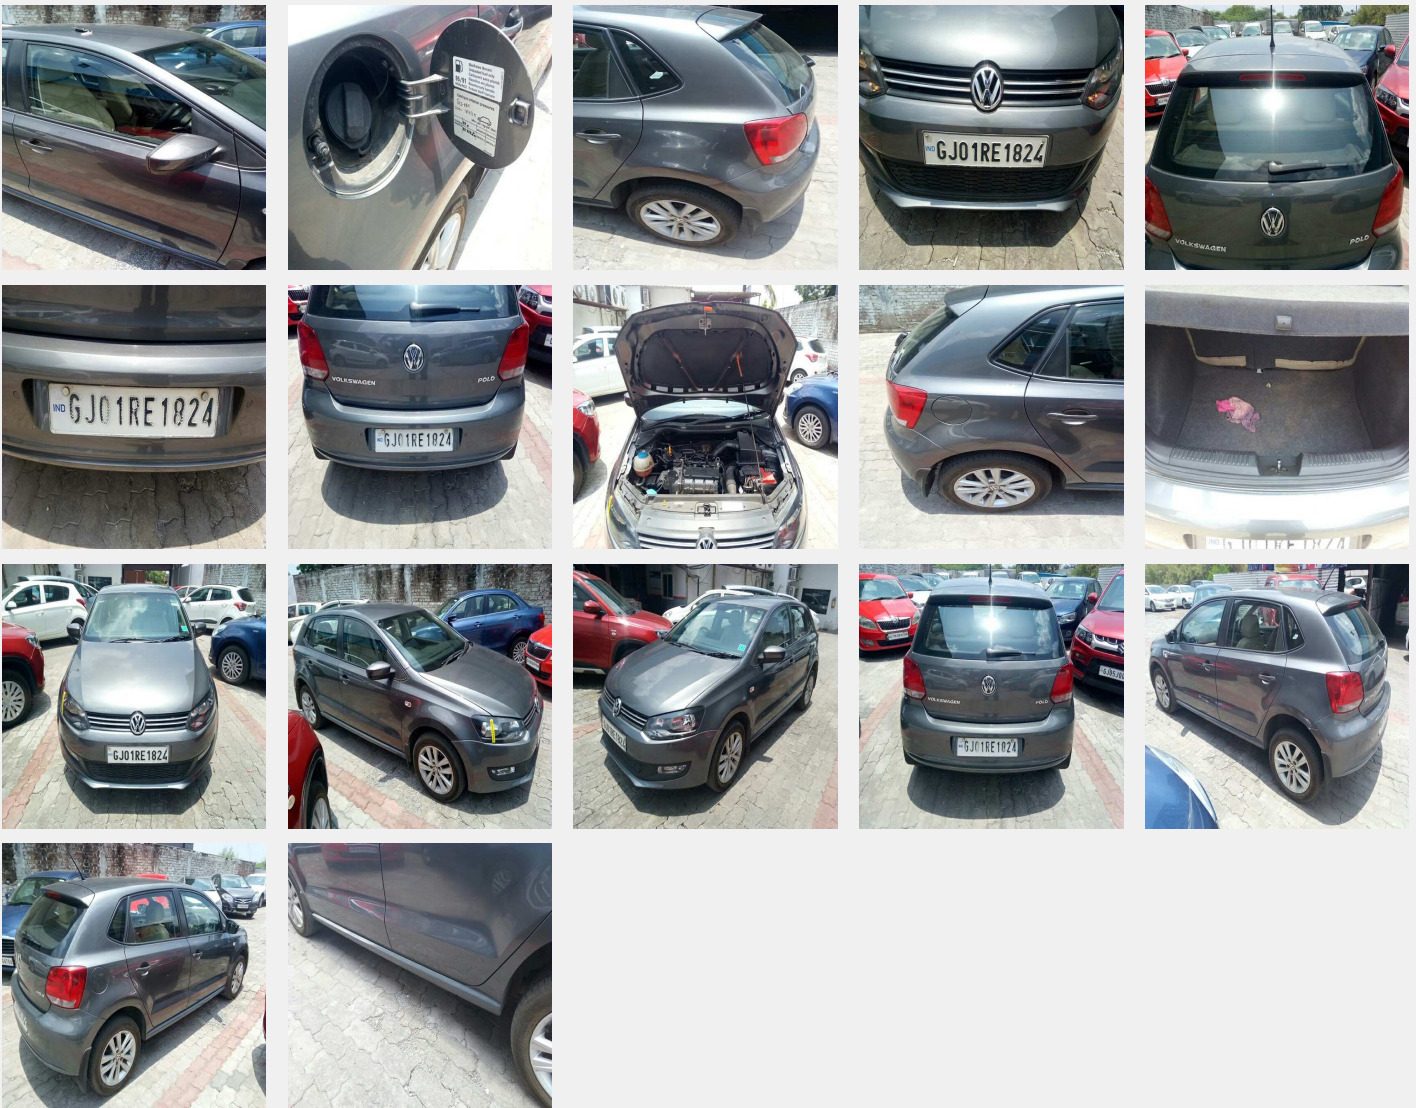
IMAGES

| INSPECTION CHECKPOINTS | SCORE(X/10) | REMARKS/COMMENTS | OPTIONAL SPEND EST. (RS) |
|---|---|---|---|
| LH QUARTER PANEL | 7 | | 0 |
| FUEL LID | 7 | | 0 |

| INSPECTION CHECKPOINTS | SCORE(X/10) | REMARKS/COMMENTS | OPTIONAL SPEND EST. (RS) |
|---|---|---|---|
| PAINT CONDITION | 10 | LIKE NEW | 0 |
