ECO INSPECTION CERTIFICATE

Order ID : 89367

121 Points Vehicle Inspection Certificate

Audi A3 35 TDI PREMIUM PLUS + SUNROOF, 2015

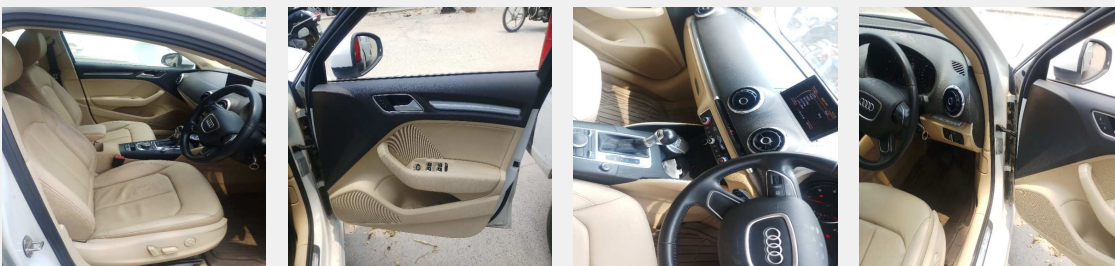
INTERIOR

INSPECTION CHECKPOINTS	SCORE(X/10)	REMARKS/COMMENTS	OPTIONAL SPEND EST. (RS)
DOOR PANEL	7		0
DOOR HINGES	7		0
CARPET & FLOOR MAT	7		0
SEAT & SEAT BELT	7		0
DASHBOARD & INSTRUMENT PANEL	7		0
HORN	7		0
SPEAKERS & MUSIC SYSTEM	7		0
HANDBRAKE	7		0
STEERING-MOUNTED CONTROLS	7		0
PEDALS	7		0
CENTRAL LOCK	7		0
A/C VENTS & HEATER	7		0
CUP HOLDERS	7		0
NAVIGATION (NO)	10		0
ODOMETER	7		0
POWER WINDOWS (YES)	7		0
HAZARD LIGHT	7		0

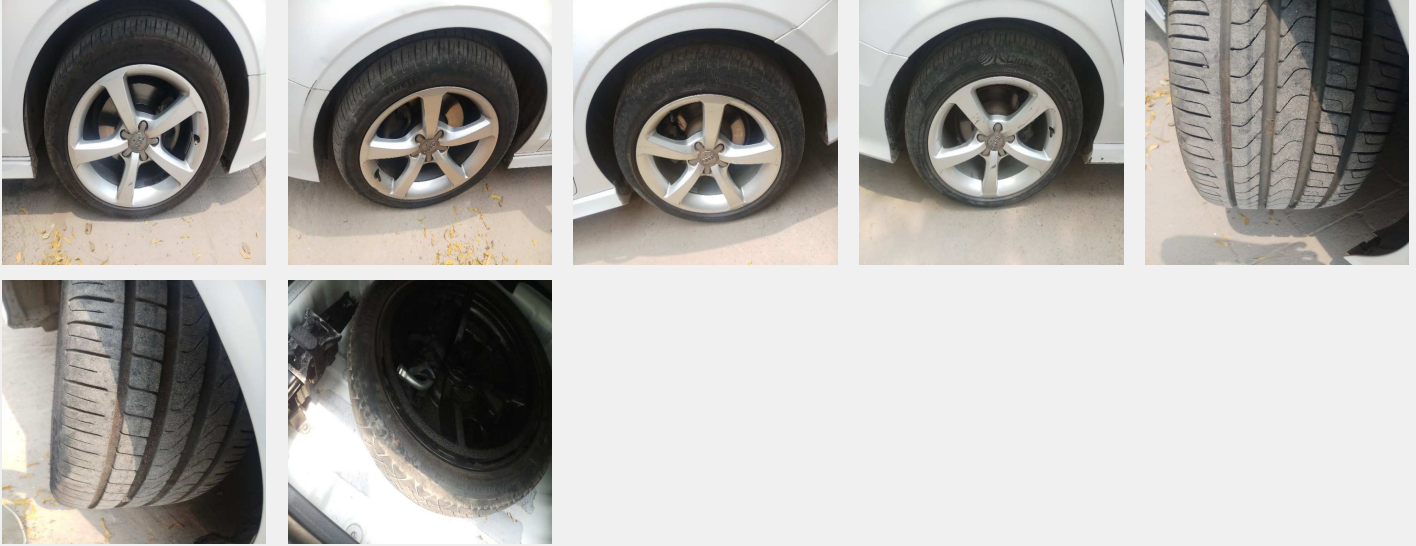
INSPECTION CHECKPOINTS	SCORE(X/10)	REMARKS/COMMENTS	OPTIONAL SPEND EST. (RS)
TYRES	7		0
SPARE TYRE (YES)	7		0
WHEEL ASSEMBLY (ALLOY RIM)	6		0

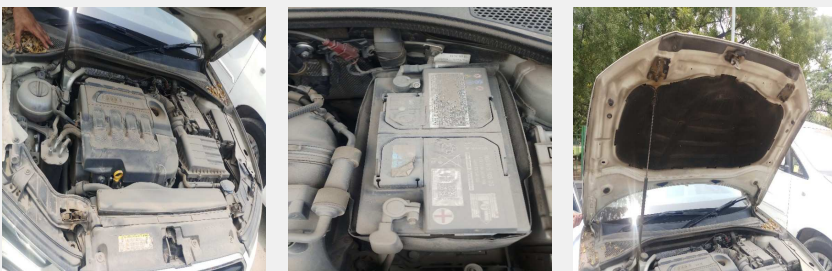
HOOD

INSPECTION CHECKPOINTS	SCORE(X/10)	REMARKS/COMMENTS	OPTIONAL SPEND EST. (RS)
LH APRON	7		0
RH APRON	7		0
RADIATOR	7		0
WIRING	7		0
BATTERY	7		0
BRAKE FLUID LEVEL	7		0
ENGINE OIL	7		0
COOLANT LEVEL	7		0
BRAKE & COOLANT HOSE PIPES	7		0
UNDERCARRIAGE	7		0
EXHAUST SYSTEM	7		0

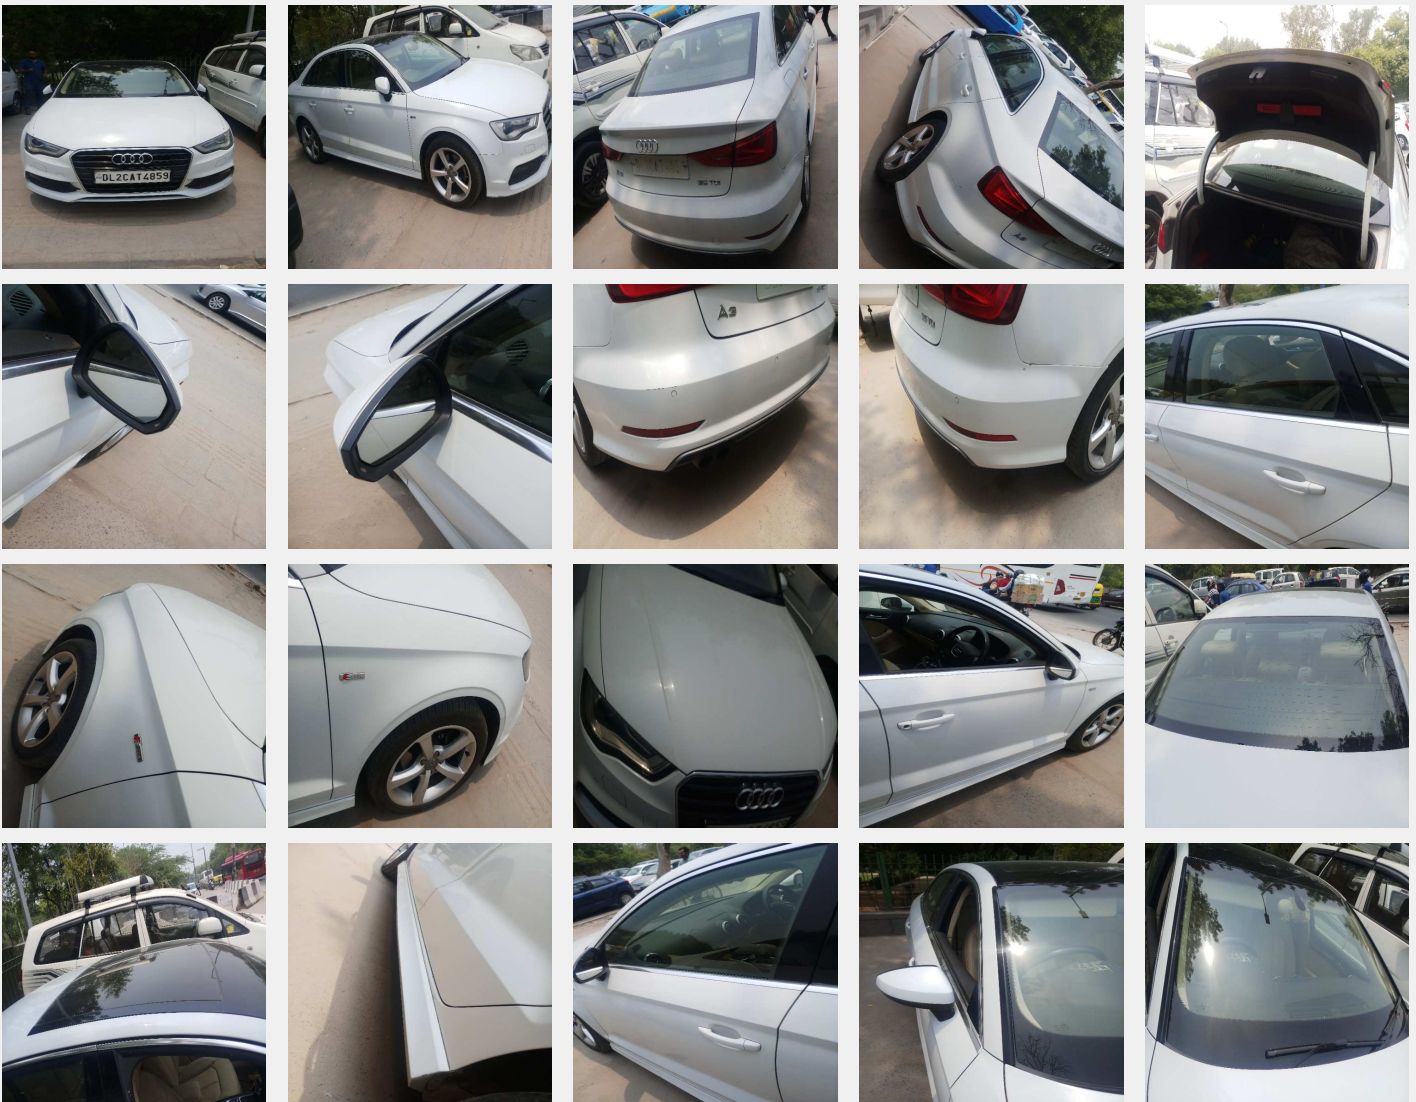
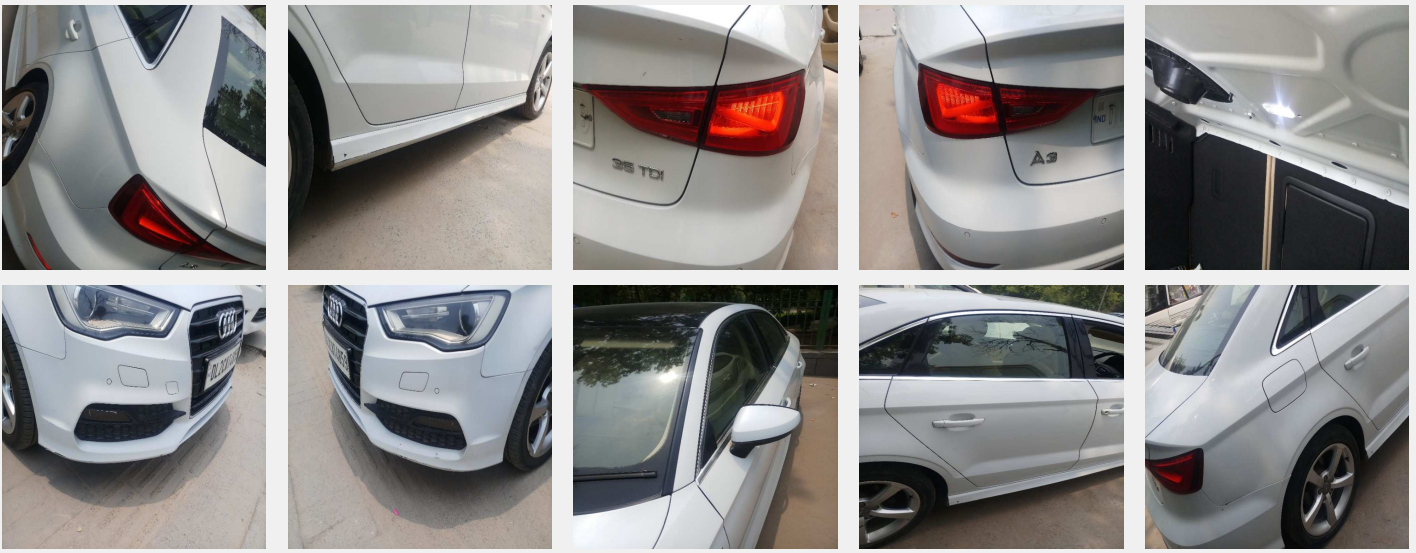
EXTERIOR (CONTINUED)

INSPECTION CHECKPOINTS	SCORE(X/10)	REMARKS/COMMENTS	OPTIONAL SPEND EST. (RS)
RH FENDER	7		0
BODY RUST	7		0
ROOF (SUN ROOF)	7		0
PAINT CONDITION	7		0
HEAD LIGHTS	5	RIGHT SIDE NOT WORKING NEED TO REPAIR	2500
