ECO INSPECTION CERTIFICATE

Order ID : 82955

121 Points Vehicle Inspection Certificate

Maruti Suzuki Swift VXI, 2005

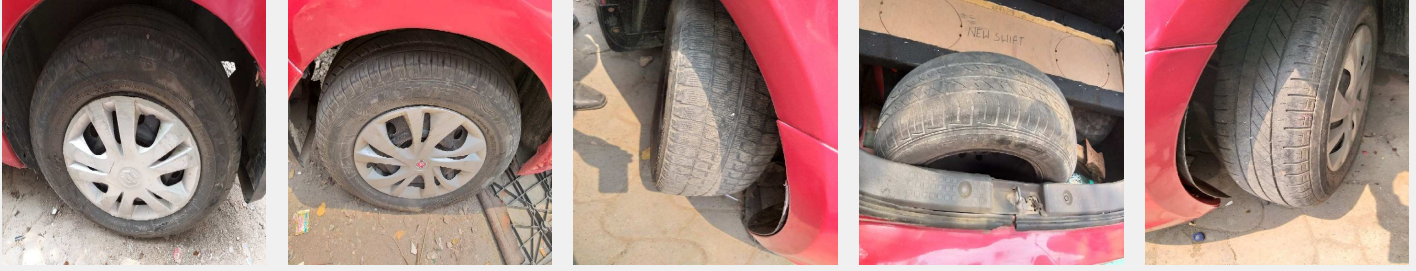
INSPECTION CHECKPOINTS	SCORE(X/10)	REMARKS/COMMENTS	OPTIONAL SPEND EST. (RS)
TYRES	7	GOOD	0
SPARE TYRE (YES)	6	FAIR	0
WHEEL ASSEMBLY (STEEL RIM)	6	FAIR	0

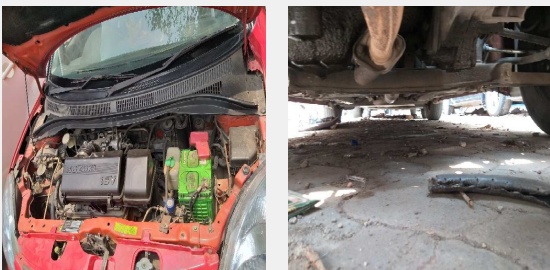
HOOD

INSPECTION CHECKPOINTS	SCORE(X/10)	REMARKS/COMMENTS	OPTIONAL SPEND EST. (RS)
LH APRON	6	FAIR	0
RH APRON	6	FAIR	0
RADIATOR	6	FAIR	0
WIRING	6	FAIR	0
BATTERY	6	FAIR	0
BRAKE FLUID LEVEL	6	FAIR	0
ENGINE OIL	6	FAIR	0
COOLANT LEVEL	6	FAIR	0
BRAKE & COOLANT HOSE PIPES	6	FAIR	0
UNDERCARRIAGE	6	FAIR	0
EXHAUST SYSTEM	6	FAIR	0

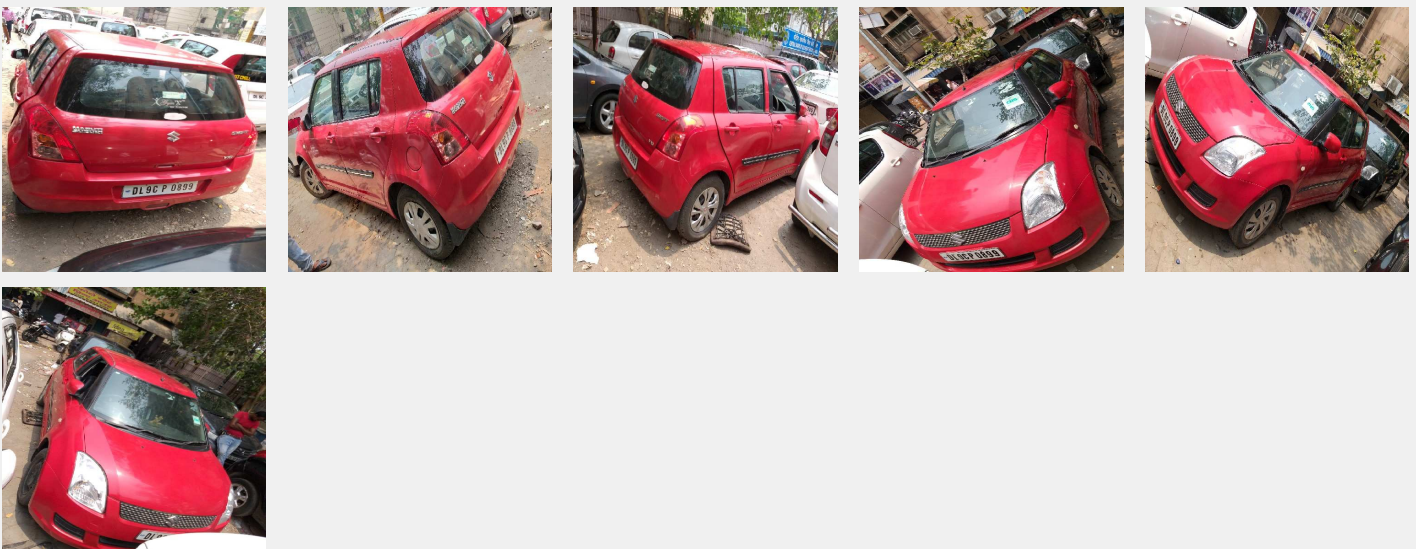
EXTERIOR

INSPECTION CHECKPOINTS	SCORE(X/10)	REMARKS/COMMENTS	OPTIONAL SPEND EST. (RS)
LICENSE PLATE	6	FAIR	0
FRONT BUMPER	6	PAINTED	0
HEAD LIGHTS	6	BOTH NOT WORKING	1000
GRILLE	6	FAIR	0
TURN SIGNAL	6	FAIR	0
FOG LAMPS	6	NO	0
HOOD	6	PAINTED	0
PILLAR	6	FAIR	0
FRONT WINDSHIELD	6	FAIR	0
SIDE VIEW MIRRORS	6	FAIR	0
LH FENDER	6	PAINTED	0
LH FRONT DOOR	6	PAINTED	0
LH REAR DOOR	6	PAINTED	0
LH RUNNING BOARD	6	PAINTED	0
LH QUARTER PANEL	6	PAINTED	0
FUEL LID	6	FAIR	0
REAR WINDSHIELD	6	FAIR	0
REAR BUMPER	6	PAINTED	0
TAIL LIGHT	6	FAIR	0
TRUNK LID/TAIL GATE	6	PAINTED	0
LUGGAGE COMPARTMENT LIGHT	6	FAIR	0
RH QUARTER PANEL	6	PAINTED	0
RH RUNNING BOARD	6	PAINTED	0
RH REAR DOOR	6	PAINTED	0

INSPECTION CHECKPOINTS	SCORE(X/10)	REMARKS/COMMENTS	OPTIONAL SPEND EST. (RS)
RH FRONT DOOR	6	PAINTED	0
RH FENDER	6	PAINTED	0
BODY RUST	6	MINOR	0
ROOF (REGULAR)	6	FAIR	0
PAINT CONDITION	6	FAIR	0
