ECO INSPECTION CERTIFICATE

121 Points Vehicle Inspection Certificate

Inspection Date :
2019-07-09

Maruti Suzuki Ertiga VDI SHVS, 2017

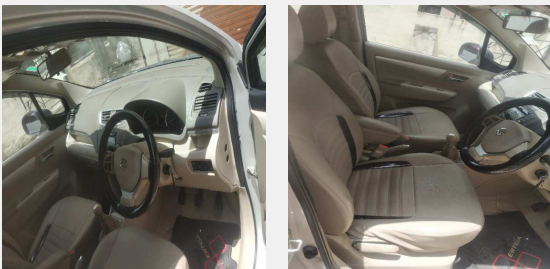
IMAGES

INSPECTION CHECKPOINTS	SCORE(X/10)	REMARKS/COMMENTS	OPTIONAL SPEND EST. (RS)
DOOR PANEL	7	GOOD	0
DOOR HINGES	7	GOOD HINGES	0
CARPET & FLOOR MAT	7	GOOD	0
SEAT & SEAT BELT	7	GOOD MOVE	0
DASHBOARD & INSTRUMENT PANEL	7	WORKING	0
HORN	7	WORKING	0
SPEAKERS & MUSIC SYSTEM	7	GOOD SOUND	0
HANDBRAKE	7	PROPER HOLD	0
STEERING-MOUNTED CONTROLS	7	WORKING	0
PEDALS	7	GOOD	0
CENTRAL LOCK	7	WORKING	0
A/C VENTS & HEATER	7	GOOD COOL	0
CUP HOLDERS	7	GOOD	0
NAVIGATION (NO)	10		0
ODOMETER	7	WORKING	0
POWER WINDOWS (YES)	7	WORKING	0
HAZARD LIGHT	7	WORKING	0

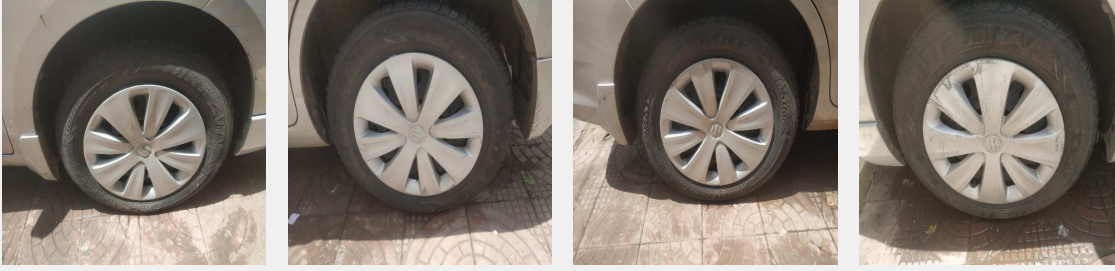
IMAGES

INSPECTION CHECKPOINTS	SCORE(X/10)	REMARKS/COMMENTS	OPTIONAL SPEND EST. (RS)
TYRES	7	GOOD TREAD	0
SPARE TYRE (YES)	7	GOOD	0
WHEEL ASSEMBLY (STEEL RIM)	7	GOOD	0

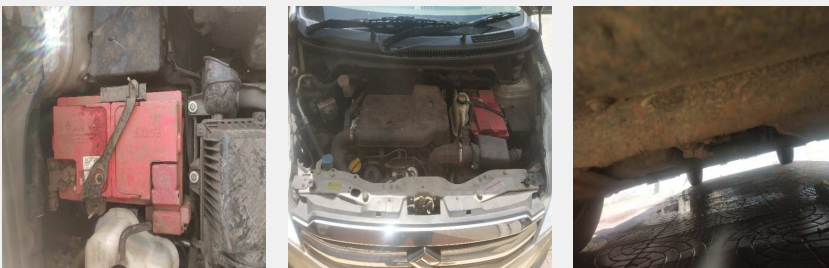
IMAGES

INSPECTION CHECKPOINTS	SCORE(X/10)	REMARKS/COMMENTS	OPTIONAL SPEND EST. (RS)
LH APRON	7	GOOD	0
RH APRON	7	GOOD	0
RADIATOR	7	GOOD	0
WIRING	7	GOOD	0
BATTERY	7	GOOD	0
BRAKE FLUID LEVEL	7	MAX	0
ENGINE OIL	7	MAX	0
COOLANT LEVEL	7	MAX	0
BRAKE & COOLANT HOSE PIPES	7	GOOD	0
UNDERCARRIAGE	7	NO RUSTY	0
EXHAUST SYSTEM	7	NO SMOKE	0

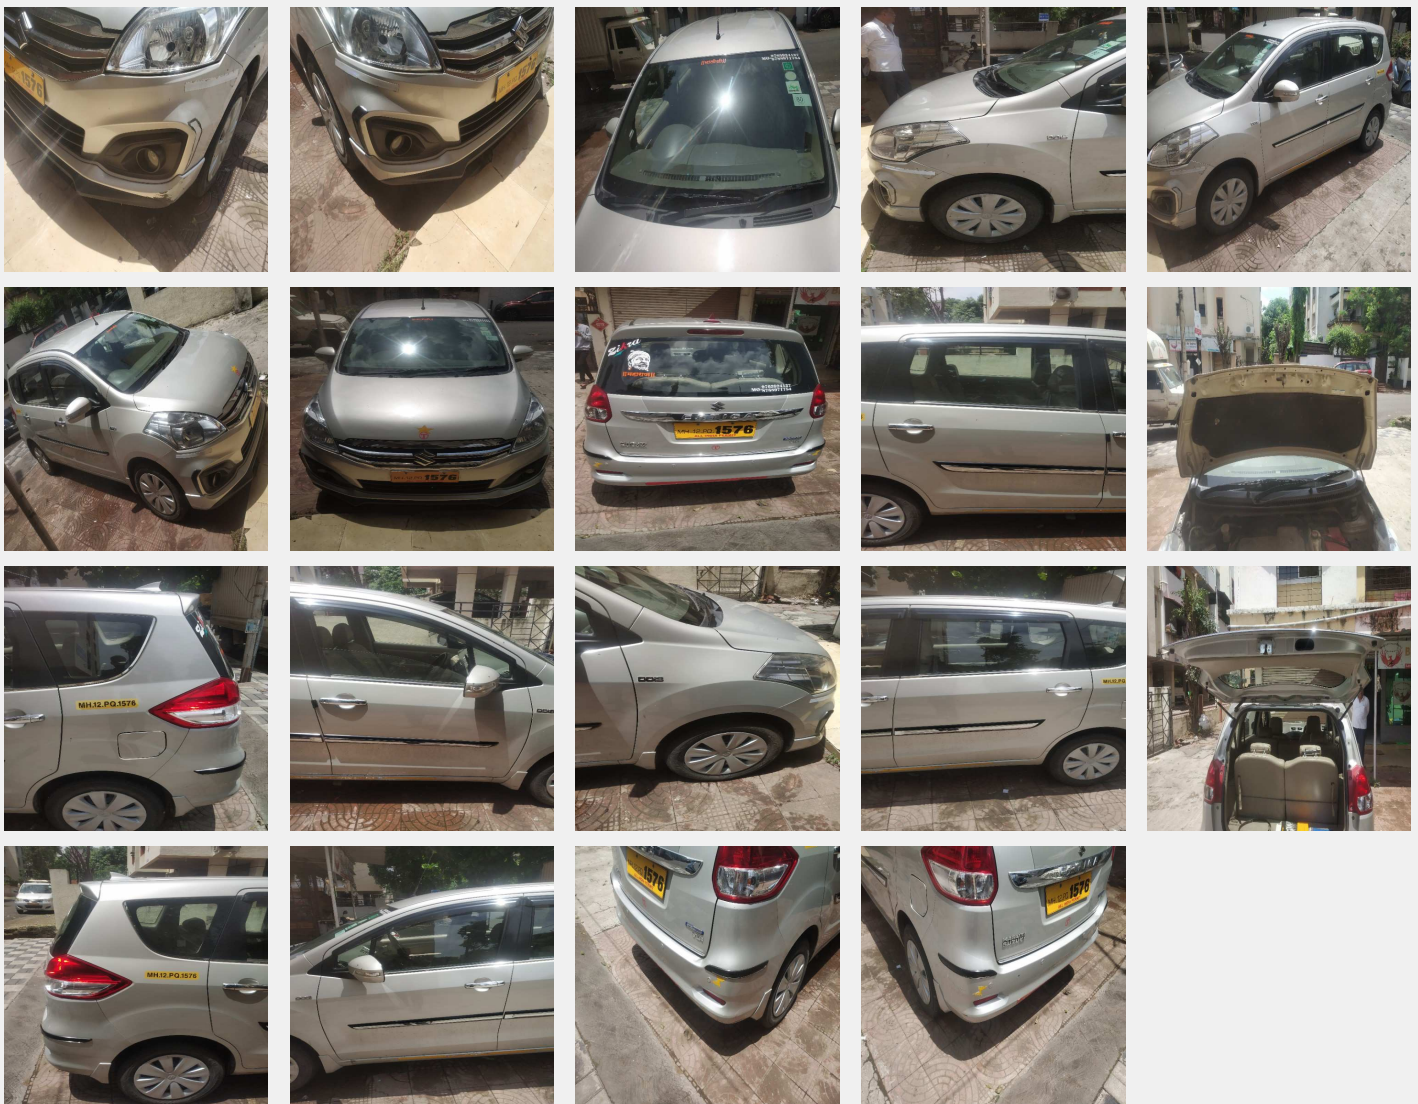
IMAGES

INSPECTION CHECKPOINTS	SCORE(X/10)	REMARKS/COMMENTS	OPTIONAL SPEND EST. (RS)
LICENSE PLATE	7	GOOD	0
FRONT BUMPER	7	SCRATCH ON IT	0
HEAD LIGHTS	7	GOOD	0
GRILLE	7	GOOD	0
TURN SIGNAL	7	WORKING	0
FOG LAMPS	7	WORKING	0
HOOD	7	GOOD	0
PILLAR	7	GOOD	0
FRONT WINDSHIELD	7	GOOD VISIBILITY	0
SIDE VIEW MIRRORS	7	GOOD	0
LH FENDER	7	GOOD	0
LH FRONT DOOR	7	GOOD	0
LH REAR DOOR	7	GOOD	0
LH RUNNING BOARD	7	GOOD	0
LH QUARTER PANEL	7	GOOD	0
FUEL LID	7	GOOD	0
REAR WINDSHIELD	7	GOOD VISIBILITY	0
REAR BUMPER	7	GOOD	0
TAIL LIGHT	7	GOOD	0
TRUNK LID/TAIL GATE	7	GOOD	0
LUGGAGE COMPARTMENT LIGHT	7	NO SPACE	0
RH QUARTER PANEL	7	GOOD	0
RH RUNNING BOARD	7	GOOD	0
RH REAR DOOR	7	GOOD	0

INSPECTION CHECKPOINTS	SCORE(X/10)	REMARKS/COMMENTS	OPTIONAL SPEND EST. (RS)
RH FRONT DOOR	7	GOOD	0
RH FENDER	7	GOOD	0
BODY RUST	7	NO RUST	0
ROOF (REGULAR)	7	GOOD	0
PAINT CONDITION	7	GOOD	0
