ECO INSPECTION CERTIFICATE

Order ID : 83052

121 Points Vehicle Inspection Certificate

Mahindra Xylo E4 ABS BS IV, 2011

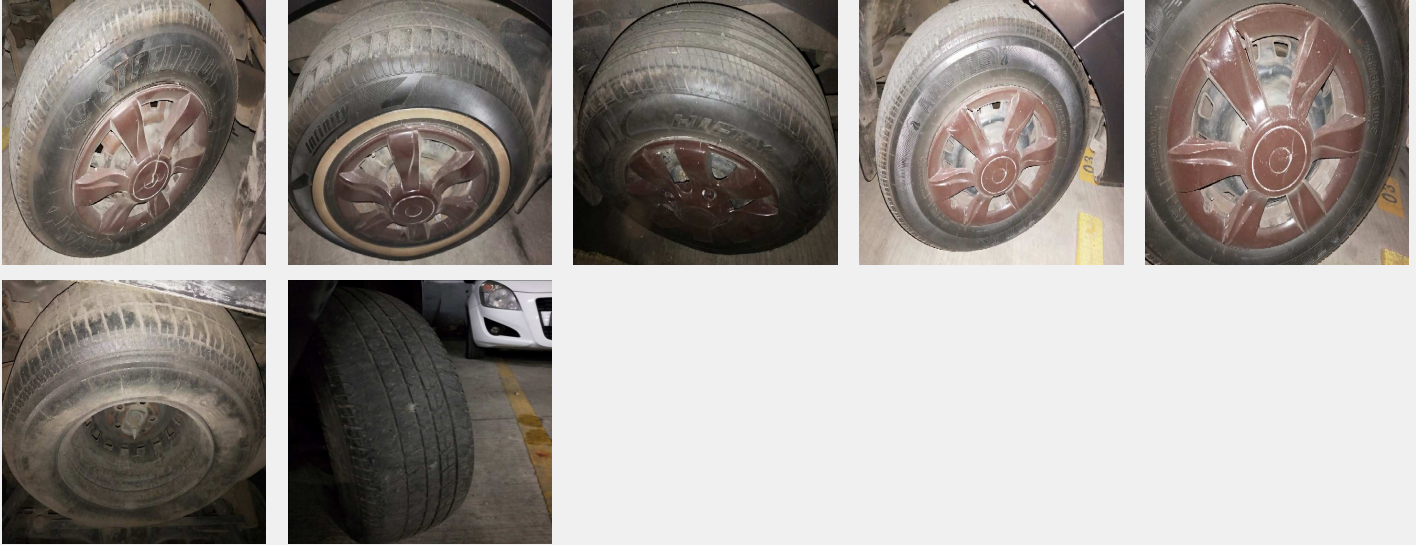
WHEEL

INSPECTION CHECKPOINTS	SCORE(X/10)	REMARKS/COMMENTS	OPTIONAL SPEND EST. (RS)
TYRES	6	NORMAL WEAR AND TEAR	0
SPARE TYRE (YES)	6	ACCEPTABLE CONDITION	0

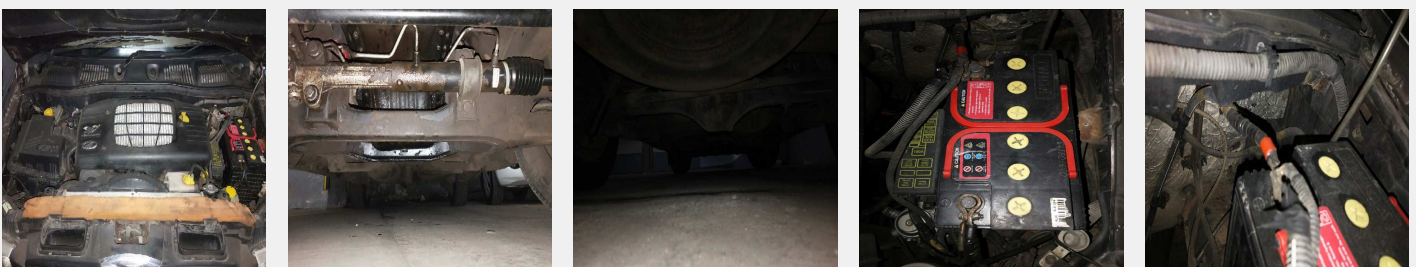
HOOD

INSPECTION CHECKPOINTS	SCORE(X/10)	REMARKS/COMMENTS	OPTIONAL SPEND EST. (RS)
LH APRON	6	ACCEPTABLE CONDITION	0
RH APRON	6	ACCEPTABLE CONDITION	0
RADIATOR	6	GOOD WORKING	0
WIRING	6	ACCEPTABLE CONDITION	0
BATTERY	6	GOOD CONDITION	0
BRAKE FLUID LEVEL	6	MAXIMUM LEVEL	0
ENGINE OIL	6	GOOD VISCOSITY	0
COOLANT LEVEL	6	MAXIMUM LEVEL	0
BRAKE & COOLANT HOSE PIPES	6	ACCEPTABLE CONDITION	0
UNDERCARRIAGE	6	NO DAMAGE	0
EXHAUST SYSTEM	6	GOOD WORKING	0

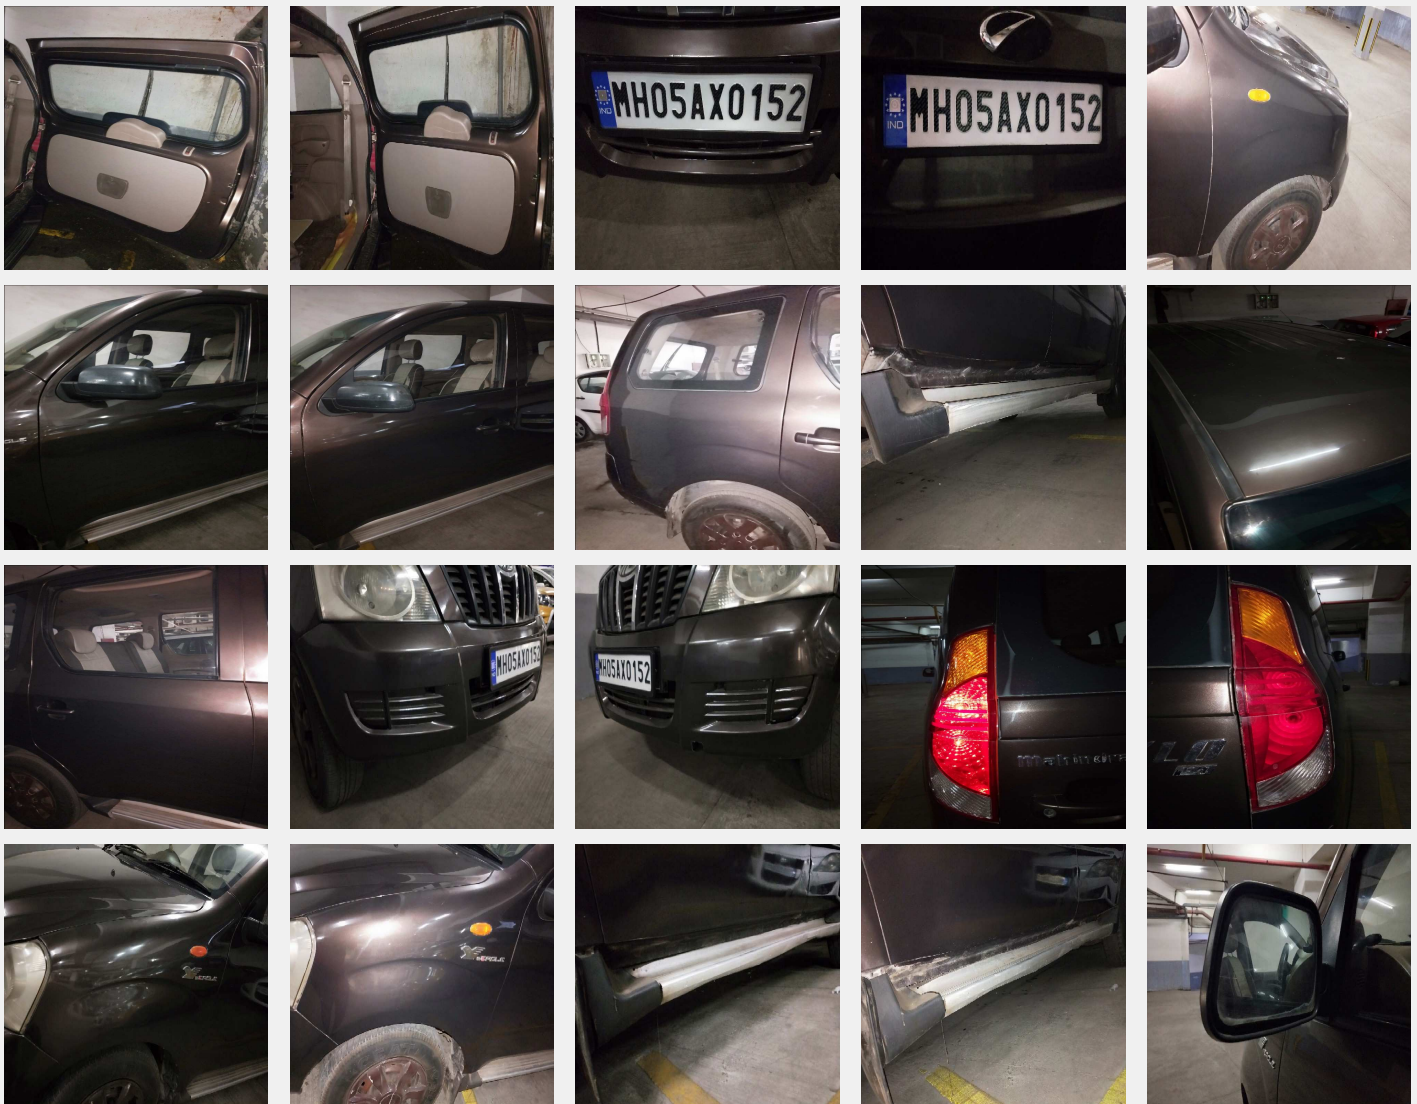
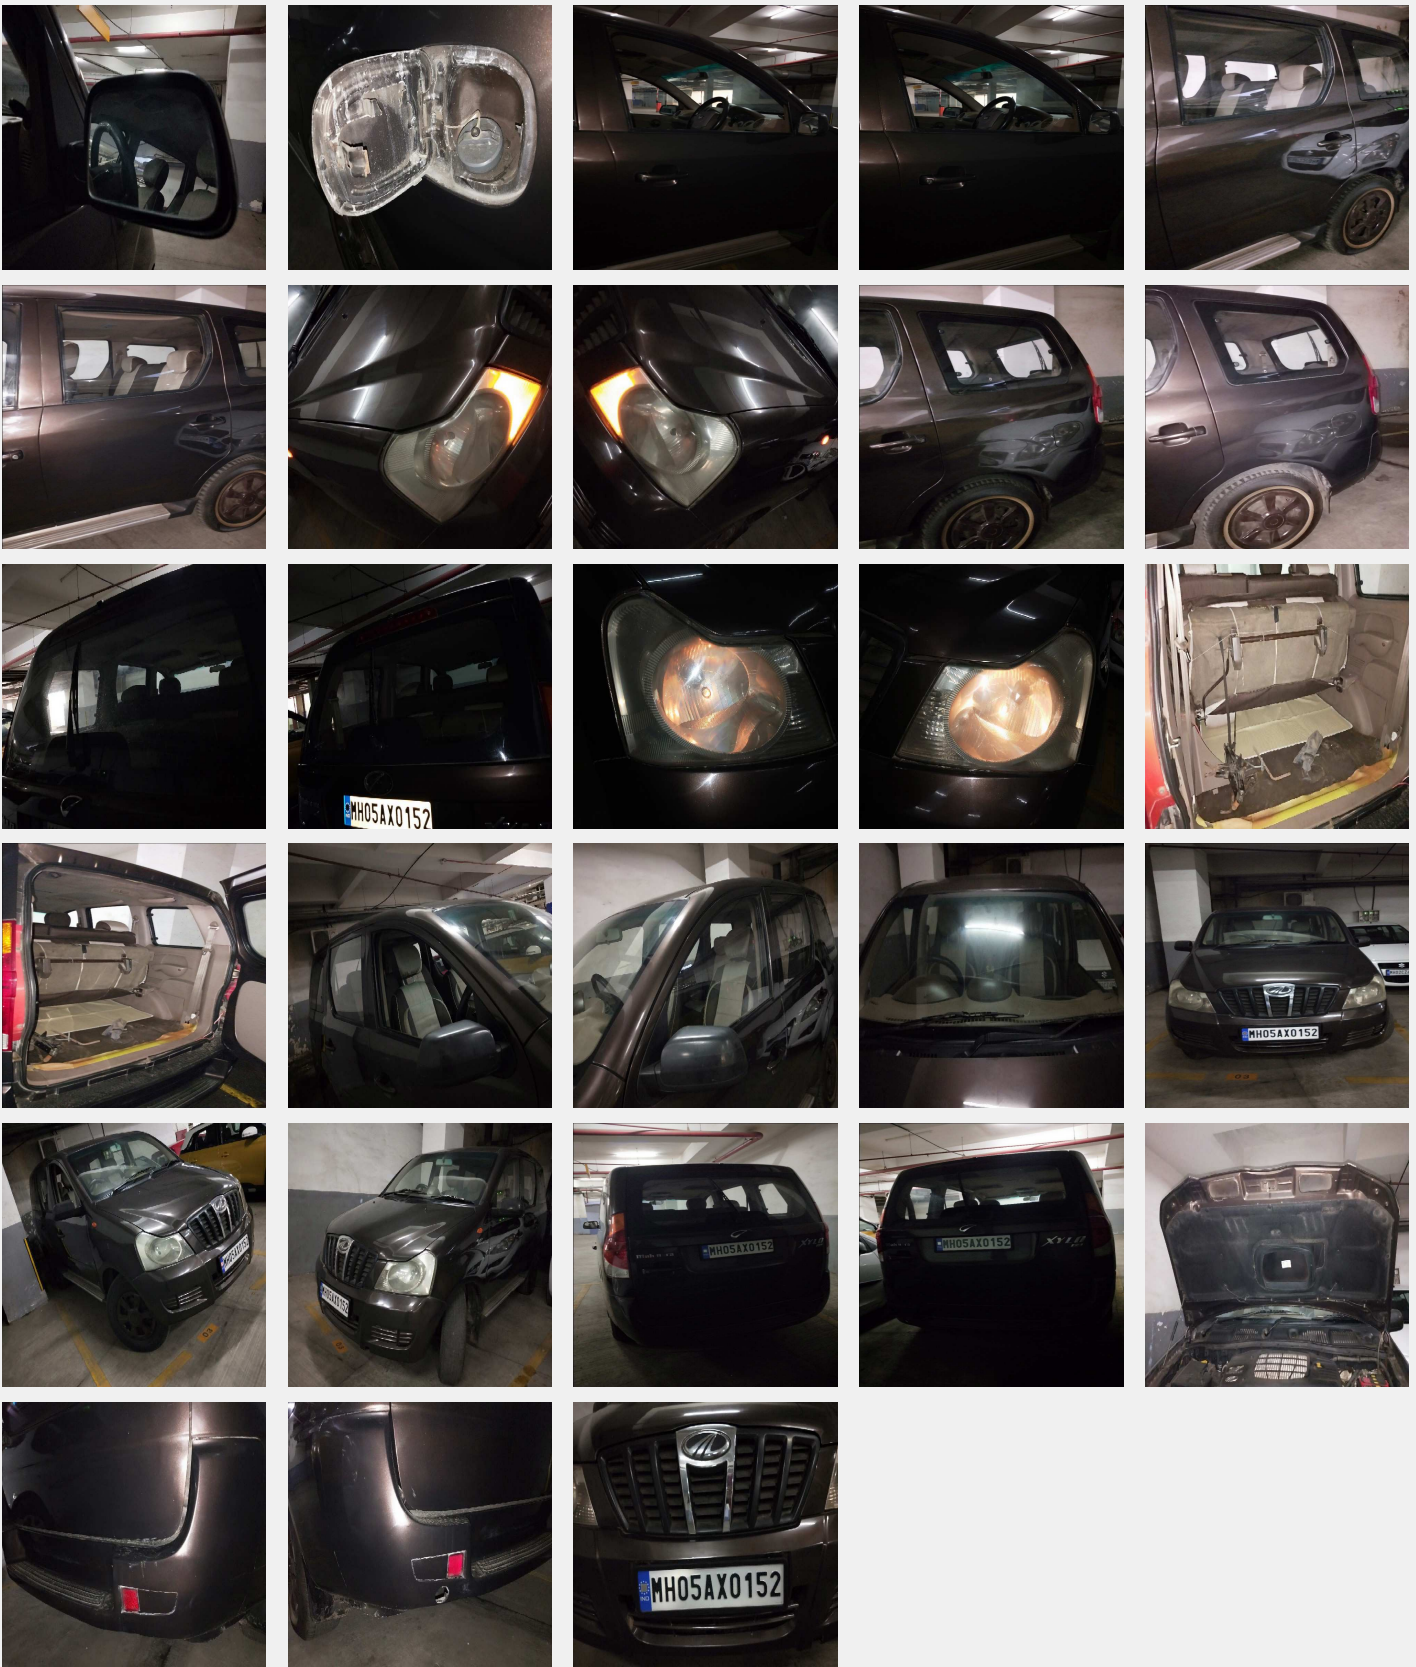
EXTERIOR (CONTINUED)

INSPECTION CHECKPOINTS	SCORE(X/10)	REMARKS/COMMENTS	OPTIONAL SPEND EST. (RS)
RH FENDER	6	GOOD CONDITION	0
BODY RUST	6	NO RUST FOUND	0
ROOF (REGULAR)	6	GOOD CONDITION	0
PAINT CONDITION	6	GOOD CONDITION	0
FOG LAMPS	0	NOT AVAILABLE	0
