ECO INSPECTION CERTIFICATE

Order ID : 95263

121 Points Vehicle Inspection Certificate

Mahindra Scorpio S4 PLUS 1.99, 2015

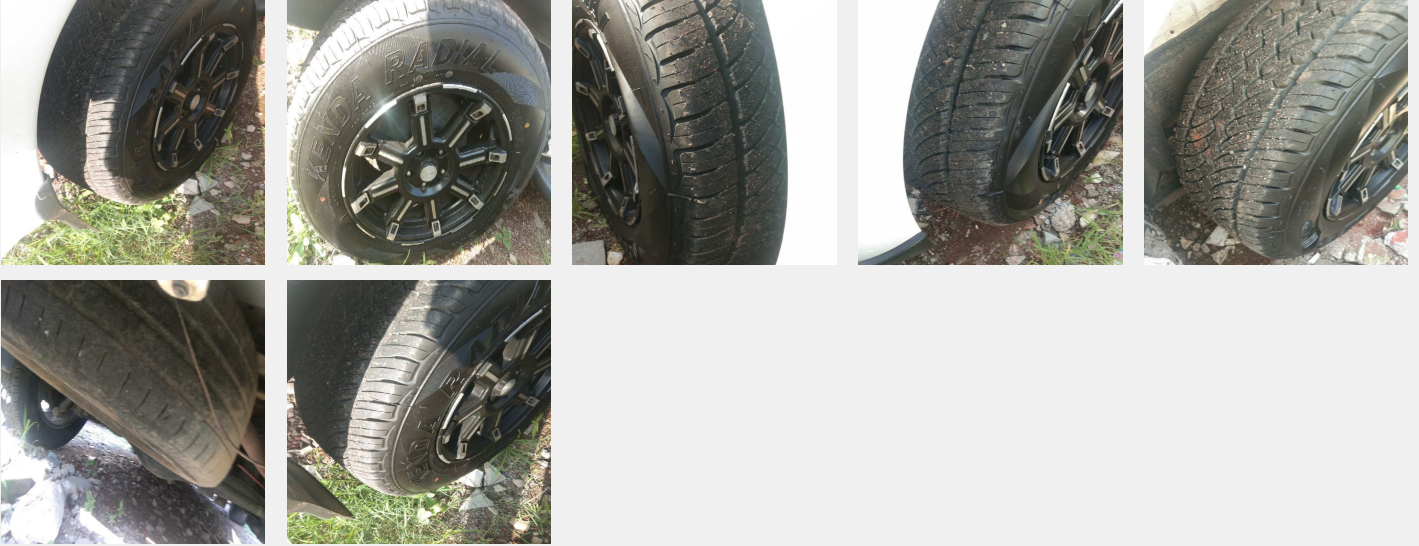
INSPECTION CHECKPOINTS	SCORE(X/10)	REMARKS/COMMENTS	OPTIONAL SPEND EST. (RS)
TYRES	8	OK	0
WHEEL ASSEMBLY (ALLOY RIM)	8	OK	0
SPARE TYRE (YES)	3	REAPLES	5000

NEED ATTENTION

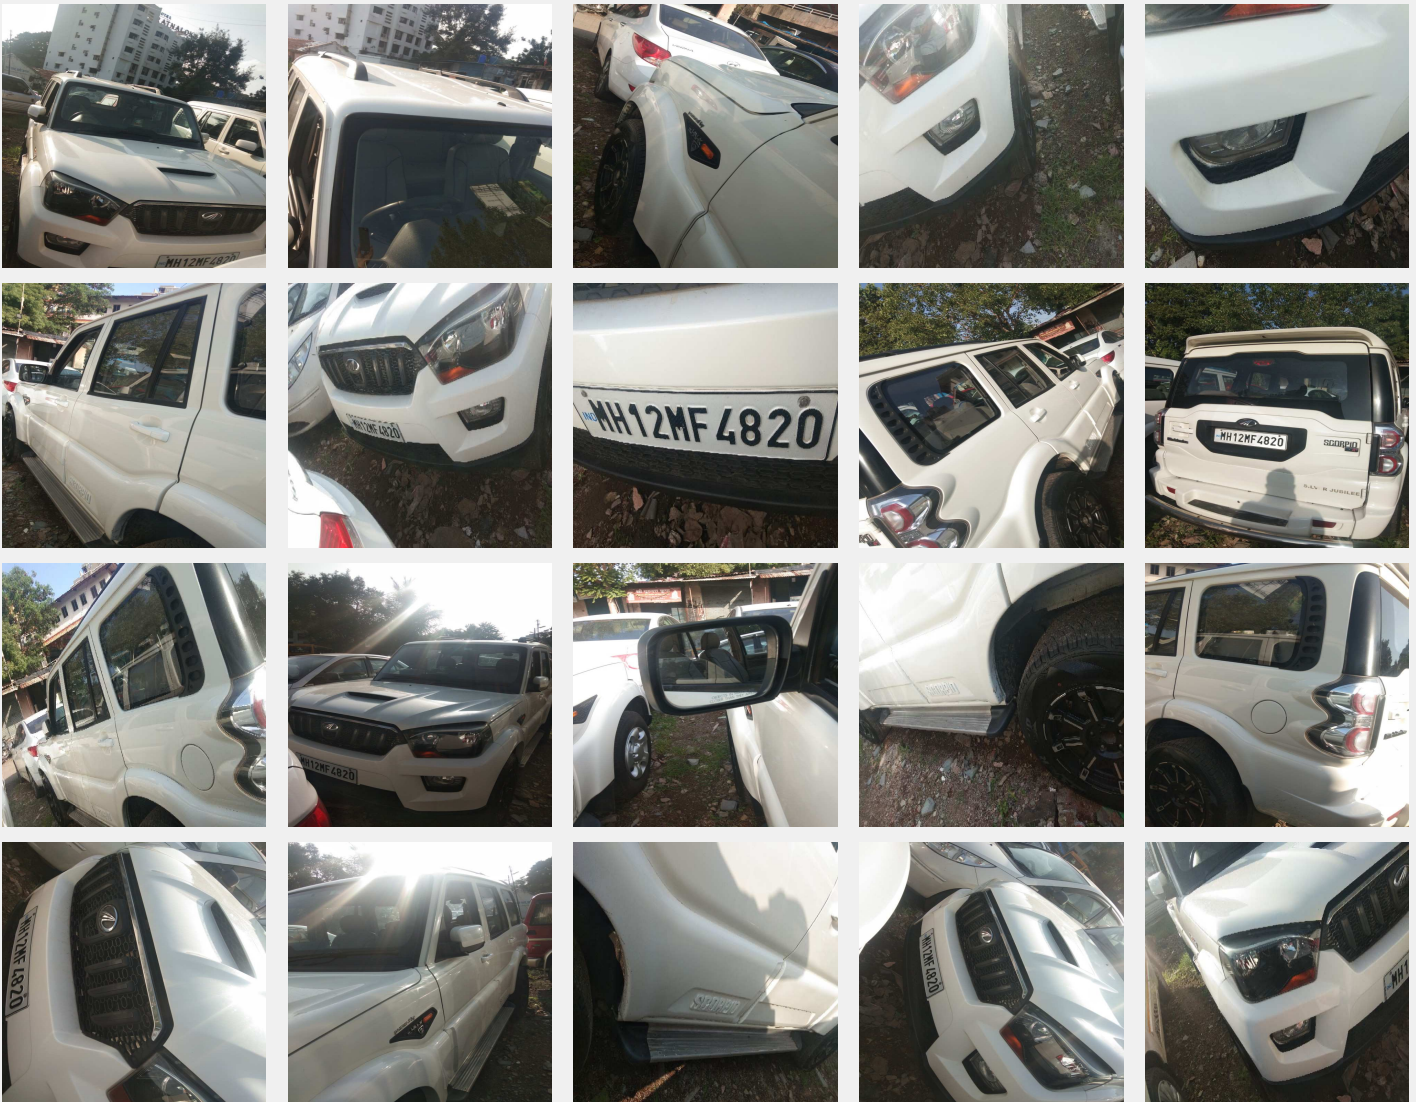
INSPECTION CHECKPOINTS	SCORE(X/10)	REMARKS/COMMENTS	OPTIONAL SPEND EST. (RS)
ROOF (REGULAR)	8	OK	0
PAINT CONDITION	8	OK	0
HEAD LIGHTS	0	OK	0
FRONT WINDSHIELD	0	OK	0
FUEL LID	3	NOT OPEN	1000

NEED ATTENTION
