ECO INSPECTION CERTIFICATE

Order ID : 95450

121 Points Vehicle Inspection Certificate

Honda Brio VX (O) MT, 2013

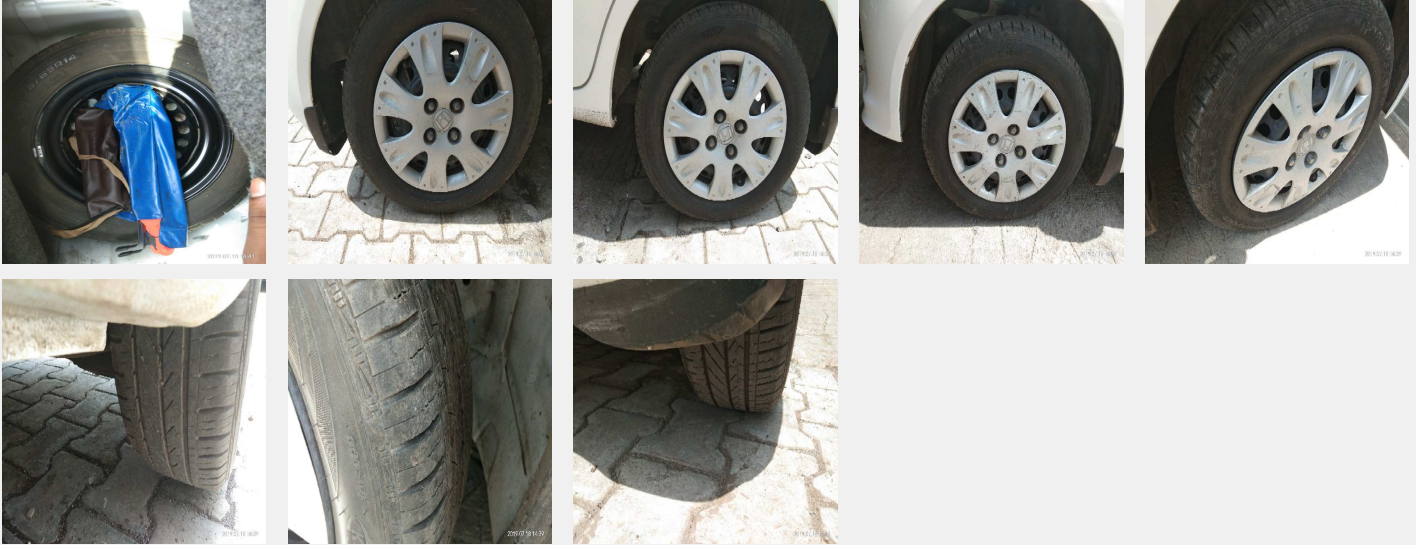
WHEEL

INSPECTION CHECKPOINTS	SCORE(X/10)	REMARKS/COMMENTS	OPTIONAL SPEND EST. (RS)
TYRES	7		0
SPARE TYRE (YES)	6		0

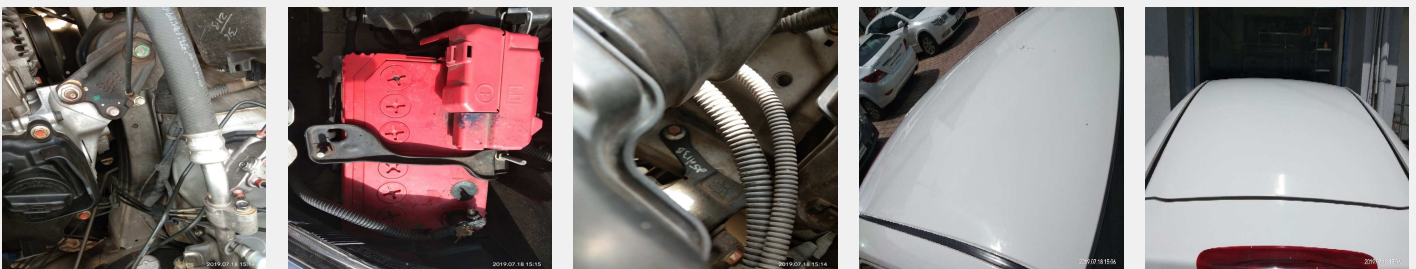
HOOD

INSPECTION CHECKPOINTS	SCORE(X/10)	REMARKS/COMMENTS	OPTIONAL SPEND EST. (RS)
LH APRON	7		0
RH APRON	7		0
RADIATOR	7		0
WIRING	8		0
BATTERY	6		0
ENGINE OIL	7		0
COOLANT LEVEL	7		0
BRAKE & COOLANT HOSE PIPES	7		0
UNDERCARRIAGE	7		0
EXHAUST SYSTEM	8		0
BRAKE FLUID LEVEL	3	NEED TO CHANGE	1200

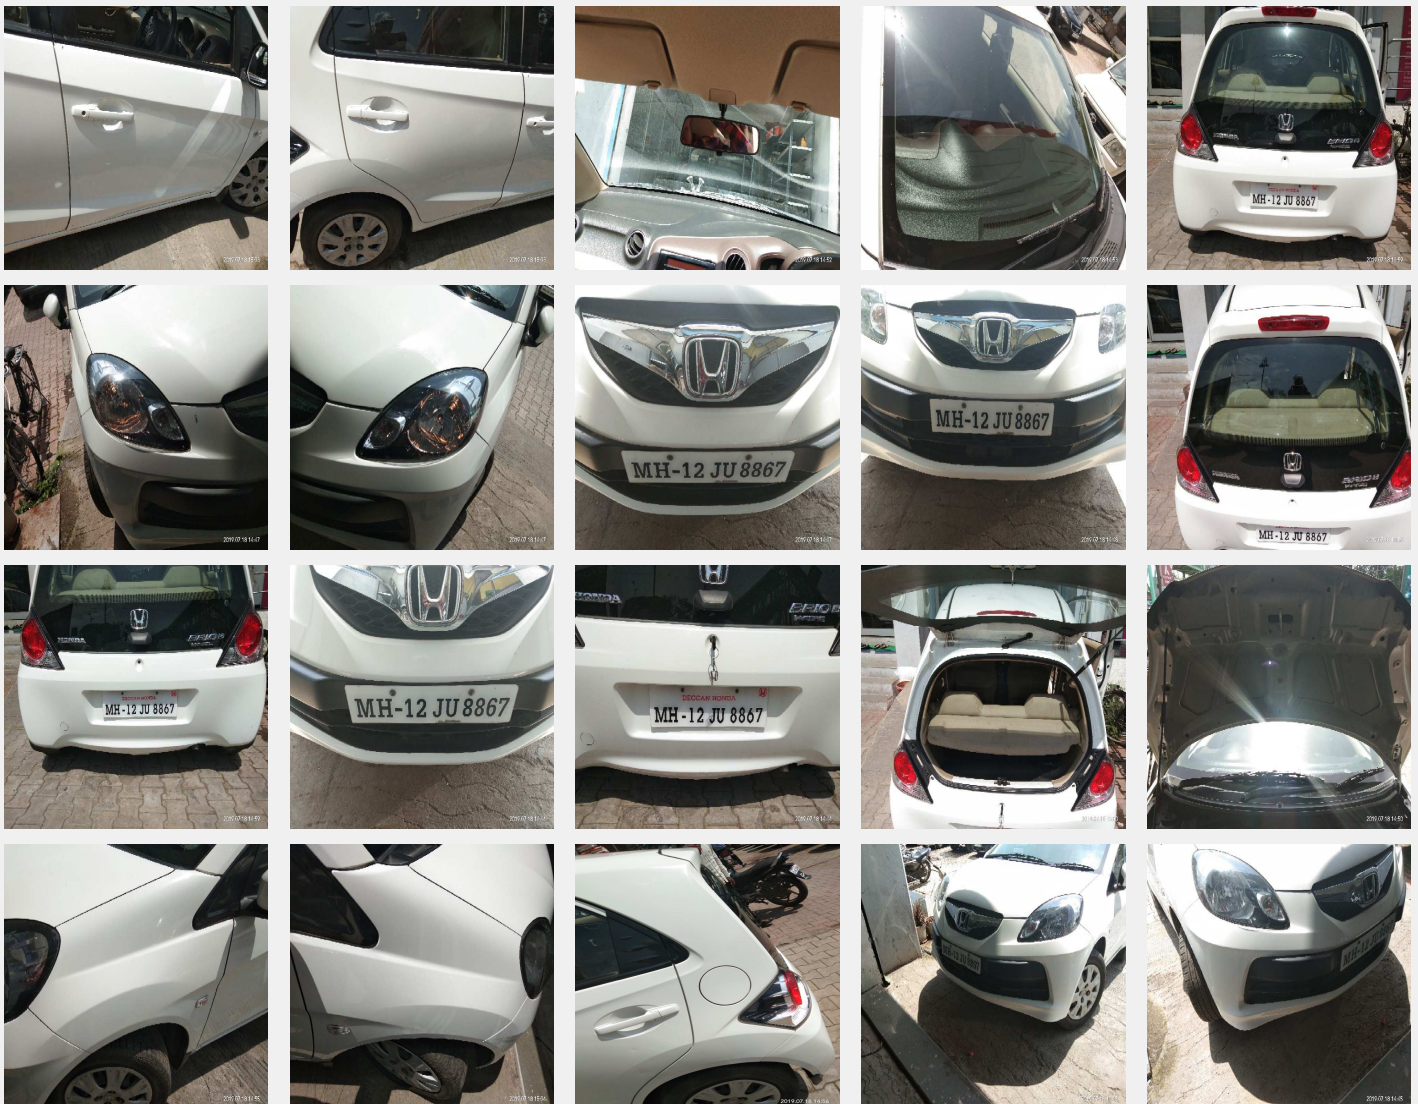
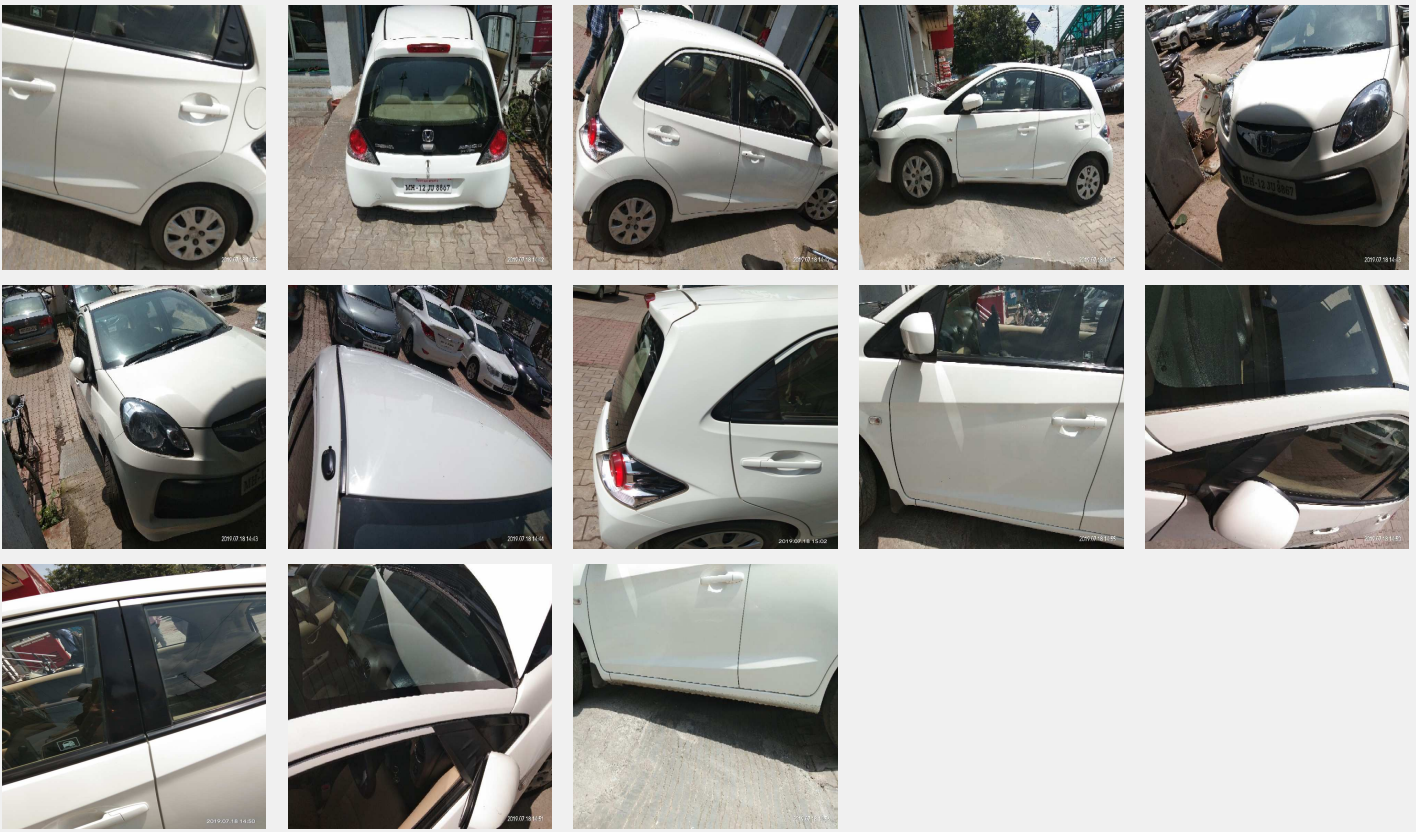
EXTERIOR (CONTINUED)

INSPECTION CHECKPOINTS	SCORE(X/10)	REMARKS/COMMENTS	OPTIONAL SPEND EST. (RS)
PAINT CONDITION	9		0
SIDE VIEW MIRRORS	3	RH MIRROR LOOSE	1200
FUEL LID	5	CAP HOLDER WIRE BROKEN	50
LUGGAGE COMPARTMENT LIGHT	0	NA	0
RH RUNNING BOARD	0	NEED TO DENTING PENTING	1800
