ECO INSPECTION CERTIFICATE

Order ID : 95259

121 Points Vehicle Inspection Certificate

Fiat Punto DYNAMIC 1.3, 2013

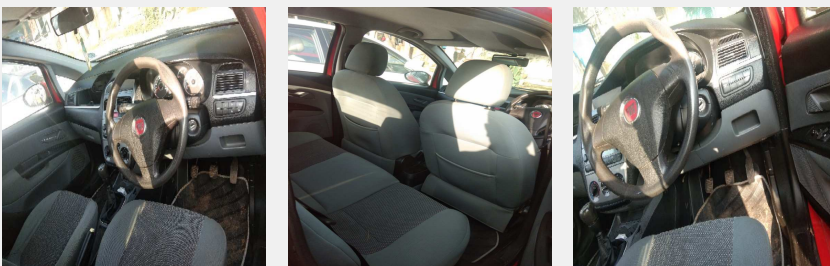
IMAGES

INSPECTION CHECKPOINTS	SCORE(X/10)	REMARKS/COMMENTS	OPTIONAL SPEND EST. (RS)
DOOR HINGES	6	OK	0
CARPET & FLOOR MAT	6	OK	0
SEAT & SEAT BELT	6	OK	0
DASHBOARD & INSTRUMENT PANEL	7	OK	0
HORN	6	OK	0
SPEAKERS & MUSIC SYSTEM	7	OK	0
HANDBRAKE	6	OK	0
PEDALS	7	OK	0
A/C VENTS & HEATER	6	OK	0
CUP HOLDERS	6	OK	0
NAVIGATION (NO)	10		0
ODOMETER	7	OK	0
POWER WINDOWS (YES)	7	OK	0
HAZARD LIGHT	8	OK	0
DOOR PANEL	5	OK	0
STEERING-MOUNTED CONTROLS	4	NOT APP	0
CENTRAL LOCK	5	REMOT NOT OK	5000

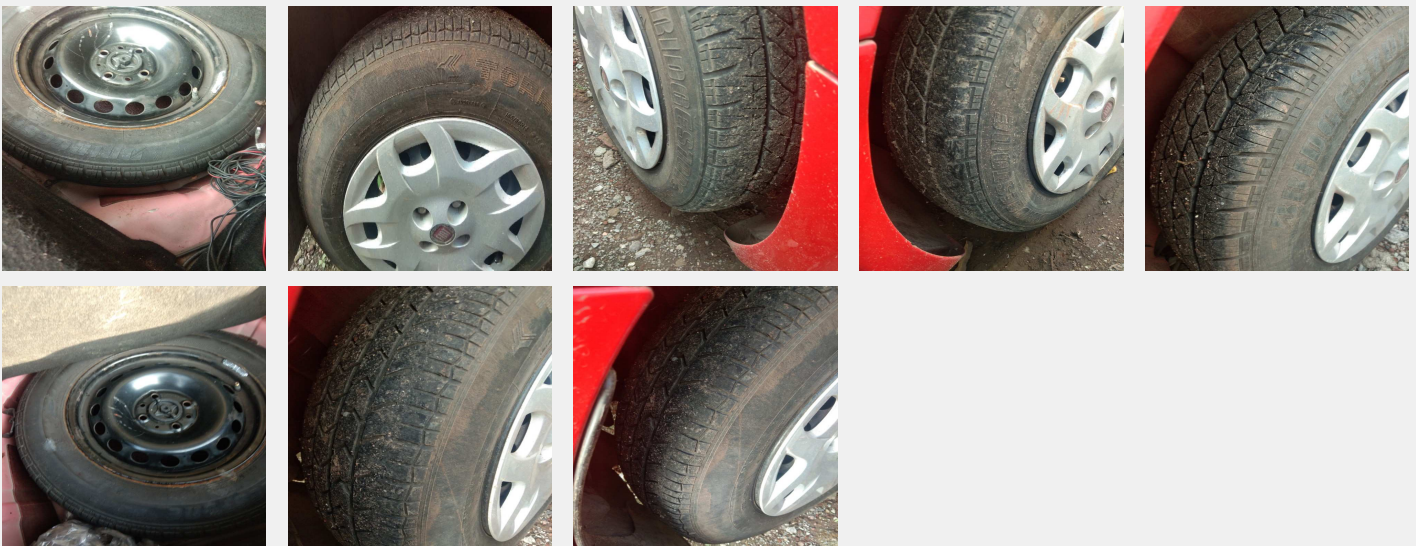
IMAGES

INSPECTION CHECKPOINTS	SCORE(X/10)	REMARKS/COMMENTS	OPTIONAL SPEND EST. (RS)
TYRES	8	OK	0
SPARE TYRE (YES)	8	OK	0
WHEEL ASSEMBLY (STEEL RIM)	7	OK	0

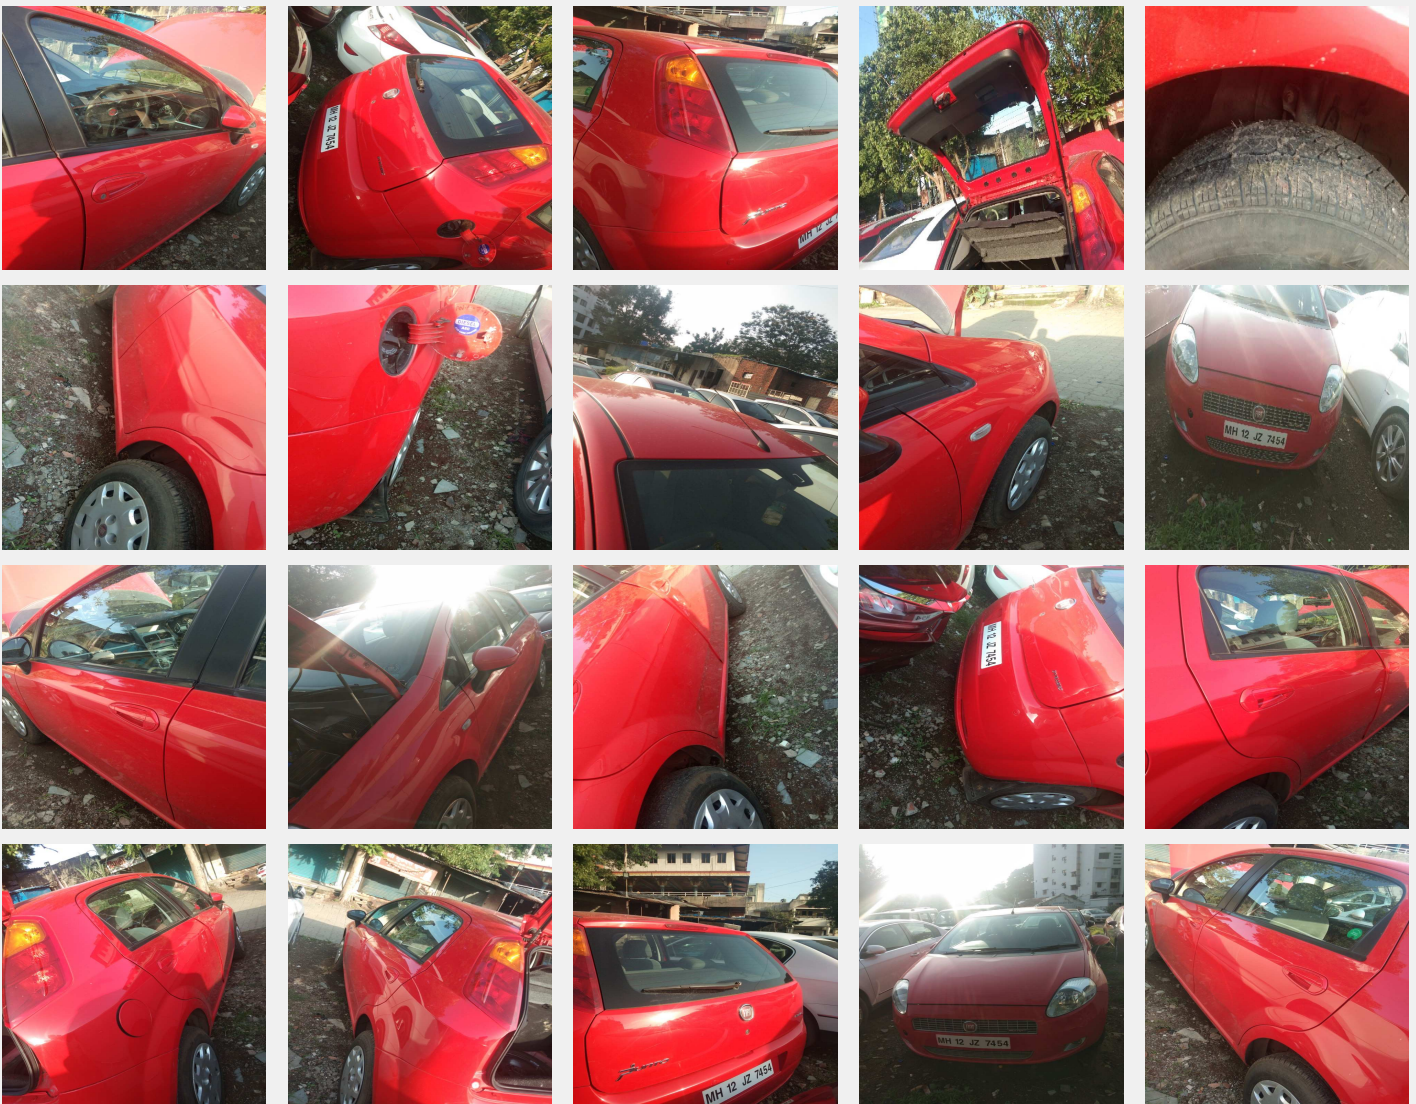
IMAGES

INSPECTION CHECKPOINTS	SCORE(X/10)	REMARKS/COMMENTS	OPTIONAL SPEND EST. (RS)
BODY RUST	8	OK	0
ROOF (REGULAR)	7	OK	0
PAINT CONDITION	8	OK	0
LUGGAGE COMPARTMENT LIGHT	0	OK	0
RH QUARTER PANEL	0	OK	0
