ECO INSPECTION CERTIFICATE

Order ID : 93890

121 Points Vehicle Inspection Certificate

Honda Activa 3g 110CC, 2016

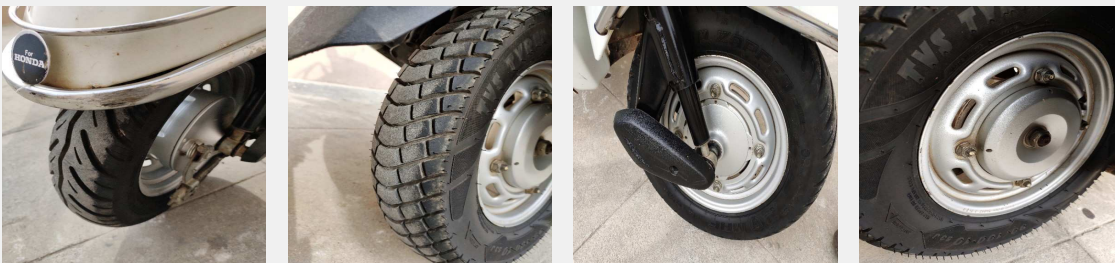
INSPECTION CHECKPOINTS	SCORE(X/10)	REMARKS/COMMENTS	OPTIONAL SPEND EST. (RS)
FRONT TYRE CONDITION & AIR PRESSURE	8		0
REAR TYRE CONDITION & AIR PRESSURE	8		0
WHEEL SPOKES FRONT	10	SPOKES NOT AVAILBLE...	0
WHEEL SPOKES REAR	10	SPIKES NOT AVAILABLE....	0
WHEEL RIM FRONT	8		0
WHEEL RIM REAR	8		0
WHEEL BEARINGS FRONT	8		0
WHEEL BEARINGS REAR	8		0
WHEEL SEALS FRONT	8		0
WHEEL SEALS REAR	8		0
BRAKE FUNCTION FRONT	8		0
BRAKE FUNCTION REAR	7		0
BRAKES CONDITION FRONT	8		0
BRAKES CONDITION REAR	7		0

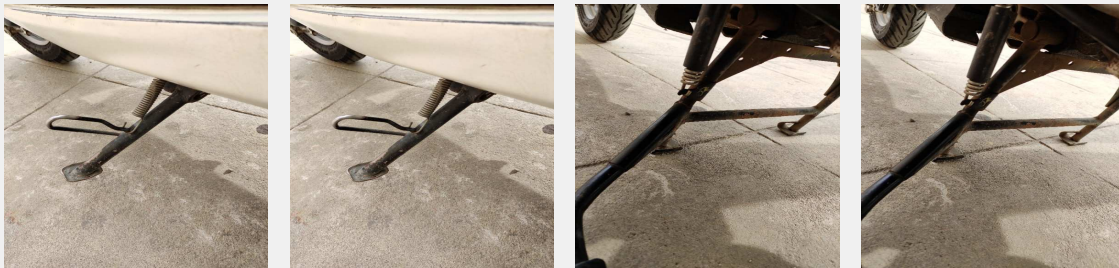
INSPECTION CHECKPOINTS	SCORE(X/10)	REMARKS/COMMENTS	OPTIONAL SPEND EST. (RS)
CENTRE STAND CONDITION	8		0
CENTRE STAND RETENTION	8		0
SIDE STAND CONDITION	8		0
SIDE STAND RETENTION	8		0

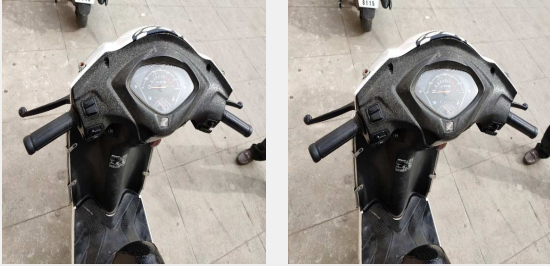
CONTROL

INSPECTION CHECKPOINTS	SCORE(X/10)	REMARKS/COMMENTS	OPTIONAL SPEND EST. (RS)
HANDLEBARS CONDITION	8		0
LEVERS & PEDAL CONDITION	8		0
PIVOTS	8		0
CABLES CONDITION	8		0
CABLES ROUTING	8		0
HOSES CONDITION	8		0
HOSES ROUTING	8		0
THROTTLE OPERATION	8		0

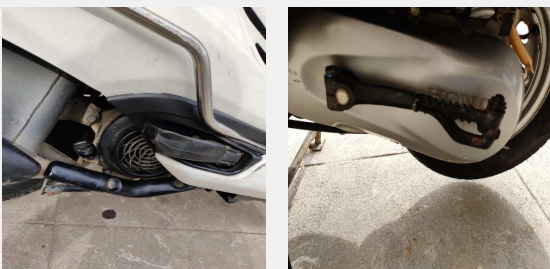
INSPECTION CHECKPOINTS	SCORE(X/10)	REMARKS/COMMENTS	OPTIONAL SPEND EST. (RS)
LEVELS - ENGINE OIL	8		0
LEVELS - GEAR OIL/SHAFT DRIVE (YES)	8		0
LEVELS - HYDRAULIC FLUID (YES)	8		0
LEVELS - COOLANT (YES)	10	NOT AVAILABLE...	0
LEVELS - FUEL	8		0
LEAKS - ENGINE OIL	8		0
LEAKS - GEAR OIL	8		0
LEAKS - HYDRAULIC FLUID	8		0
LEAKS - COOLANT	10	NOT AVAILABLE....	0
LEAKS - FUEL	8		0
