# ECO INSPECTION CERTIFICATE

Order ID : 95750

121 Points Vehicle Inspection Certificate

## Toyota Etios Liva GD SP, 2014

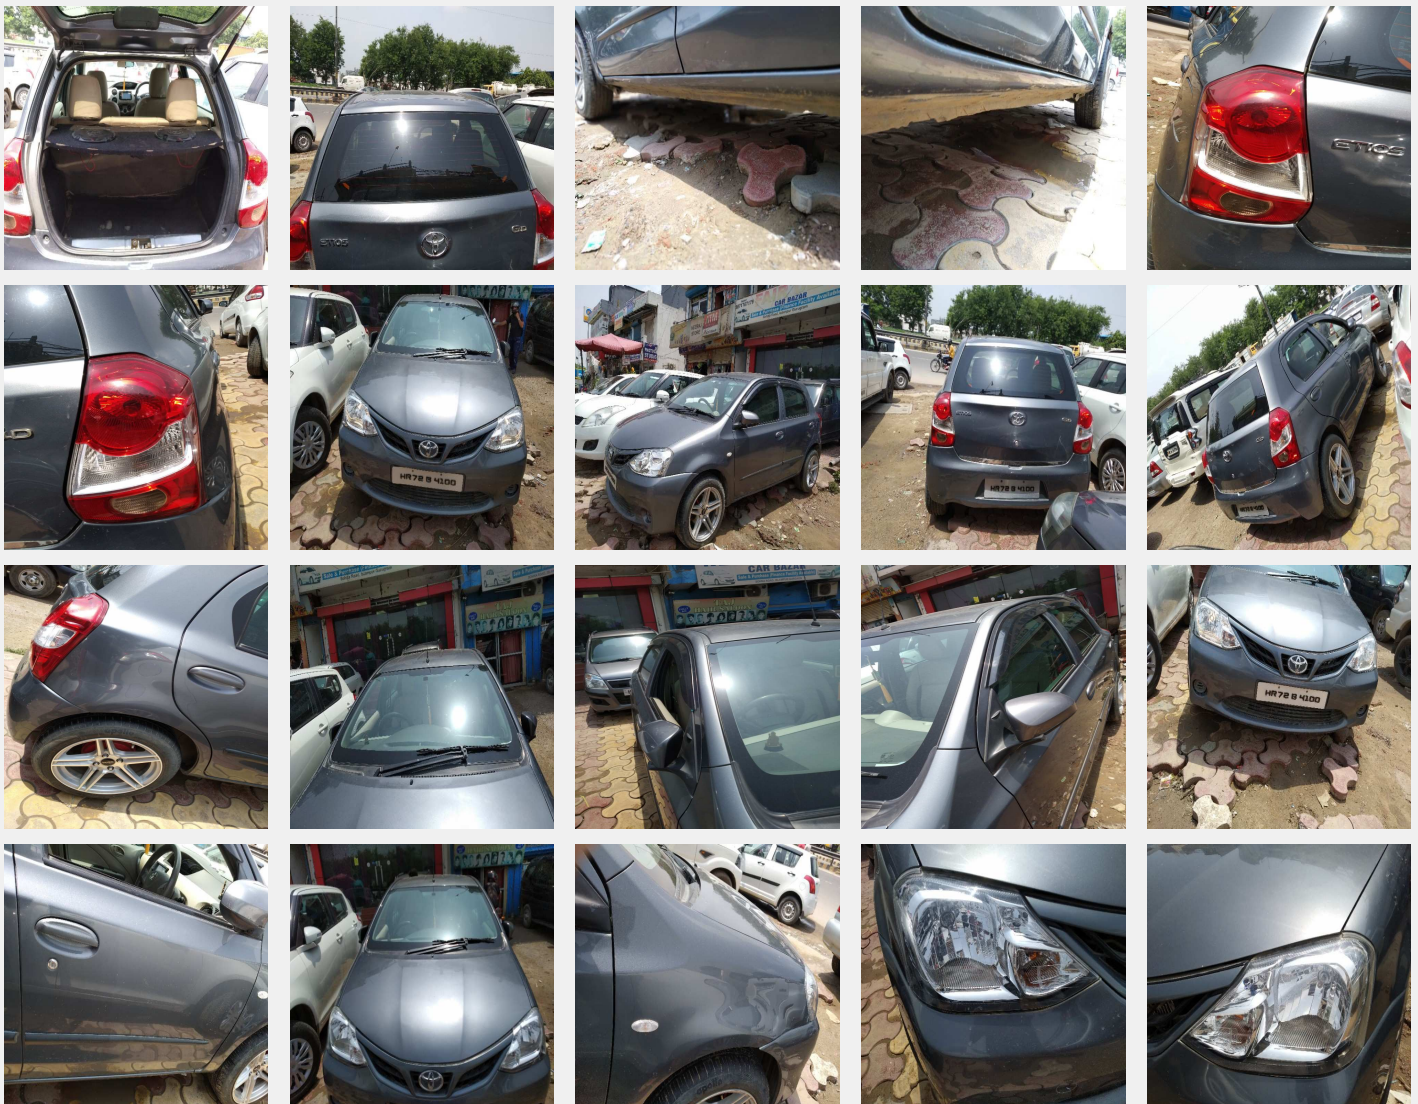
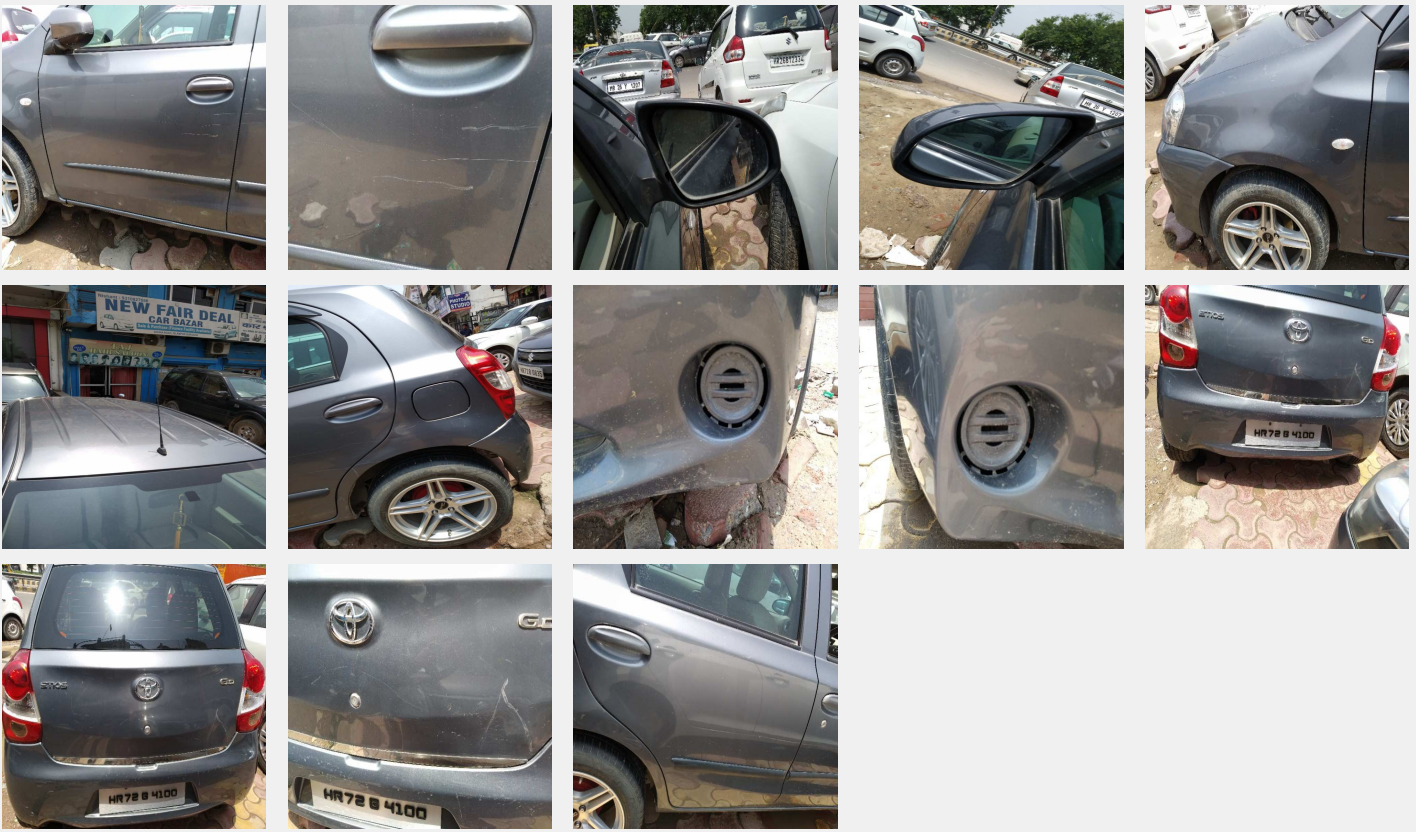
## IMAGES

INSPECTION CHECKPOINTS	SCORE(X/10)	REMARKS/COMMENTS	OPTIONAL SPEND EST. (RS)
RH FENDER	7		0
BODY RUST	7		0
ROOF (REGULAR)	7		0
PAINT CONDITION	7		0
LH REAR DOOR	4	NEED TO REPAIR	2500

minor scratches and minor dent front bumper and rear bumper already painted rear back door already p
