ECO INSPECTION CERTIFICATE

Order ID : 94104

121 Points Vehicle Inspection Certificate

Triumph Thunderbird Lt 1700CC, 2016

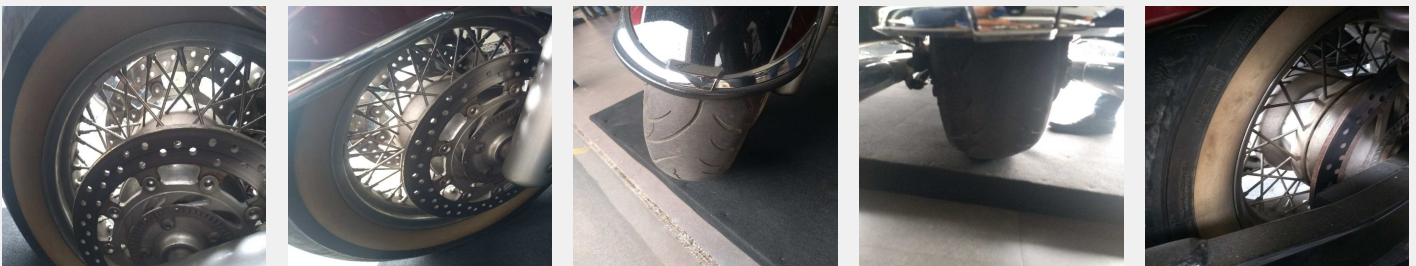
TYRE

INSPECTION CHECKPOINTS	SCORE(X/10)	REMARKS/COMMENTS	OPTIONAL SPEND EST. (RS)
FRONT TYRE CONDITION & AIR PRESSURE	9	GOOD	0
REAR TYRE CONDITION & AIR PRESSURE	10	GOOD	0
WHEEL SPOKES FRONT	10	GOOD	0
WHEEL SPOKES REAR	10	GOOD	0
WHEEL RIM FRONT	10	GOOD	0
WHEEL RIM REAR	10	GOOD	0
WHEEL BEARINGS FRONT	10	GOOD	0
WHEEL BEARINGS REAR	9	GOOD	0
WHEEL SEALS FRONT	10	GOOD	0
WHEEL SEALS REAR	10	GOOD	0
BRAKE FUNCTION FRONT	9	GOOD	0
BRAKE FUNCTION REAR	10	GOOD	0
BRAKES CONDITION FRONT	10	GOOD	0
BRAKES CONDITION REAR	10	GOOD	0

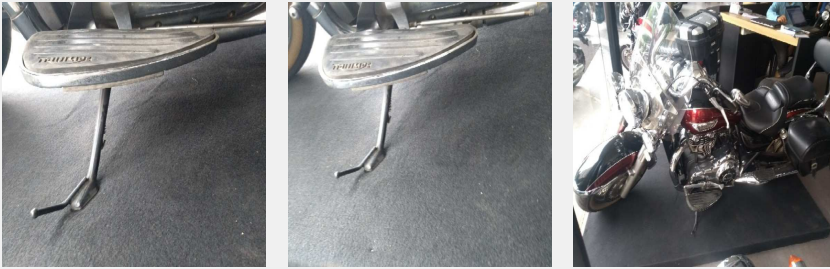
STAND

INSPECTION CHECKPOINTS	SCORE(X/10)	REMARKS/COMMENTS	OPTIONAL SPEND EST. (RS)
CENTRE STAND CONDITION	10		0
CENTRE STAND RETENTION	10		0
SIDE STAND CONDITION	10		0
SIDE STAND RETENTION	10		0
