ECO INSPECTION CERTIFICATE

121 Points Vehicle Inspection Certificate

Ordered By : CARS&ME Wasim Shaikh	Inspection Date : 2019-07-21	Location : PUNE	Inspected By

Ford Figo 1.5 TDCI TITANIUM, 2011

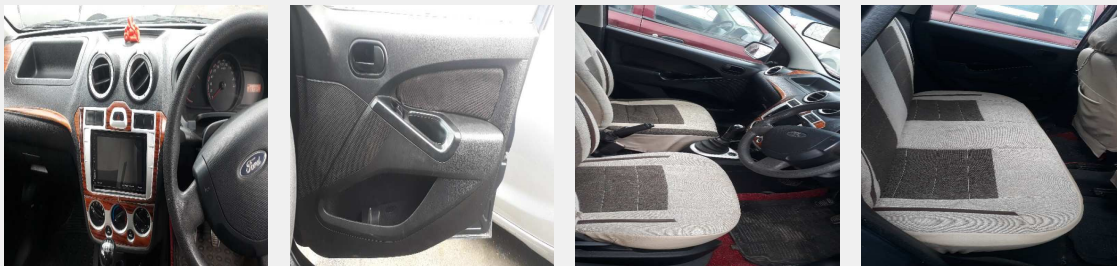
IMAGES

INSPECTION CHECKPOINTS	SCORE(X/10)	REMARKS/COMMENTS	OPTIONAL SPEND EST. (RS)
DOOR PANEL	7	GOOD	0
DOOR HINGES	7	GOOD	0
CARPET & FLOOR MAT	7	GOOD	0
SEAT & SEAT BELT	7	GOOD	0
DASHBOARD & INSTRUMENT PANEL	7	GOOD	0
HORN	7	GOOD	0
SPEAKERS & MUSIC SYSTEM	7	GOOD	0
HANDBRAKE	7	GOOD	0
STEERING-MOUNTED CONTROLS	7	GOOD	0
PEDALS	7	GOOD	0
CENTRAL LOCK	7	GOOD	0
A/C VENTS & HEATER	7	GOOD	0
CUP HOLDERS	7	GOOD	0
NAVIGATION (NO)	10		0
ODOMETER	7	GOOD	0
POWER WINDOWS (YES - FRONT ONLY)	7	GOOD	0
HAZARD LIGHT	7	GOOD	0

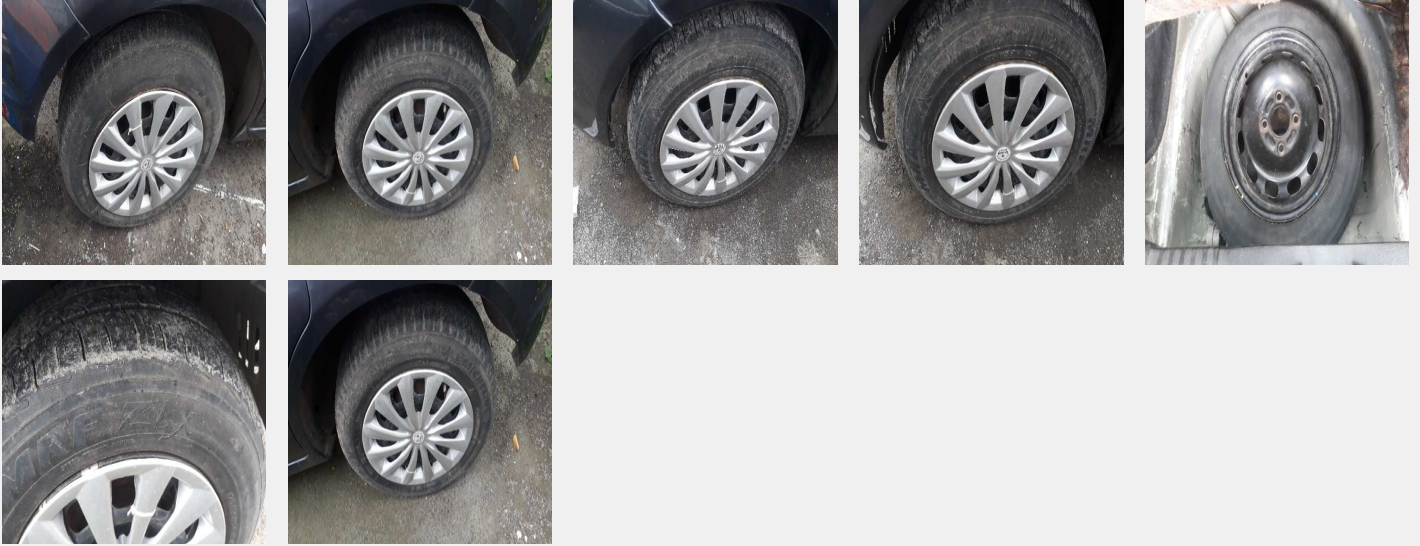
IMAGES

INSPECTION CHECKPOINTS	SCORE(X/10)	REMARKS/COMMENTS	OPTIONAL SPEND EST. (RS)
TYRES	7	GOOD	0
SPARE TYRE (YES)	7	GOOD	0
WHEEL ASSEMBLY (STEEL RIM)	7	GOOD	0

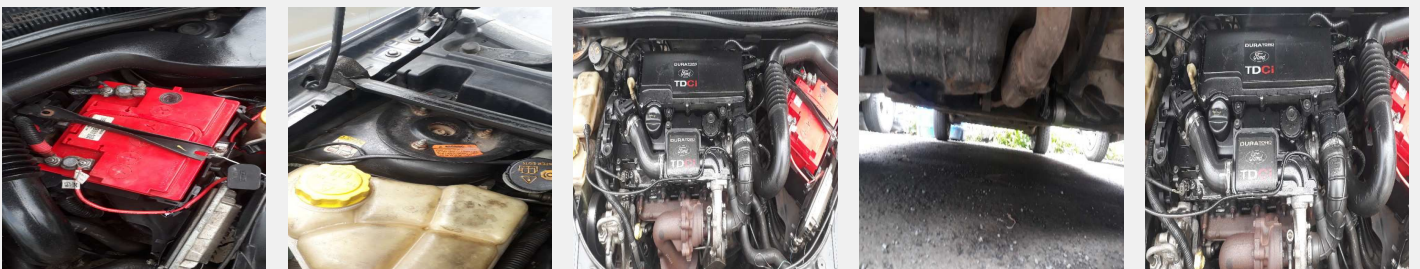
IMAGES

INSPECTION CHECKPOINTS	SCORE(X/10)	REMARKS/COMMENTS	OPTIONAL SPEND EST. (RS)
LH APRON	7	GOOD	0
RH APRON	7	GOOD	0
RADIATOR	7	GOOD	0
WIRING	7	GOOD	0
BATTERY	7	GOOD	0
BRAKE FLUID LEVEL	7	GOOD	0
ENGINE OIL	7	GOOD	0
COOLANT LEVEL	7	GOOD	0
BRAKE & COOLANT HOSE PIPES	7	GOOD	0
UNDERCARRIAGE	7	GOOD	0
EXHAUST SYSTEM	7	GOOD	0

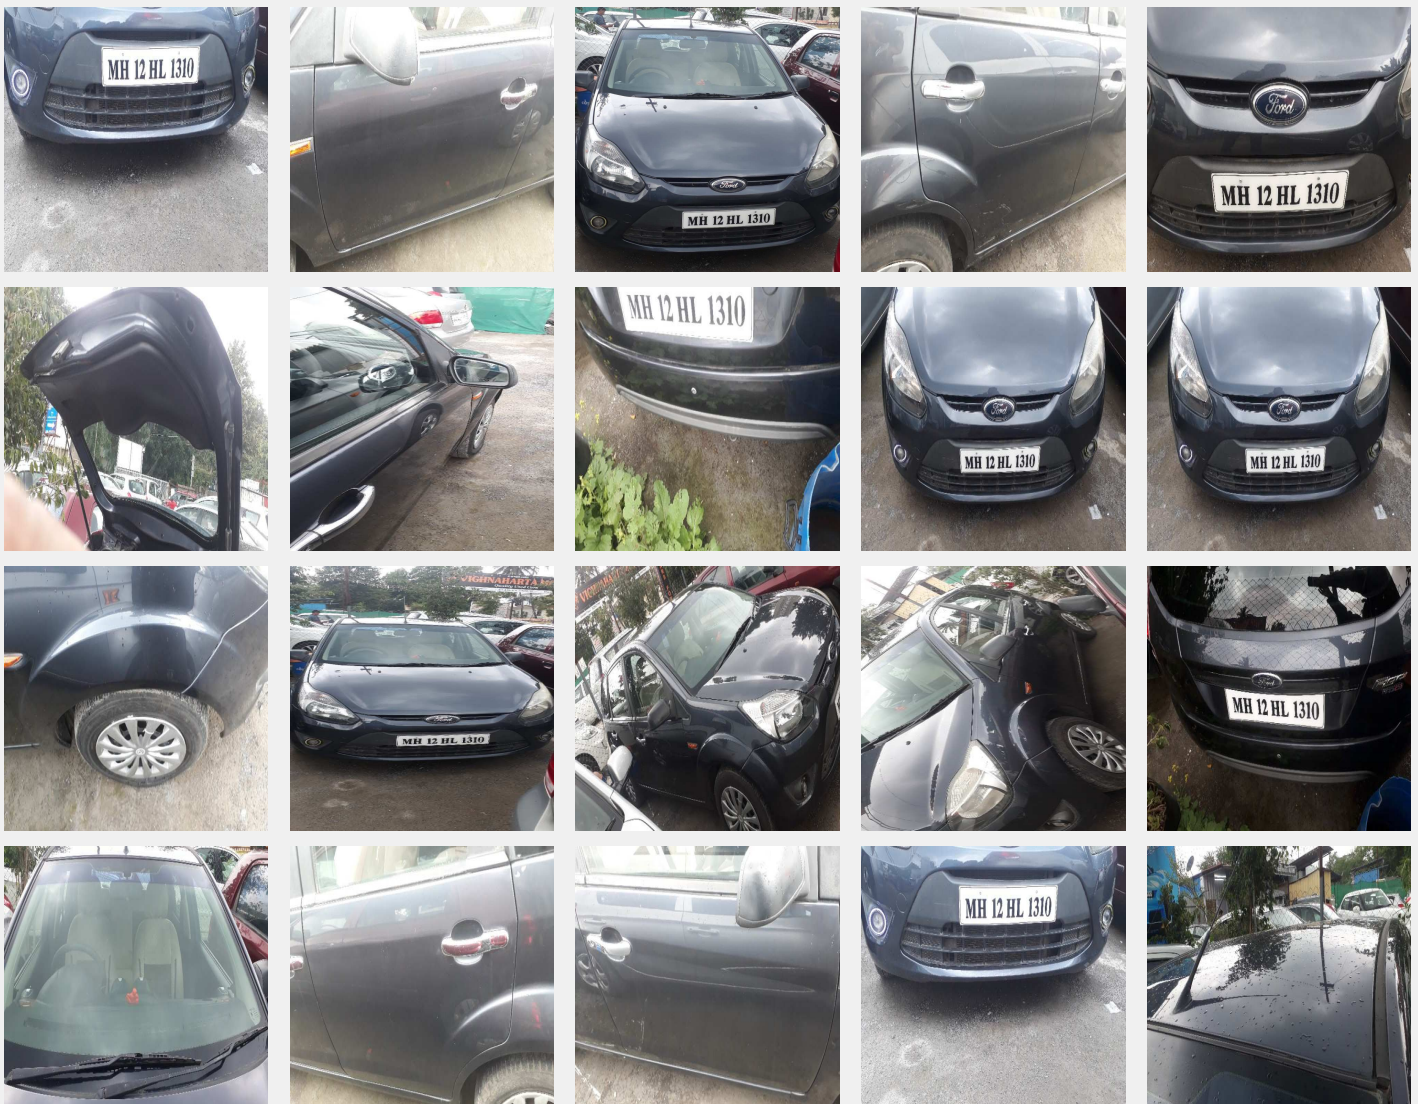
IMAGES

INSPECTION CHECKPOINTS	SCORE(X/10)	REMARKS/COMMENTS	OPTIONAL SPEND EST. (RS)
RH FRONT DOOR	7	GOOD	0
RH FENDER	7	GOOD	0
BODY RUST	7	GOOD	0
ROOF (REGULAR)	7	GOOD	0
PAINT CONDITION	7	GOOD	0
