ECO INSPECTION CERTIFICATE

121 Points Vehicle Inspection Certificate

Bmw S1000rr Hp4 999CC, 2013

MAKE	BMW	ENGINE NUMBER	0512E007
MODEL	S1000RR HP4	REGISTRATION NO.	MH02CM7789
YEAR	2013	VIN/CHASSIS NUMBER	WB1050704AZV32997
TRIM	999CC	ODOMETER READING	34958
COLOR	WHITE	INSURANCE EXPIRY	2019-2-3
FUEL TYPE	PETROL	ENGINE SOUND LINK	LISTEN ENGINE SOUND

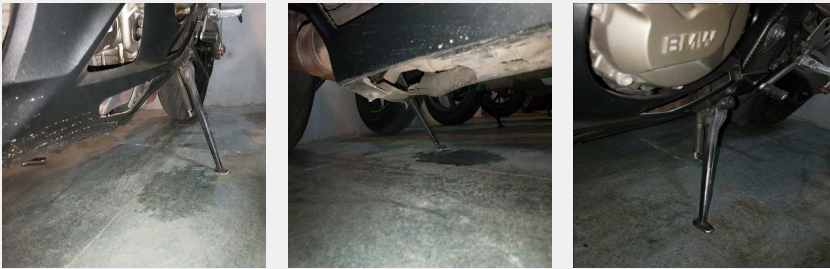
INSPECTION CHECKPOINTS	SCORE(X/10)	REMARKS/COMMENTS	OPTIONAL SPEND EST. (RS)
SIDE STAND CONDITION	6	GOOD CONDITION	0
SIDE STAND RETENTION	6	GOOD WORKING	0
CENTRE STAND CONDITION	0	NOT AVAILABLE	0
CENTRE STAND RETENTION	0	NOT AVAILABLE	0

NEED ATTENTION ⚠️
