ECO INSPECTION CERTIFICATE

121 Points Vehicle Inspection Certificate

Ordered By : Avinash Thakur	Inspection Date : 2019-07-24	Location : SHYAMBAZAR	Inspected By

Maruti Suzuki Wagon R Vxi, 2010

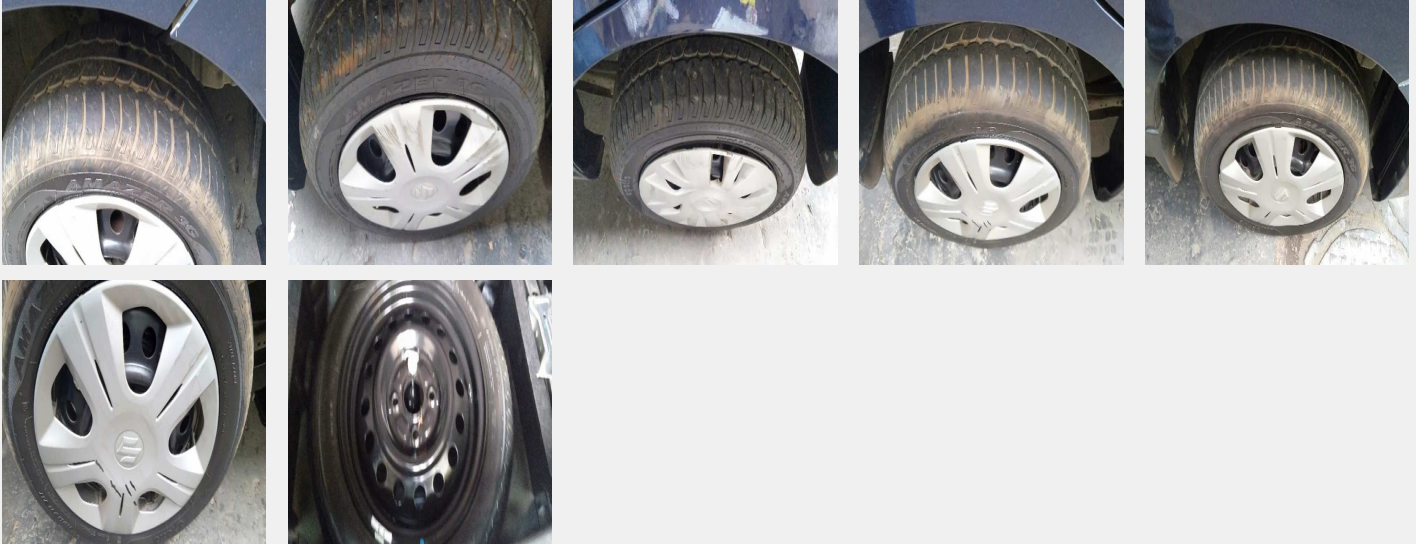
IMAGES

INSPECTION CHECKPOINTS	SCORE(X/10)	REMARKS/COMMENTS	OPTIONAL SPEND EST. (RS)
TYRES	6	GOOD	0
SPARE TYRE (YES)	6	GOOD	0
WHEEL ASSEMBLY (STEEL RIM)	6	GOOD	0

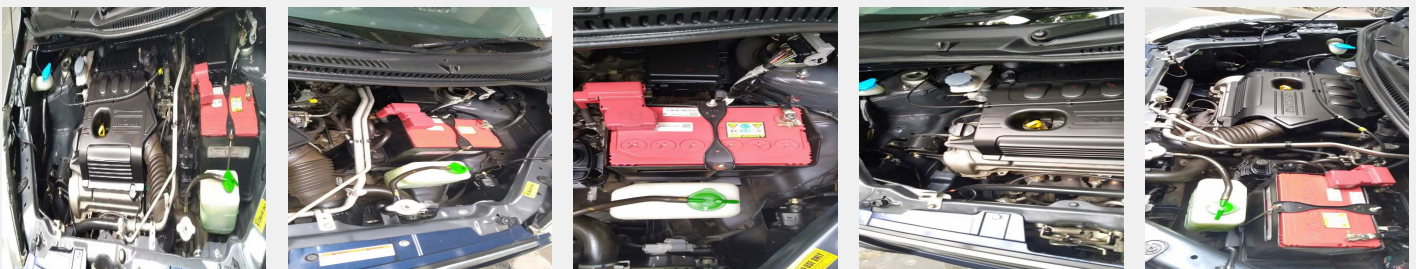
IMAGES

INSPECTION CHECKPOINTS	SCORE(X/10)	REMARKS/COMMENTS	OPTIONAL SPEND EST. (RS)
LH APRON	6	GOOD	0
RH APRON	6	GOOD	0
RADIATOR	6	GOOD	0
WIRING	6	GOOD	0
BATTERY	6	GOOD	0
BRAKE FLUID LEVEL	6	GOOD	0
ENGINE OIL	6	GOOD	0
COOLANT LEVEL	6	GOOD	0
BRAKE & COOLANT HOSE PIPES	6	GOOD	0
UNDERCARRIAGE	6	GOOD	0
EXHAUST SYSTEM	6	GOOD	0

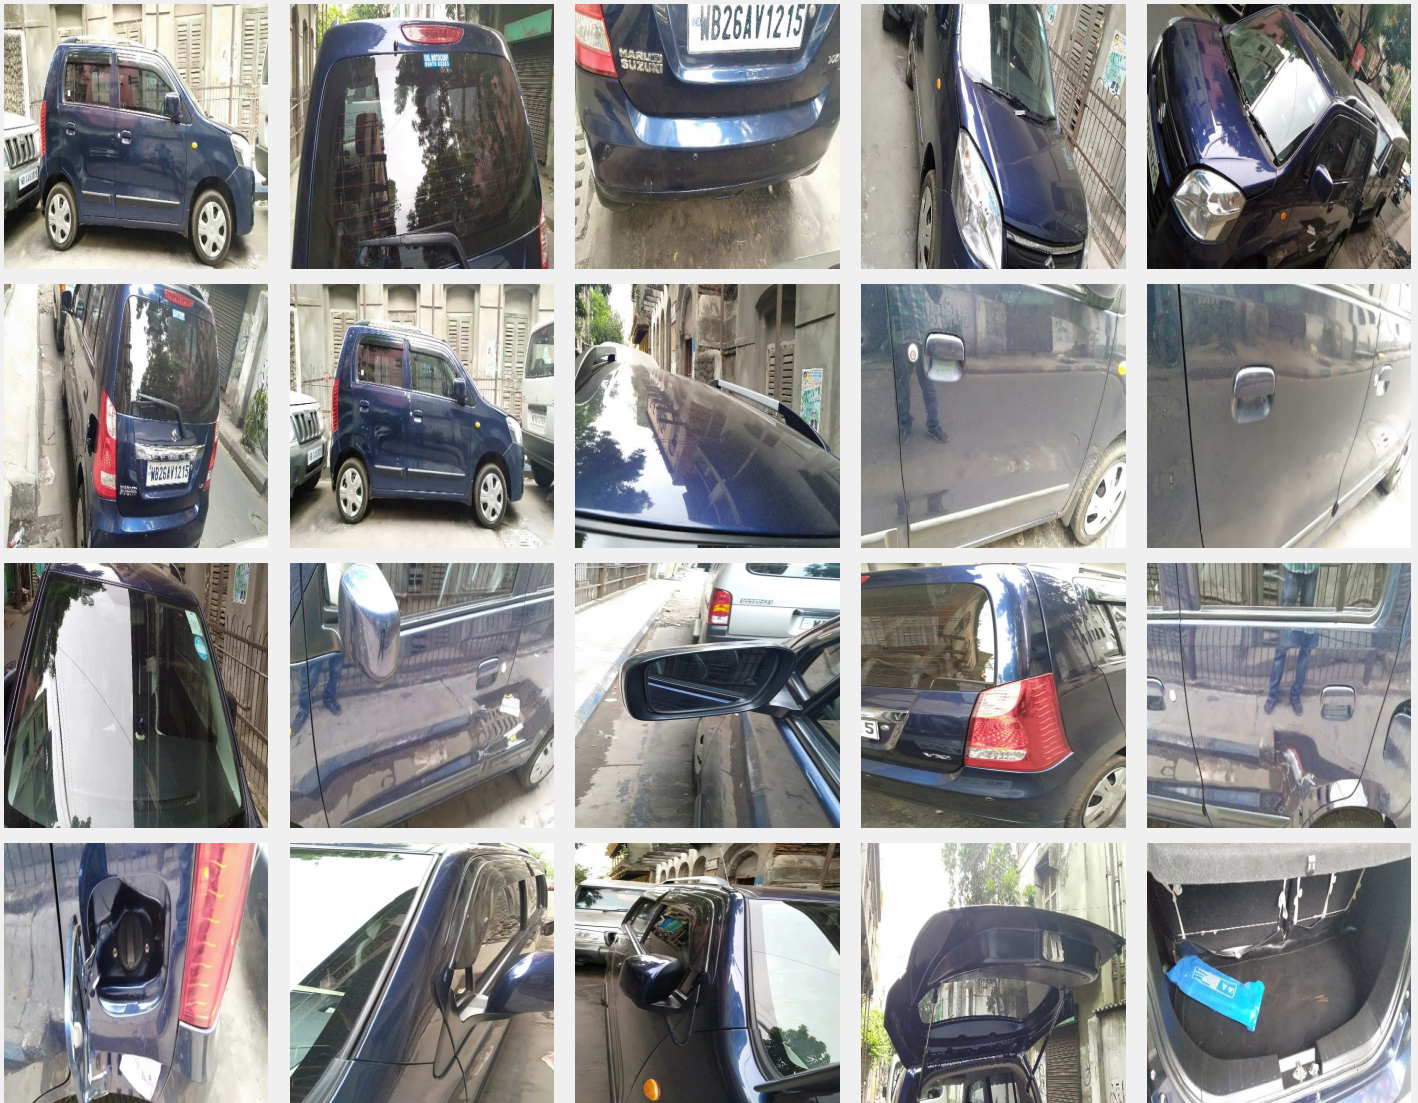
IMAGES

INSPECTION CHECKPOINTS	SCORE(X/10)	REMARKS/COMMENTS	OPTIONAL SPEND EST. (RS)
LICENSE PLATE	6	GOOD	0
FRONT BUMPER	6	GOOD	0
HEAD LIGHTS	6	GOOD	0
GRILLE	6	GOOD	0
TURN SIGNAL	6	GOOD	0
FOG LAMPS	6	GOOD	0
HOOD	6	GOOD	0
PILLAR	6	GOOD	0
FRONT WINDSHIELD	6	GOOD	0
SIDE VIEW MIRRORS	6	GOOD	0
LH FENDER	6	GOOD	0
LH FRONT DOOR	6	GOOD	0
LH REAR DOOR	6	GOOD	0
LH RUNNING BOARD	6	GOOD	0
LH QUARTER PANEL	6	GOOD	0
FUEL LID	6	GOOD	0
REAR WINDSHIELD	6	GOOD	0
REAR BUMPER	6	GOOD	0
TAIL LIGHT	6	GOOD	0
TRUNK LID/TAIL GATE	6	GOOD	0
LUGGAGE COMPARTMENT LIGHT	6	GOOD	0
RH QUARTER PANEL	6	GOOD	0
RH RUNNING BOARD	6	GOOD	0
RH REAR DOOR	6	GOOD	0

INSPECTION CHECKPOINTS	SCORE(X/10)	REMARKS/COMMENTS	OPTIONAL SPEND EST. (RS)
RH FRONT DOOR	6	GOOD	0
RH FENDER	6	GOOD	0
BODY RUST	6	GOOD	0
ROOF (REGULAR)	6	GOOD	0
PAINT CONDITION	6	GOOD	0
