ECO INSPECTION CERTIFICATE

Order ID : 96078

121 Points Vehicle Inspection Certificate

Maruti Suzuki Ertiga VXI, 2016

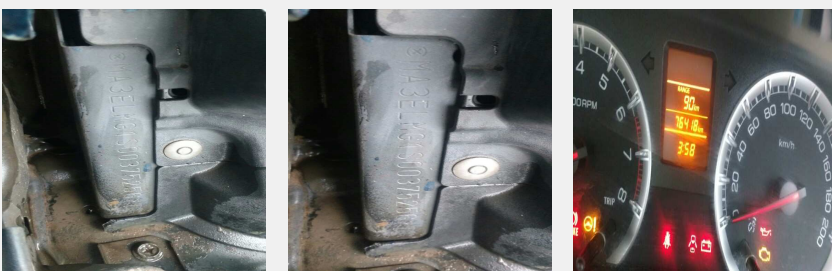
IMAGES

INSPECTION CHECKPOINTS	SCORE(X/10)	REMARKS/COMMENTS	OPTIONAL SPEND EST. (RS)
STEERING PERFORMANCE	6		0
BRAKE PERFORMANCE	6		0
CLUTCH PERFORMANCE	6		0
ENGINE NOISE	7		0
IGNITION SYSTEM	6		0
SUSPENSION PERFORMANCE	6		0
SUSPENSION FRONT SHOCKS	7		0
SUSPENSION REAR SHOCKS	7		0
TRANSMISSION ENGAGE	7		0
CRUISE CONTROL (YES)	6		0
REAR PARKING SENSORS (YES)	6		0
REAR VIEW CAMERA (NO)	10		0

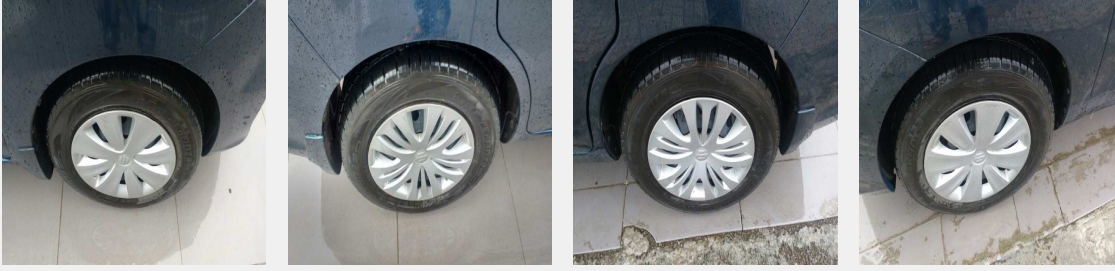
IMAGES

INSPECTION CHECKPOINTS	SCORE(X/10)	REMARKS/COMMENTS	OPTIONAL SPEND EST. (RS)
TYRES	6		0
SPARE TYRE (YES)	6		0
WHEEL ASSEMBLY (STEEL RIM)	6		0

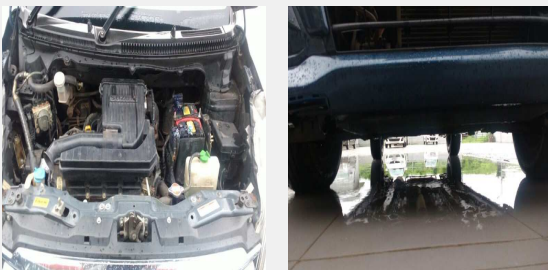
IMAGES

INSPECTION CHECKPOINTS	SCORE(X/10)	REMARKS/COMMENTS	OPTIONAL SPEND EST. (RS)
LH APRON	6		0
RH APRON	6		0
RADIATOR	6		0
WIRING	7		0
BATTERY	6		0
BRAKE FLUID LEVEL	6		0
ENGINE OIL	6		0
COOLANT LEVEL	6		0
BRAKE & COOLANT HOSE PIPES	6		0
UNDERCARRIAGE	6		0
EXHAUST SYSTEM	6		0

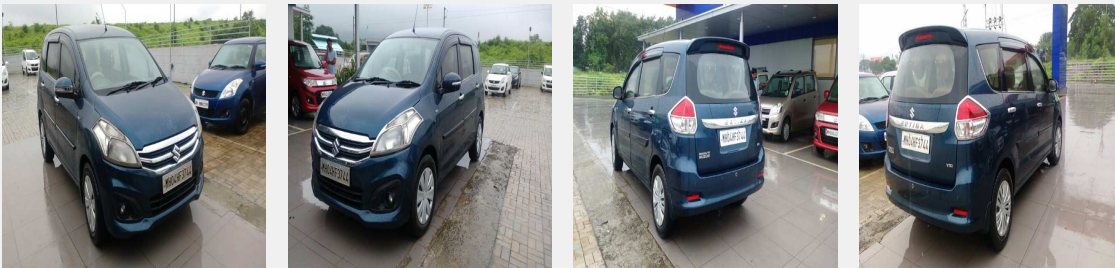
IMAGES

INSPECTION CHECKPOINTS	SCORE(X/10)	REMARKS/COMMENTS	OPTIONAL SPEND EST. (RS)
RH FRONT DOOR	6		0
RH FENDER	7		0
BODY RUST	6		0
ROOF (REGULAR)	6		0
PAINT CONDITION	7		0
