ECO INSPECTION CERTIFICATE

Order ID : 96067

121 Points Vehicle Inspection Certificate

Maruti Suzuki Ertiga ZXI, 2012

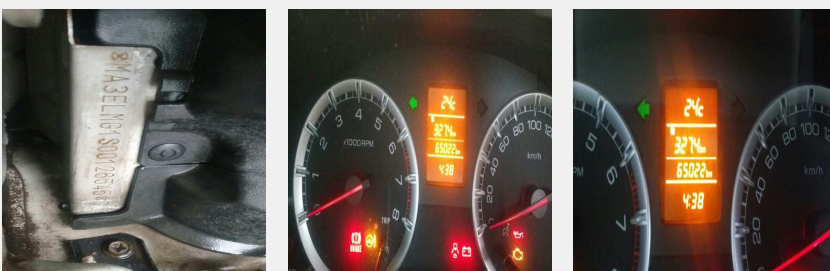
IMAGES

INSPECTION CHECKPOINTS	SCORE(X/10)	REMARKS/COMMENTS	OPTIONAL SPEND EST. (RS)
STEERING PERFORMANCE	6		0
BRAKE PERFORMANCE	6		0
CLUTCH PERFORMANCE	7		0
ENGINE NOISE	6		0
IGNITION SYSTEM	6		0
SUSPENSION PERFORMANCE	6		0
SUSPENSION FRONT SHOCKS	6		0
SUSPENSION REAR SHOCKS	6		0
TRANSMISSION ENGAGE	7		0
CRUISE CONTROL (YES)	6		0
REAR PARKING SENSORS (YES)	7		0
REAR VIEW CAMERA (NO)	10		0

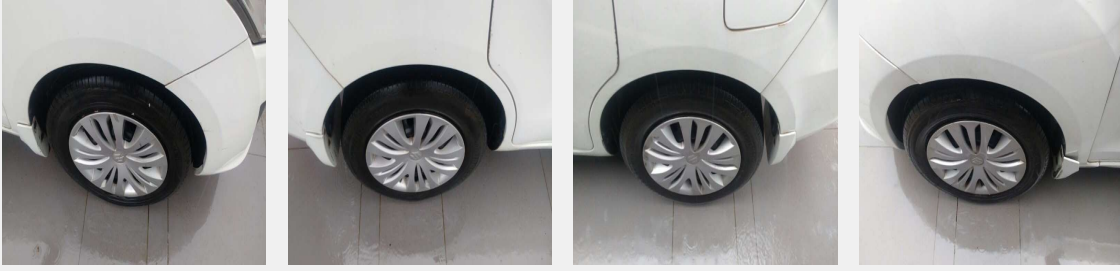
IMAGES

INSPECTION CHECKPOINTS	SCORE(X/10)	REMARKS/COMMENTS	OPTIONAL SPEND EST. (RS)
TYRES	6		0
SPARE TYRE (YES)	6		0
WHEEL ASSEMBLY (STEEL RIM)	6		0

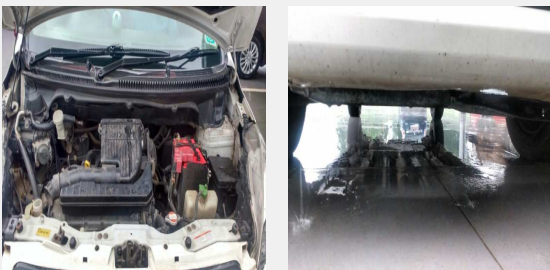
IMAGES

INSPECTION CHECKPOINTS	SCORE(X/10)	REMARKS/COMMENTS	OPTIONAL SPEND EST. (RS)
LH APRON	6		0
RH APRON	6		0
RADIATOR	6		0
WIRING	6		0
BATTERY	6		0
BRAKE FLUID LEVEL	6		0
ENGINE OIL	6		0
COOLANT LEVEL	6		0
BRAKE & COOLANT HOSE PIPES	6		0
UNDERCARRIAGE	6		0
EXHAUST SYSTEM	6		0
