# ECO INSPECTION CERTIFICATE

Order ID : 91678

121 Points Vehicle Inspection Certificate

## Hyosung Gt250r 250cc, 2017

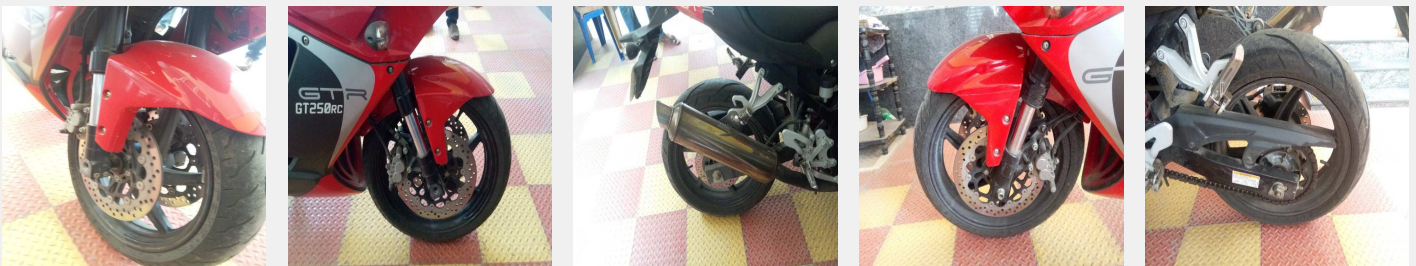
## TYRE

| INSPECTION CHECKPOINTS | SCORE(X/10) | REMARKS/COMMENTS | OPTIONAL SPEND EST. (RS) |
|---|---|---|---|
| WHEEL BEARINGS FRONT | 7 | | 0 |

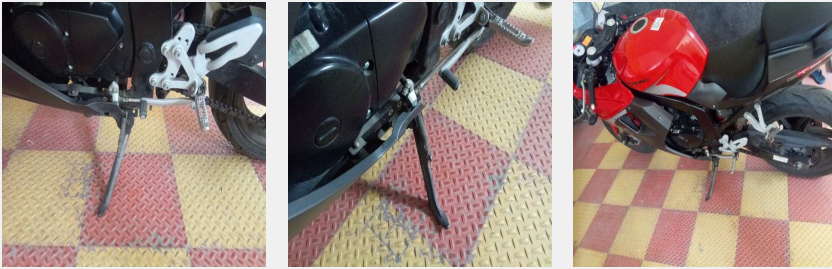
## STAND

| INSPECTION CHECKPOINTS | SCORE(X/10) | REMARKS/COMMENTS | OPTIONAL SPEND EST. (RS) |
|---|---|---|---|
| CENTRE STAND CONDITION | 10 | NOT AVAILABLE | 0 |

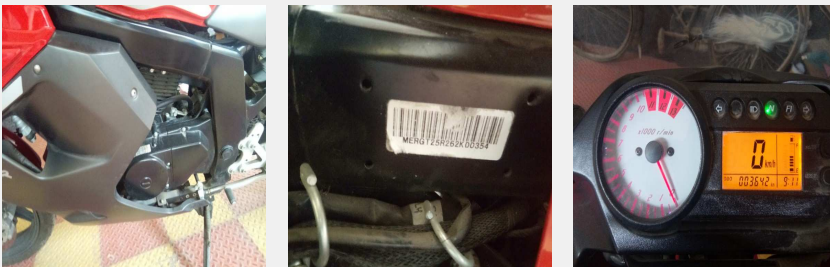
## CHASSIS

| INSPECTION CHECKPOINTS | SCORE(X/10) | REMARKS/COMMENTS | OPTIONAL SPEND EST. (RS) |
|---|---|---|---|
| FRAME STEERING-HEAD BEARINGS | 7 | | 0 |
| SUSPENSION FRONT FORKS LEFT | 7 | | 0 |
| SUSPENSION REAR SHOCKS RIGHT | 7 | | 0 |

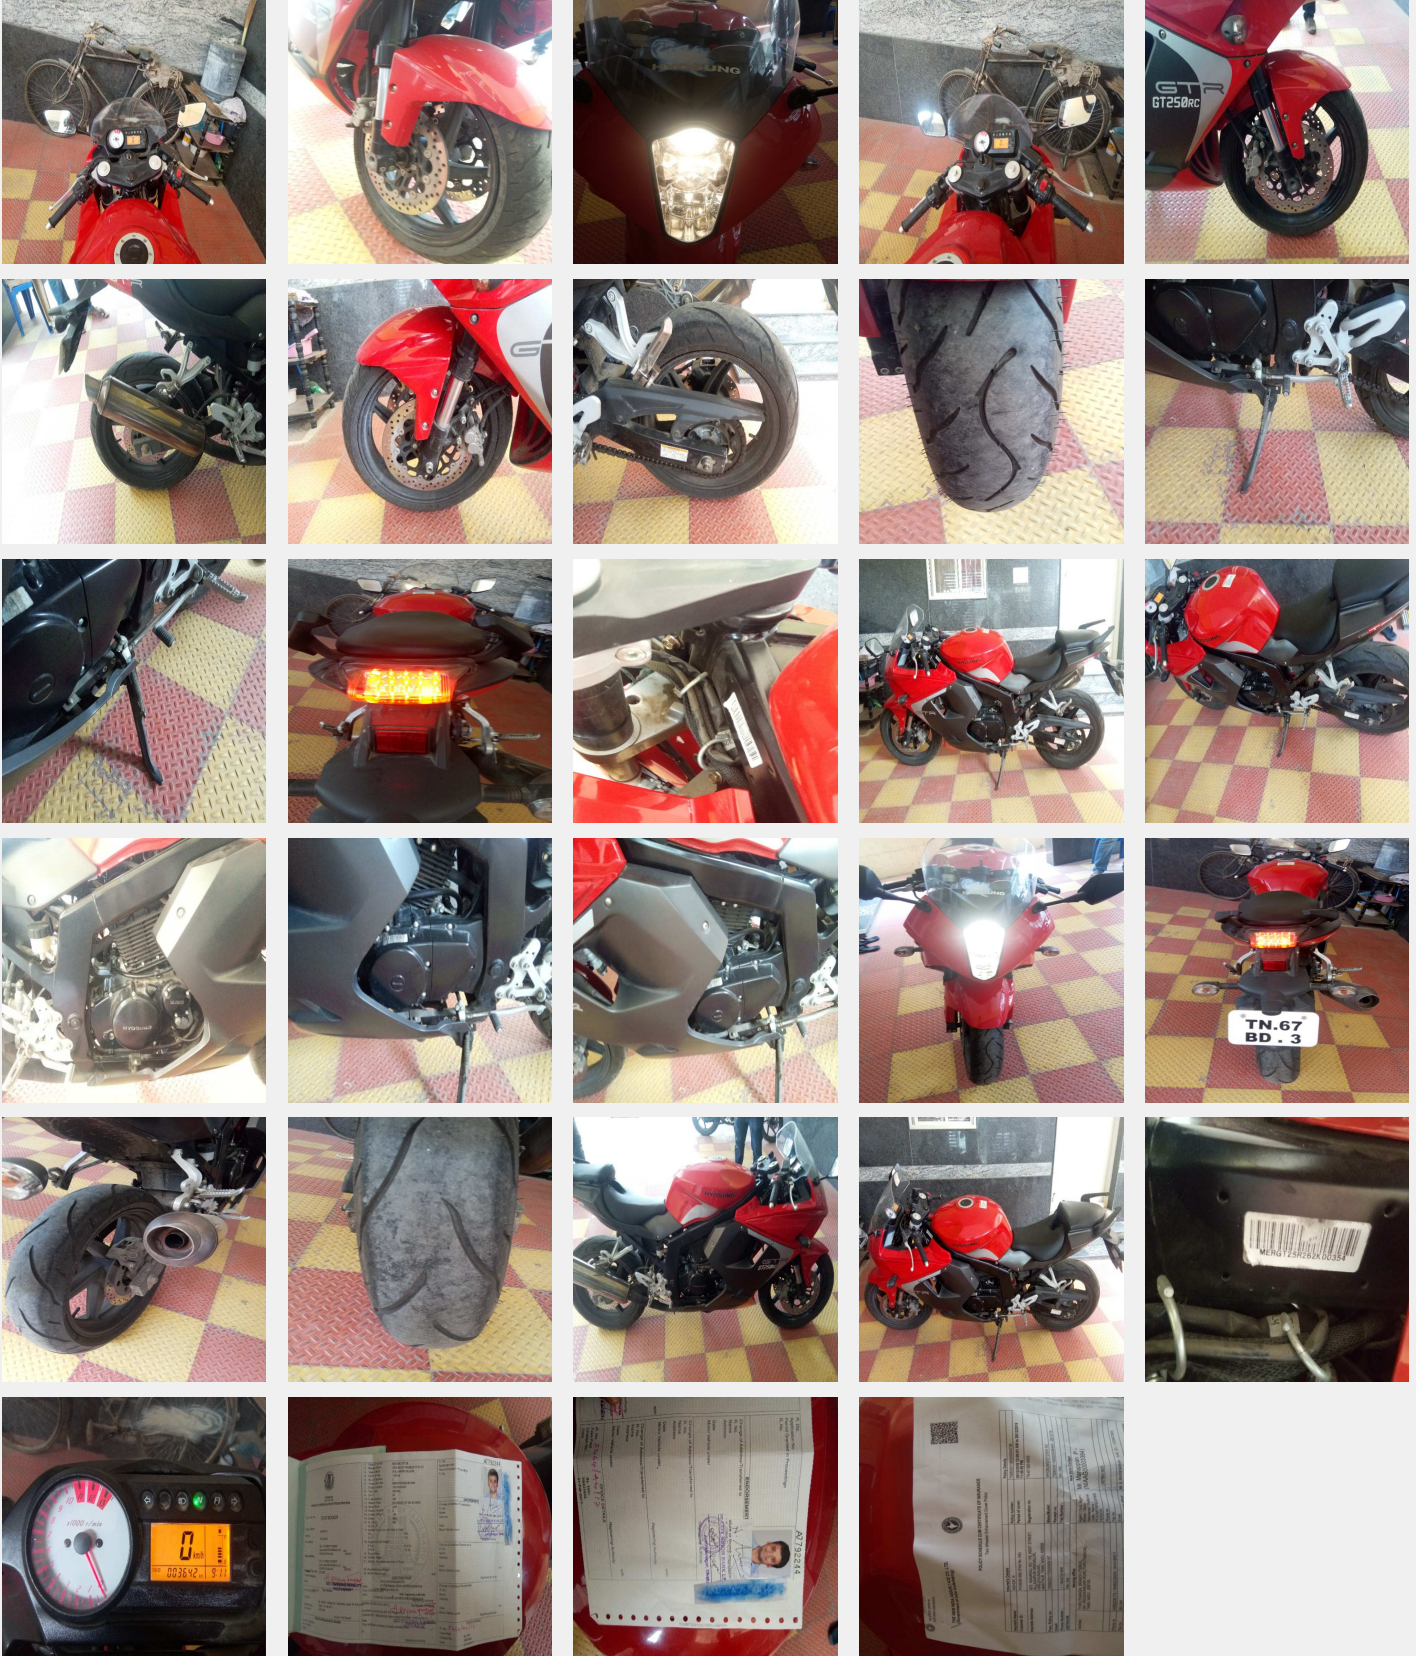
IMAGES (29)

Front side license plate not available and HP cancellation TN reg bike. good condition bike
