# ECO INSPECTION CERTIFICATE

121 Points Vehicle Inspection Certificate

Ordered By : Komal Anand	Inspection Date : 2019-08-03	Location : DELHI	Inspected By

## Royal Enfield Interceptor 650CC, 2019

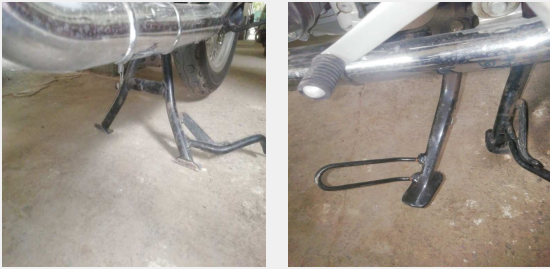
## STAND

INSPECTION CHECKPOINTS	SCORE(X/10)	REMARKS/COMMENTS	OPTIONAL SPEND EST. (RS)
CENTRE STAND CONDITION	8		0
CENTRE STAND RETENTION	8		0
SIDE STAND CONDITION	8		0
SIDE STAND RETENTION	8		0
