ECO INSPECTION CERTIFICATE

Order ID : 96737

121 Points Vehicle Inspection Certificate

Benelli Tnt 300 300CC, 2016

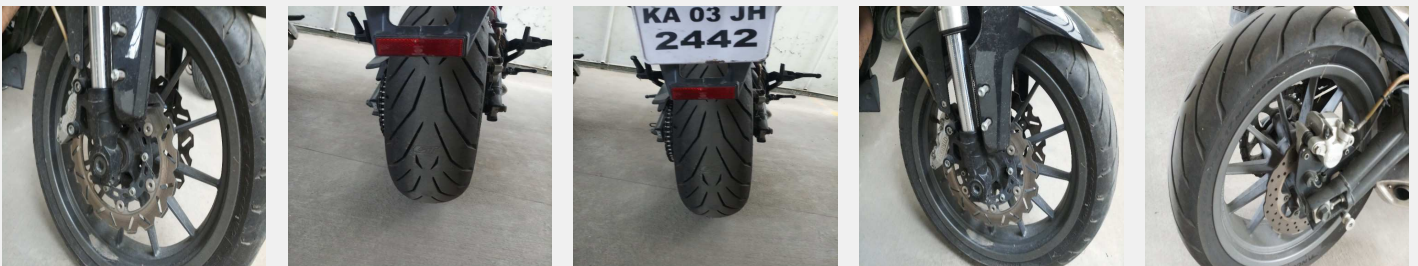
INSPECTION CHECKPOINTS	SCORE(X/10)	REMARKS/COMMENTS	OPTIONAL SPEND EST. (RS)
FRONT TYRE CONDITION & AIR PRESSURE	7		0
REAR TYRE CONDITION & AIR PRESSURE	7		0
WHEEL SPOKES FRONT	7		0
WHEEL SPOKES REAR	7		0
WHEEL RIM FRONT	7		0
WHEEL RIM REAR	7		0
WHEEL BEARINGS FRONT	7		0
WHEEL BEARINGS REAR	7		0
WHEEL SEALS FRONT	7		0
WHEEL SEALS REAR	7		0
BRAKE FUNCTION FRONT	7		0
BRAKE FUNCTION REAR	7		0
BRAKES CONDITION FRONT	7		0
BRAKES CONDITION REAR	7		0

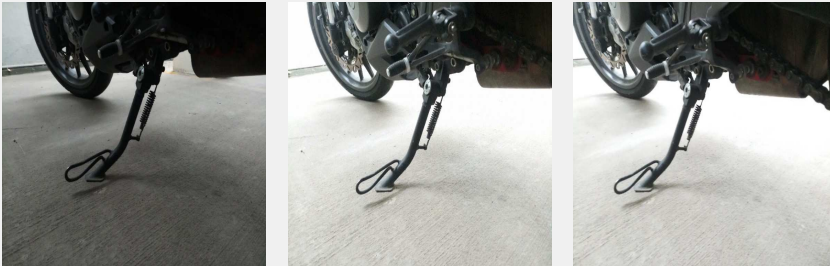
INSPECTION CHECKPOINTS	SCORE(X/10)	REMARKS/COMMENTS	OPTIONAL SPEND EST. (RS)
CENTRE STAND CONDITION	10	FUCHER NOT AVAILABLE	0
CENTRE STAND RETENTION	7		0
SIDE STAND CONDITION	7		0
SIDE STAND RETENTION	7		0
