ECO INSPECTION CERTIFICATE

121 Points Vehicle Inspection Certificate

Harley-Davidson Street 750 750CC, 2014

MAKE	HARLEY-DAVIDSON	ENGINE NUMBER	NBBF502900
MODEL	STREET 750	REGISTRATION NO.	MH14EQ9193
YEAR	2014	VIN/CHASSIS NUMBER	MEG4NBBNXFN502900
TRIM	750CC	ODOMETER READING	13921
COLOR	BLACK	INSURANCE EXPIRY	2020-10-15
FUEL TYPE	PETROL	ENGINE SOUND LINK	LISTEN ENGINE SOUND

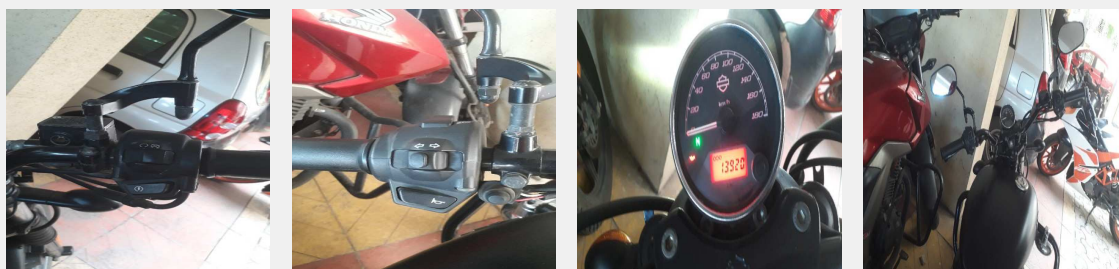
CONTROL

INSPECTION CHECKPOINTS	SCORE(X/10)	REMARKS/COMMENTS	OPTIONAL SPEND EST. (RS)
HANDLEBARS CONDITION	8	HANDLE GRIP IS IN GOOD CONDITION	0
LEVERS & PEDAL CONDITION	8	LEVERS & PEDAL ARE IN GOOD CONDITION	0

PIVOTS	8	PIVOTS ARE IN GOOD CONDITION	0
CABLES CONDITION	8	CABLE/TUBE IS IN GOOD CONDITION	0
CABLES ROUTING	8	CABLE/TUBE IS IN GOOD CONDITION	0
HOSES CONDITION	8	ALL HOSES/PIPES IS IN GOOD CONDITION	0
HOSES ROUTING	8	ALL HOSES/PIPES IS IN GOOD CONDITION	0
THROTTLE OPERATION	8	THROTTLE IS WORKING IN GOOD CONDITION	0

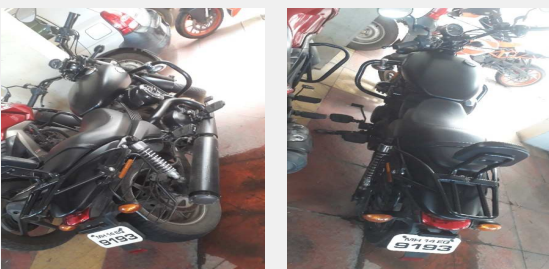
INSPECTION CHECKPOINTS	SCORE(X/10)	REMARKS/COMMENTS	OPTIONAL SPEND EST. (RS)
FRAME CONDITION	8	BASE FRAME IS IN GOOD CONDITION	0
FRAME STEERING-HEAD BEARINGS	8	STEERING BEARING IS WORKING IN GOOD CONDITION	0
FRAME SWINGARM BUSHINGS	8	FRAME SWINGARM BUSHINGS IS IN GOOD CONDITION	0
SUSPENSION FRONT FORKS LEFT	8	FRONT LEFT FORK IS IN GOOD CONDITION	0
SUSPENSION FRONT FORKS RIGHT	8	FRONT RIGHT FORK IS IN GOOD CONDITION	0
SUSPENSION REAR SHOCKS LEFT	8	REAR LEFT SHOCK ABSORBER IS WORKING IN GOOD CONDITION	0
SUSPENSION REAR SHOCKS RIGHT	8	REAR RIGHT SHOCK ABSORBER IS WORKING IN GOOD CONDITION	0
CHAIN/BELT TENSION	8	DRIVE CHAIN TENSIONER IS IN GOOD CONDITION	0
CHAIN/BELT LUBRICATION	6	DRIVE CHAIN AVERAGE LUBRICATION	0
CHAIN/BELT SPROCKETS	8	DRIVE CHAIN SPROCKET IS IN GOOD CONDITION	0
FASTENERS THREADED	8	FASTENERS THREADED IS IN GOOD CONDITION	0
FASTENERS CLIPS & COTTER PINS	8	FASTENERS CLIPS & COTTER PINS IS IN GOOD CONDITION	0

ENGINE	8	ENGINE PERFORMANCE IS IN GOOD CONDITION	0
TRANSMISSION	8	TRANSMISSION PERFORMANCE IS IN GOOD CONDITION	0
