ECO INSPECTION CERTIFICATE

121 Points Vehicle Inspection Certificate

Kawasaki Ninja 650 KRT EDITION, 2017

MAKE	KAWASAKI	ENGINE NUMBER	D4026
MODEL	NINJA	REGISTRATION NO.	MH01CW7072
YEAR	2017	VIN/CHASSIS NUMBER	T00117
TRIM	650 KRT EDITION	ODOMETER READING	17285
COLOR	LIME GREEN	INSURANCE EXPIRY	2019-8-29
FUEL TYPE	PETROL	ENGINE SOUND LINK	LISTEN ENGINE SOUND

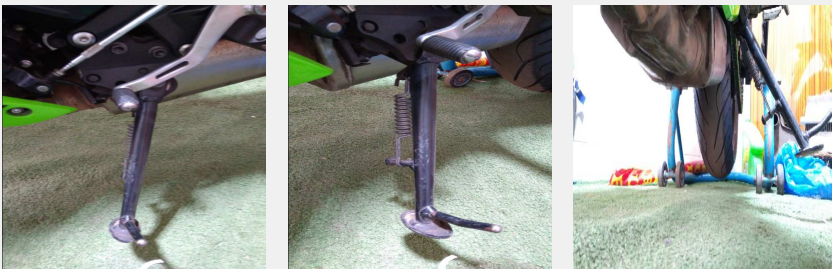
INSPECTION CHECKPOINTS	SCORE(X/10)	REMARKS/COMMENTS	OPTIONAL SPEND EST. (RS)
SIDE STAND CONDITION	8	SIDE STAND IS IN GOOD CONDITION	0
SIDE STAND RETENTION	8	SIDE STAND IS IN GOOD CONDITION	0
CENTRE STAND CONDITION	0	CENTRE STAND NOT AVAILABLE	0
CENTRE STAND RETENTION	0	CENTRE STAND NOT AVAILABLE	0

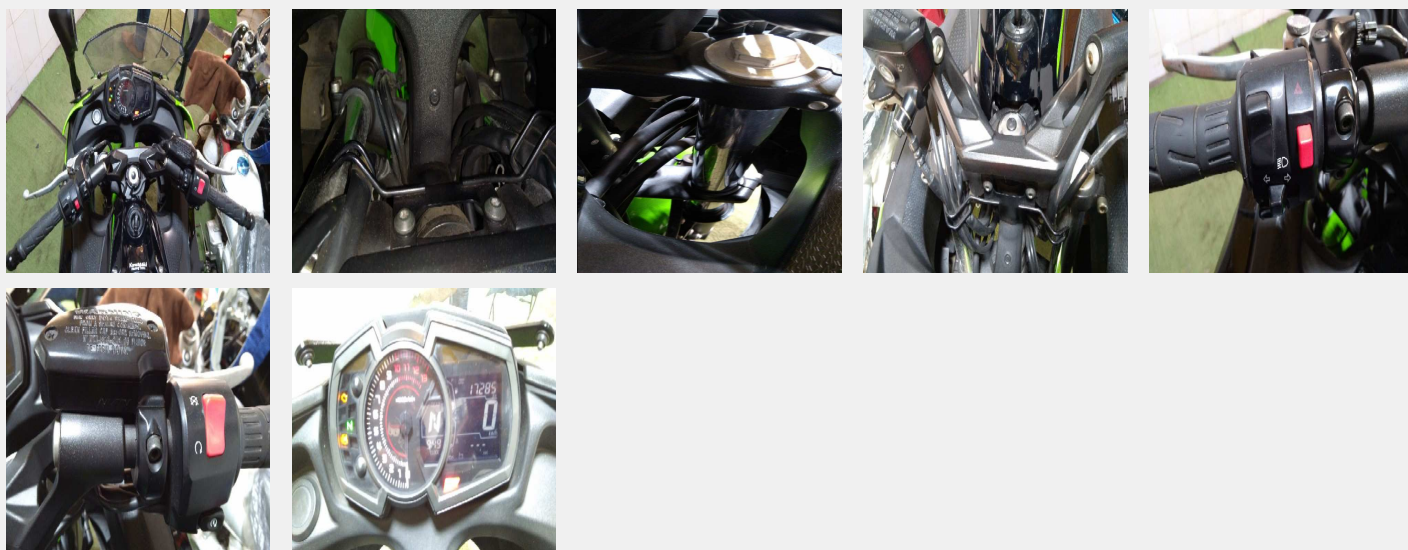
CONTROL

INSPECTION CHECKPOINTS	SCORE(X/10)	REMARKS/COMMENTS	OPTIONAL SPEND EST. (RS)
HANDLEBARS CONDITION	8	HANDLE GRIP IS IN GOOD CONDITION	0
LEVERS & PEDAL CONDITION	8	LEVERS & PEDAL ARE IN GOOD CONDITION	0

PIVOTS	8	PIVOTS ARE IN GOOD CONDITION	0
CABLES CONDITION	8	CABLE/TUBE IS IN GOOD CONDITION	0
CABLES ROUTING	8	CABLE/TUBE IS IN GOOD CONDITION	0
HOSES CONDITION	8	ALL HOSES/PIPES IS IN GOOD CONDITION	0
HOSES ROUTING	8	ALL HOSES/PIPES IS IN GOOD CONDITION	0
THROTTLE OPERATION	8	THROTTLE IS WORKING IN GOOD CONDITION	0

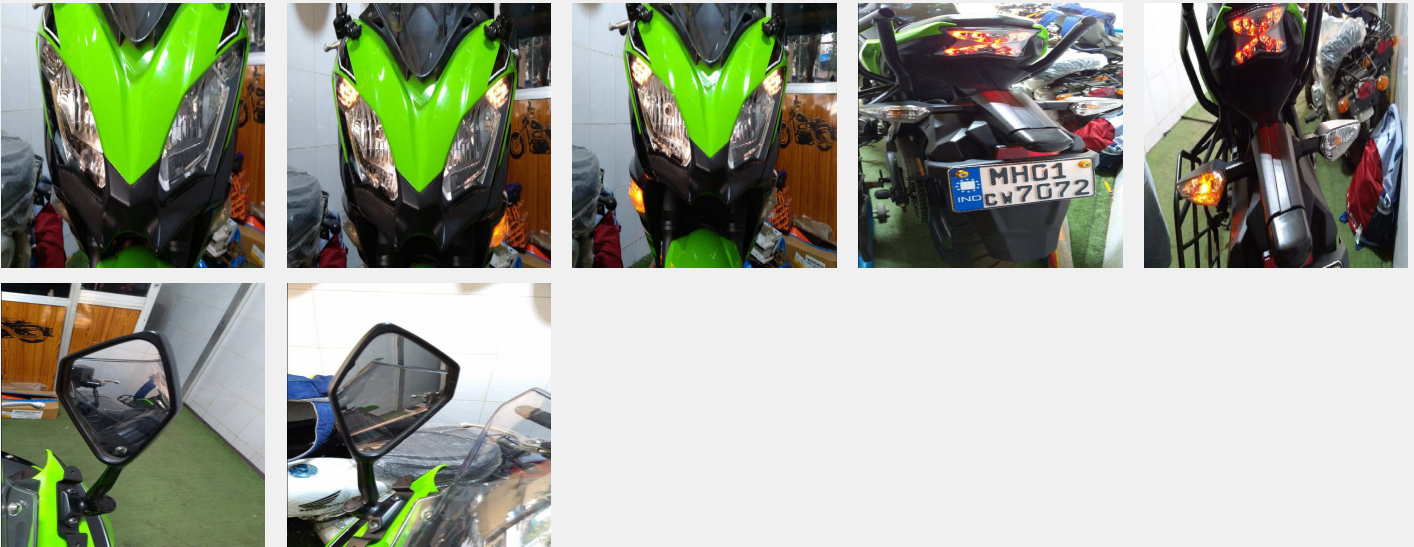
LIGHT

INSPECTION CHECKPOINTS	SCORE(X/10)	REMARKS/COMMENTS	OPTIONAL SPEND EST. (RS)
BATTERY CONDITION	6	BATTERY IS WORKING IN AVERAGE CONDITION	0
BATTERY VENT TUBE	8	CABLE/TUBE IS IN GOOD CONDITION	0
HEADLAMP CONDITION	8	HEAD LIGHTS ARE WORKING IN GOOD CONDITION	0
TAILLAMP/BRAKELAMP CONDITION	8	TAILLAMP/BRAKELAMP ARE WORKING IN GOOD CONDITION	0
TAILLAMP/BRAKELAMP OPERATION	8	TAILLAMP/BRAKELAMP ARE WORKING IN GOOD CONDITION	0
TURN SIGNALS OPERATION FRONT LEFT	8	FRONT LEFT INDICATOR IS WORKING IN GOOD CONDITION	0
TURN SIGNALS OPERATION FRONT RIGHT	8	FRONT RIGHT INDICATOR IS WORKING IN GOOD CONDITION	0
TURN SIGNALS OPERATION REAR LEFT	8	REAR LEFT INDICATOR IS WORKING IN GOOD CONDITION	0
TURN SIGNALS OPERATION REAR RIGHT	8	REAR RIGHT INDICATOR IS WORKING IN GOOD CONDITION	0
SWITCHES OPERATION	8	LIGHT/INDICATOR SWITCHES ARE WORKING IN GOOD CONDITION	0
MIRRORS CONDITION	8	MIRRORS ARE IN GOOD CONDITION	0
MIRRORS AIM	8	MIRRORS ARE IN GOOD CONDITION	0

LENSES & REFLECTORS CONDITION	8	LENSES & REFLECTORS ARE IN GOOD CONDITION	0
WIRING CONDITION	8	WIRING HARNESS IS IN GOOD CONDITION	0
WIRING ROUTING	8	WIRING HARNESS IS IN GOOD CONDITION	0

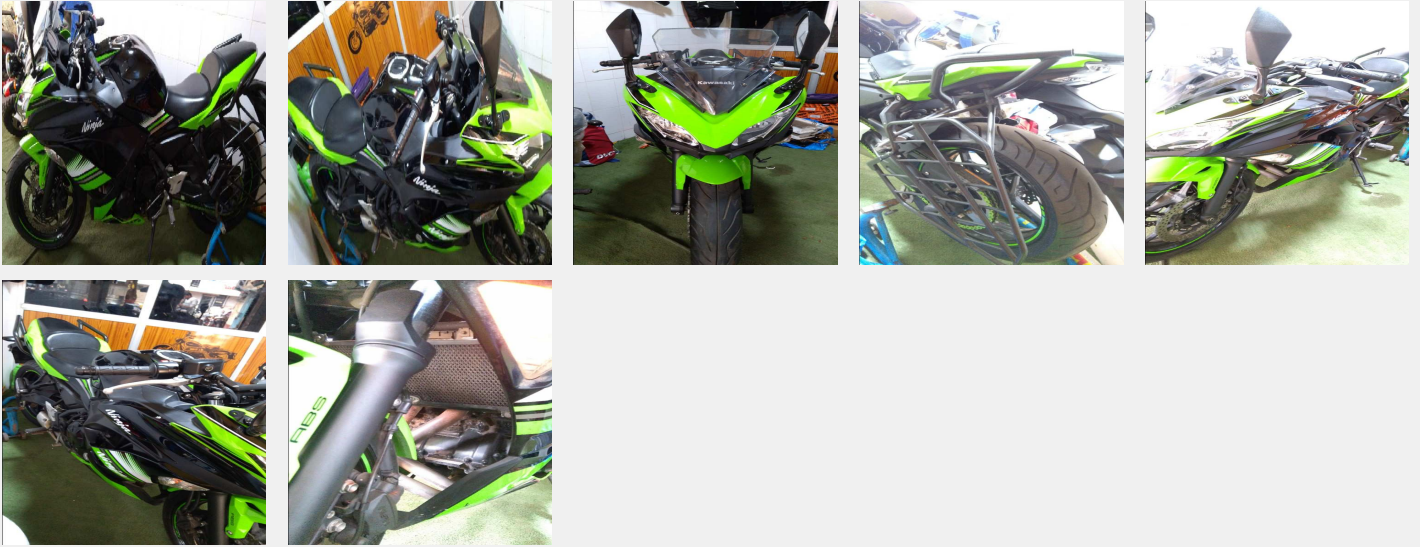
CHASSIS

INSPECTION CHECKPOINTS	SCORE(X/10)	REMARKS/COMMENTS	OPTIONAL SPEND EST. (RS)
FRAME CONDITION	8	BASE FRAME IS IN GOOD CONDITION	0
FRAME STEERING-HEAD BEARINGS	8	STEERING BEARING IS WORKING IN GOOD CONDITION	0
FRAME SWINGARM BUSHINGS	8	FRAME SWINGARM BUSHINGS IS IN GOOD CONDITION	0
SUSPENSION FRONT FORKS LEFT	8	FRONT LEFT FORK IS IN GOOD CONDITION	0
SUSPENSION FRONT FORKS RIGHT	8	FRONT RIGHT FORK IS IN GOOD CONDITION	0
SUSPENSION REAR SHOCKS LEFT	8	REAR LEFT SHOCK ABSORBER IS WORKING IN GOOD CONDITION	0
SUSPENSION REAR SHOCKS RIGHT	8	REAR RIGHT SHOCK ABSORBER IS WORKING IN GOOD CONDITION	0
CHAIN/BELT TENSION	8	DRIVE CHAIN TENSIONER IS IN GOOD CONDITION	0
CHAIN/BELT LUBRICATION	6	DRIVE CHAIN AVERAGE LUBRICATION	0
CHAIN/BELT SPROCKETS	8	DRIVE CHAIN SPROCKET IS IN GOOD CONDITION	0
FASTENERS THREADED	8	FASTENERS THREADED IS IN GOOD CONDITION	0

FASTENERS CLIPS & COTTER PINS	8	FASTENERS CLIPS & COTTER PINS IS IN GOOD CONDITION	0
ENGINE	8	ENGINE PERFORMANCE IS IN GOOD CONDITION	0
TRANSMISSION	8	TRANSMISSION PERFORMANCE IS IN GOOD CONDITION	0
