# ECO INSPECTION CERTIFICATE

121 Points Vehicle Inspection Certificate

Inspection Date :  
2019-10-19

## Royal Enfield Interceptor 650CC, 2019

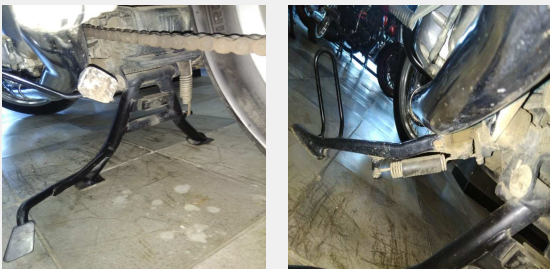
IMAGES

INSPECTION CHECKPOINTS	SCORE(X/10)	REMARKS/COMMENTS	OPTIONAL SPEND EST. (RS)
CENTRE STAND CONDITION	6	CENTRE STAND IS IN AVERAGE CONDITION	0
CENTRE STAND RETENTION	6	CENTRE STAND IS IN AVERAGE CONDITION	0
SIDE STAND CONDITION	6	SIDE STAND IS IN AVERAGE CONDITION	0
SIDE STAND RETENTION	6	SIDE STAND IS IN AVERAGE CONDITION	0
