# ECO INSPECTION CERTIFICATE

121 Points Vehicle Inspection Certificate

## Hyosung Gt250r 250cc, 2016

Ordered by: Shantanu Bobade | Inspected date: 2019-11-03

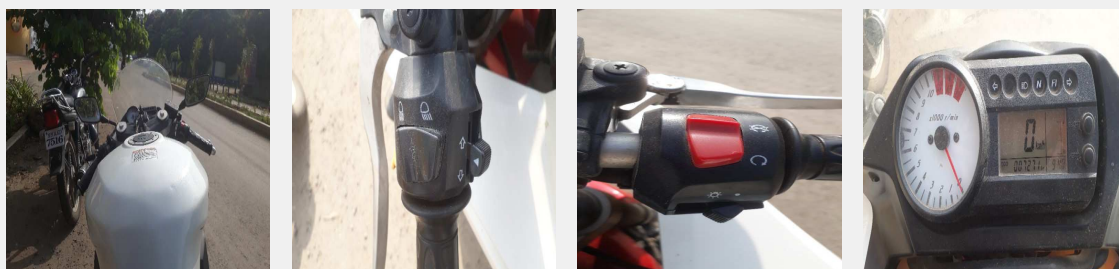
## IMAGES

INSPECTION CHECKPOINTS	SCORE(X/10)	REMARKS/COMMENTS	OPTIONAL SPEND EST. (RS)
HANDLEBARS CONDITION	8	HANDLE GRIP IS IN GOOD CONDITION	0
LEVERS & PEDAL CONDITION	8	LEVERS & PEDAL ARE IN GOOD CONDITION	0

PIVOTS	8	PIVOTS ARE IN GOOD CONDITION	0
CABLES CONDITION	8	CABLE/TUBE IS IN GOOD CONDITION	0
CABLES ROUTING	8	CABLE/TUBE IS IN GOOD CONDITION	0
HOSES CONDITION	8	ALL HOSES/PIPES IS IN GOOD CONDITION	0
HOSES ROUTING	8	ALL HOSES/PIPES IS IN GOOD CONDITION	0
THROTTLE OPERATION	8	THROTTLE IS WORKING IN GOOD CONDITION	0
