# ECO INSPECTION CERTIFICATE

Order ID : 121135

121 Points Vehicle Inspection Certificate

## Benelli Tnt 300 300CC, 2017

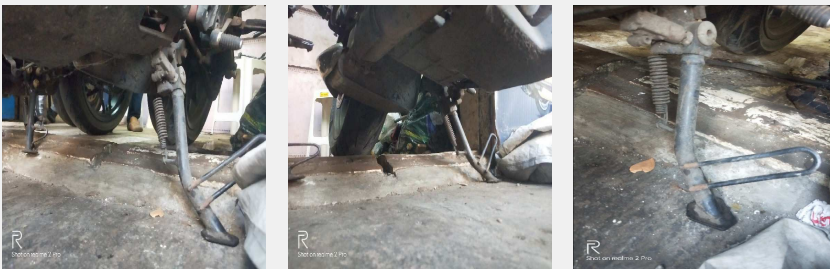
## STAND

INSPECTION CHECKPOINTS	SCORE(X/10)	REMARKS/COMMENTS	OPTIONAL SPEND EST. (RS)
SIDE STAND CONDITION	6	SIDE STAND IS IN AVERAGE CONDITION	0
SIDE STAND RETENTION	6	SIDE STAND IS IN AVERAGE CONDITION	0
CENTRE STAND CONDITION	0	CENTRE STAND NOT AVAILABLE	0
CENTRE STAND RETENTION	0	CENTRE STAND NOT AVAILABLE	0

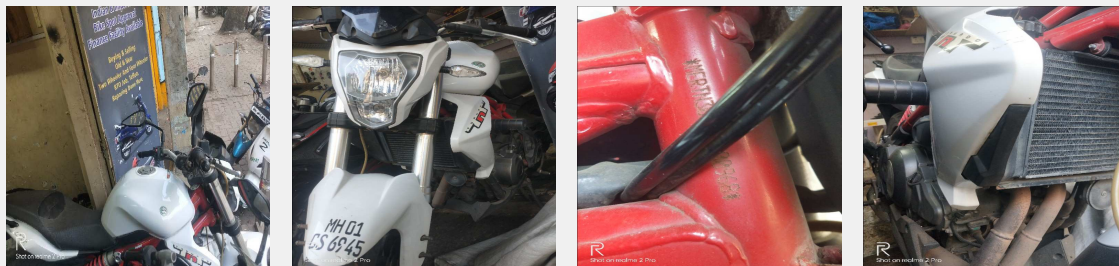
## CHASSIS

INSPECTION CHECKPOINTS	SCORE(X/10)	REMARKS/COMMENTS	OPTIONAL SPEND EST. (RS)
FRAME CONDITION	6	BASE FRAME IS IN AVERAGE CONDITION	0
FRAME STEERING-HEAD BEARINGS	6	STEERING BEARING IS WORKING IN AVERAGE CONDITION	0
FRAME SWINGARM BUSHINGS	6	FRAME SWINGARM BUSHINGS IS IN AVERAGE CONDITION	0
SUSPENSION FRONT FORKS LEFT	6	FRONT LEFT FORK IS IN AVERAGE CONDITION	0
SUSPENSION FRONT FORKS RIGHT	6	FRONT RIGHT FORK IS IN AVERAGE CONDITION	0
SUSPENSION REAR SHOCKS LEFT	6	REAR LEFT SHOCK ABSORBER IS WORKING IN AVERAGE CONDITION	0
SUSPENSION REAR SHOCKS RIGHT	6	REAR RIGHT SHOCK ABSORBER IS WORKING IN AVERAGE CONDITION	0
CHAIN/BELT TENSION	8	DRIVE CHAIN TENSIONER IS IN GOOD CONDITION	0
CHAIN/BELT LUBRICATION	8	DRIVE CHAIN GOOD LUBRICATION	0
CHAIN/BELT SPROCKETS	8	DRIVE CHAIN SPROCKET IS IN GOOD CONDITION	0
FASTENERS THREADED	6	FASTENERS THREADED IS IN AVERAGE CONDITION	0

FASTENERS CLIPS & COTTER PINS	6	FASTENERS CLIPS & COTTER PINS IS IN AVERAGE CONDITION	0
ENGINE	8	ENGINE PERFORMANCE IS IN GOOD CONDITION	0
TRANSMISSION	8	TRANSMISSION PERFORMANCE IS IN GOOD CONDITION	0
