# ECO INSPECTION CERTIFICATE

121 Points Vehicle Inspection Certificate

<b>Ordered By :</b> Mahesh Patankar	<b>Inspection Date :</b> 2019-12-01	<b>Location :</b> VILEPARLE	<b>Inspected By</b>

## Indian Scout 1130cc, 2016

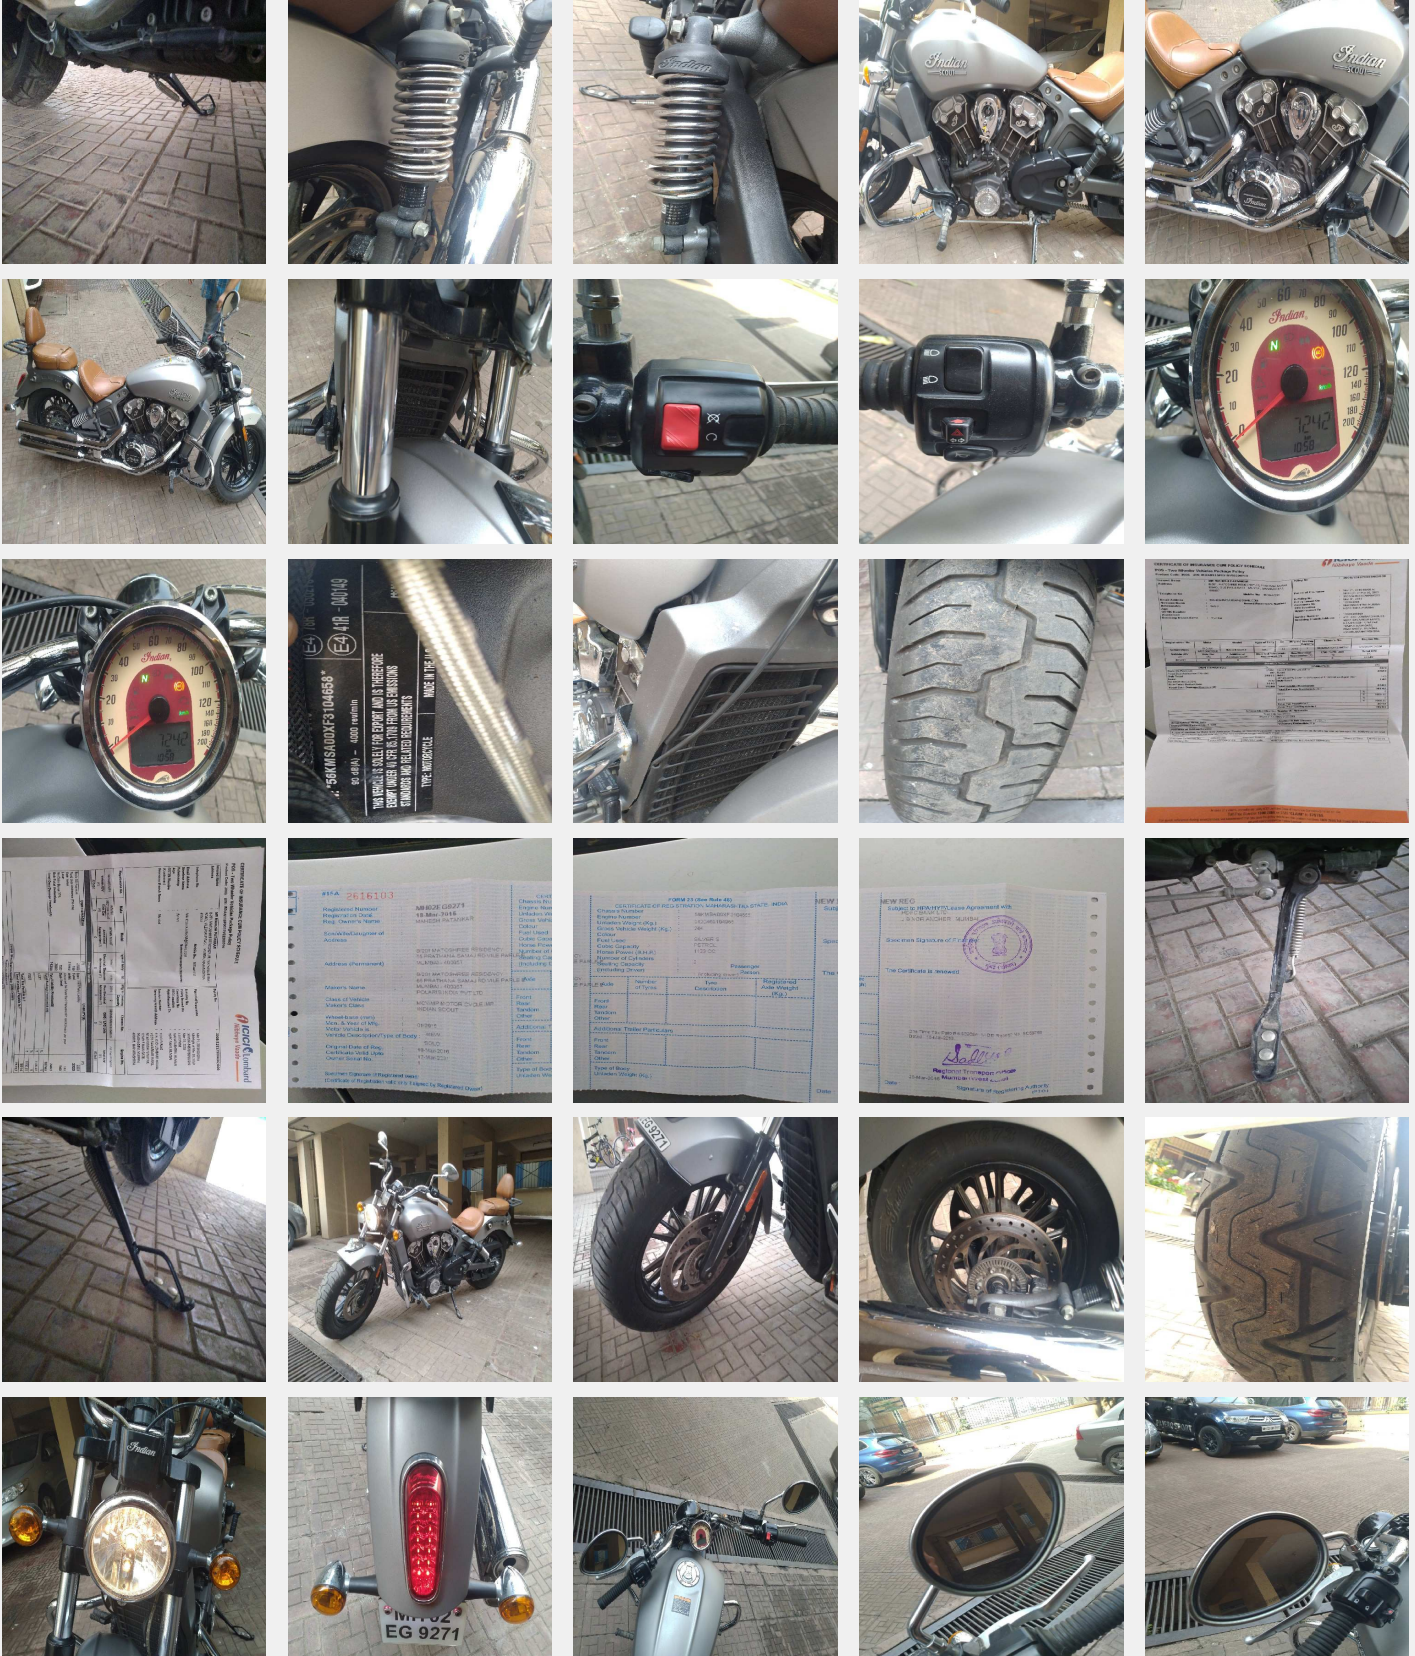
IMAGES (30)

good condition bike
