ECO INSPECTION CERTIFICATE

Order ID : 124645

121 Points Vehicle Inspection Certificate

MV Agusta F3 800cc, 2015

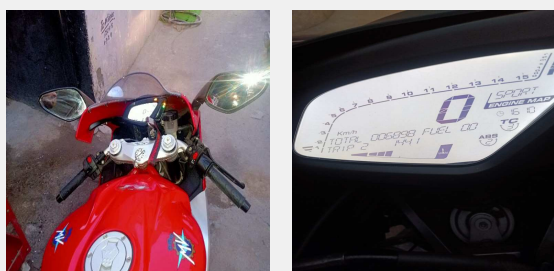
IMAGES

INSPECTION CHECKPOINTS	SCORE(X/10)	REMARKS/COMMENTS	OPTIONAL SPEND EST. (RS)
HANDLEBARS CONDITION	8	HANDLE GRIP IS IN GOOD CONDITION	0
LEVERS & PEDAL CONDITION	8	LEVERS & PEDAL ARE IN GOOD CONDITION	0
PIVOTS	8	PIVOTS ARE IN GOOD CONDITION	0

CABLES CONDITION	8	CABLE/TUBE IS IN GOOD CONDITION	0
CABLES ROUTING	8	CABLE/TUBE IS IN GOOD CONDITION	0
HOSES CONDITION	8	ALL HOSES/PIPES IS IN GOOD CONDITION	0
HOSES ROUTING	8	ALL HOSES/PIPES IS IN GOOD CONDITION	0
THROTTLE OPERATION	8	THROTTLE IS WORKING IN GOOD CONDITION	0
